Re: Letter of Concern
Compliance Evaluation Inspection
National Pollutant Discharge Elimination System Permit No. AL0003247

Walter Coke, Inc. Municipal Wastewater Treatment and Stormwater Inspection,
September 12-14, 2011 and December 12, 2011

Compliance Evaluation Inspection Report Walter Coke Inc. Industrial Wastewater Treatment System and Stormwater Collection and Discharge System

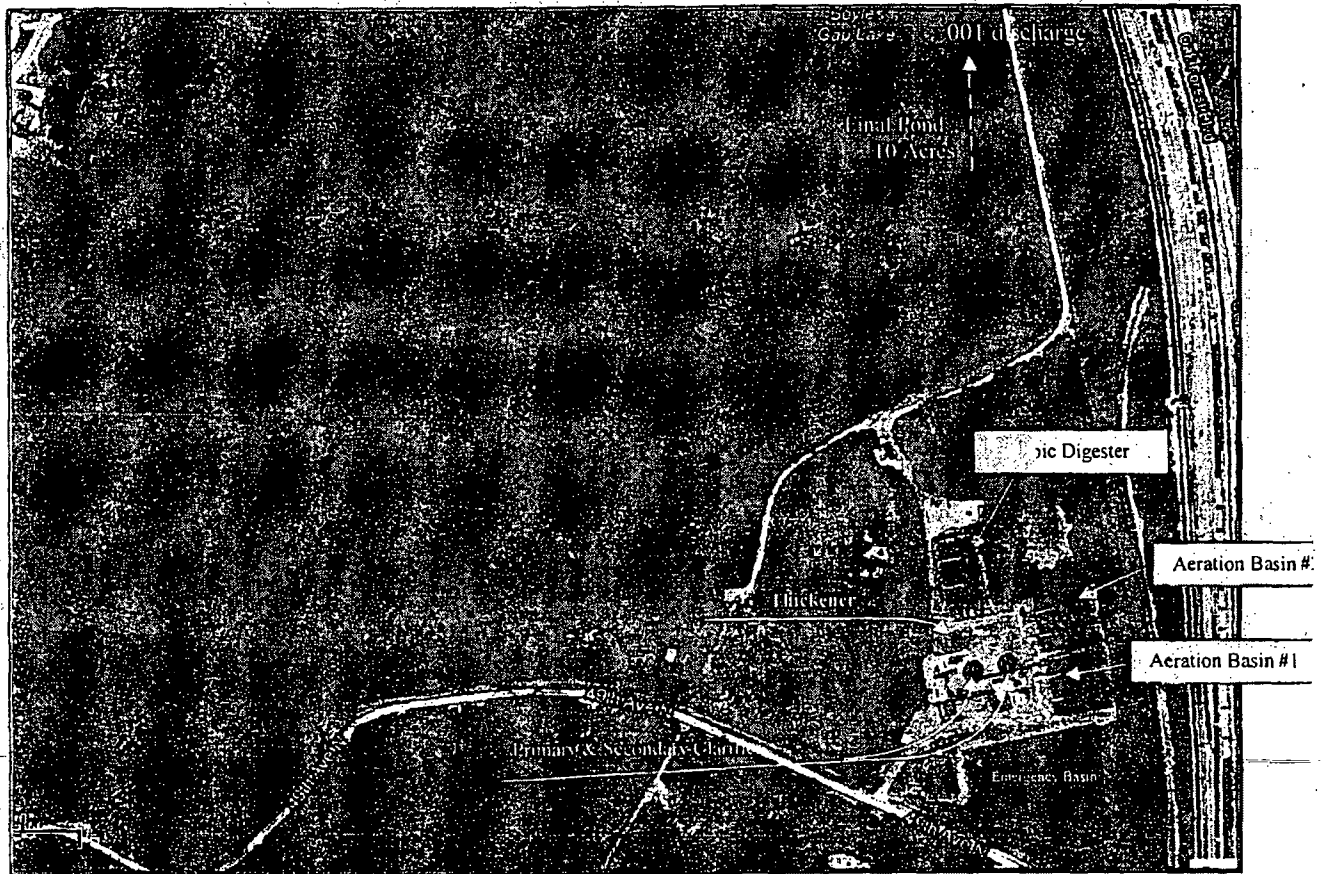
Photo 2- Walter Coke Inc. Biological Treatment Facility

The Facility operates a Biological Treatment Facility (BTF) with advance treatment for the phenol compound and cyanide removal (Photo 2). Figure 1 is a schematic diagram of the process wastewater flow for both Outfalls 001B and Outfall 001. The configuration of the schematic diagram is based on information provided to the EPA by Walter Coke Inc.

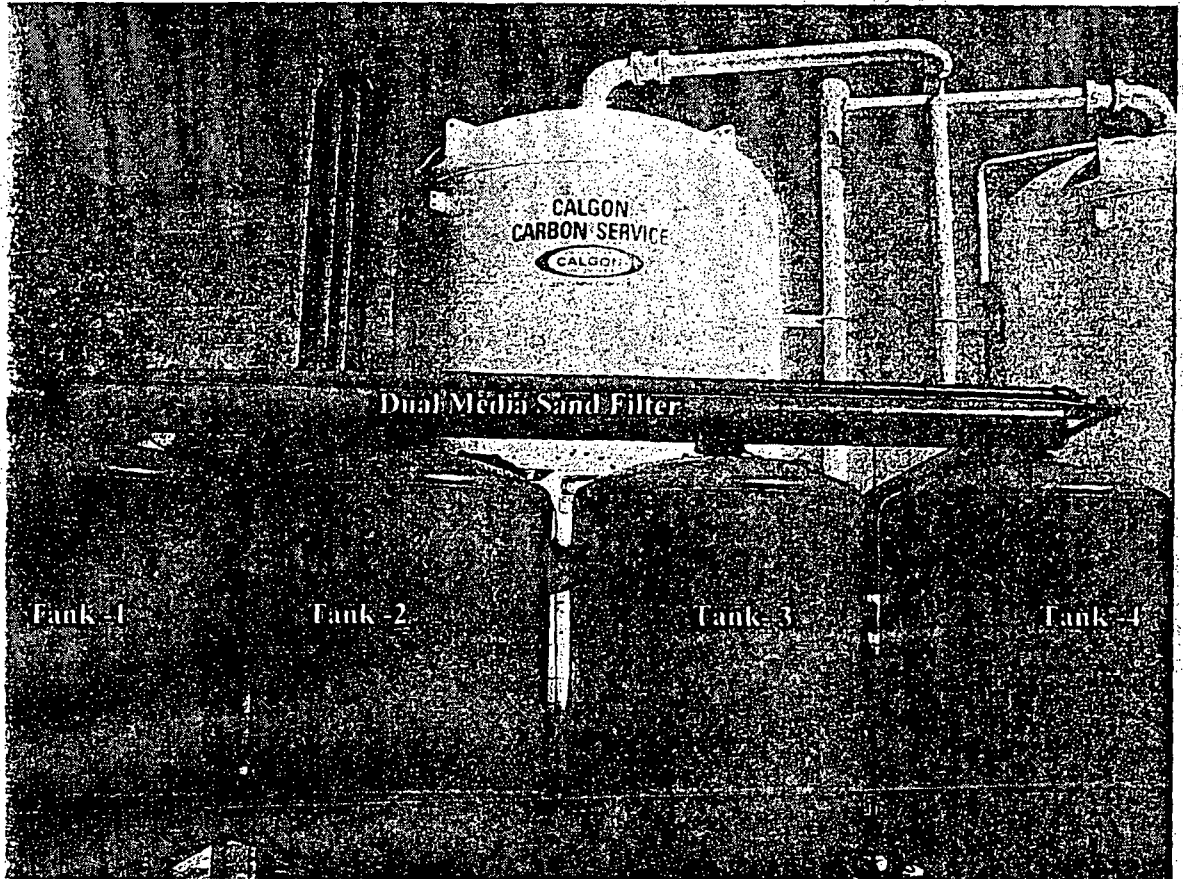
Photo 8 - Sand and Carbon Absorption Filters

The Facility's Dual Media Filter is designed to remove phenol compounds from the wastewater (Photo 8). The Dual Media Filter treatment consists of sand filtration followed by active carbon absorption.

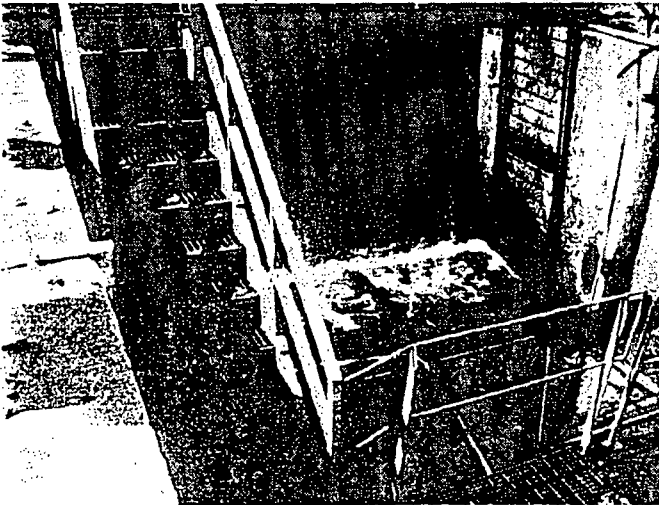
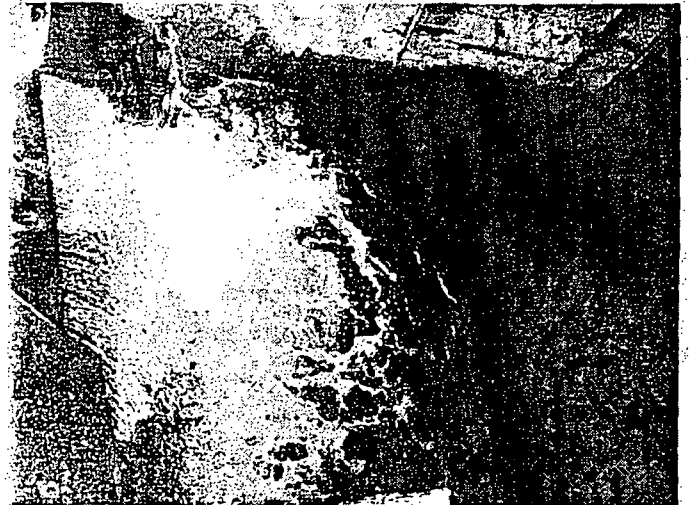
The EPA Sewer, which collects non-contact cooling water and stormwater runoff, discharges into a 10 acre Final Pond for treatment. Also, treated process wastewater from the BTF discharges into the Final Pond as an internal discharge outfall 001B as shown below in Photo 11. The combined treated wastewater from these main sources is discharged through Outfall 001 into Five Mile Creek (Photos 12 and 13).

Photo 12 - Outfall 001 treated effluent

Photo 13 - Discharge to Five Mile Creek

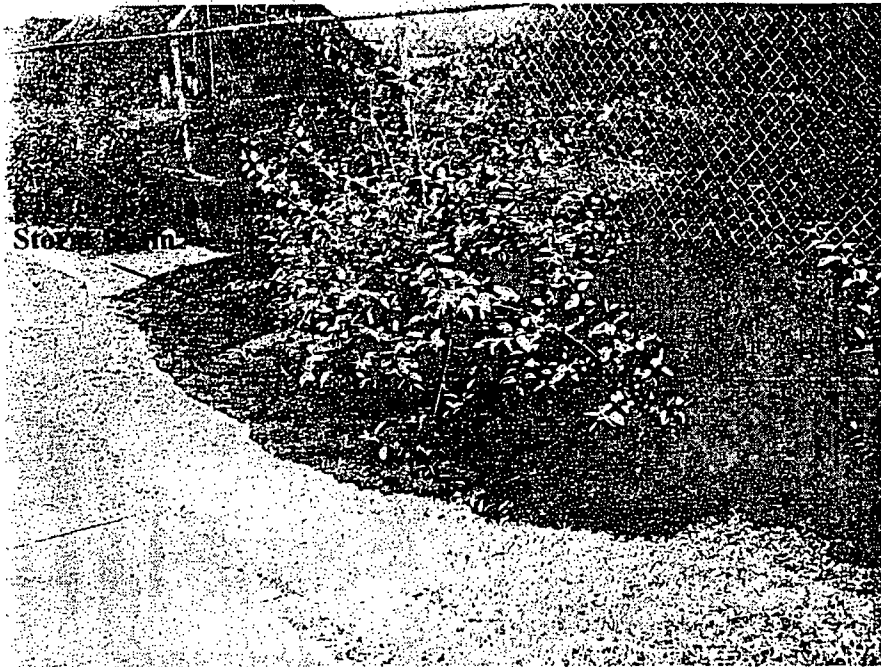
1. Coal Pile Storage Area – The coal pile storage at the Southside of the Facility has a perimeter berm to contain coal material on-site. On December 12, 2011, coal material was observed overtopping the concrete berm along 35th Avenue into the City of Birmingham's storm drain system (Photos 20 -22).

Photo taken by James Couch of the ADEM
Photo 20 - Coal discharging to City Stormwater drain

Photo 21 - Coal pile overtopping concrete berm and disposed around a storm drain

Photo 22 – Inside view of the City of Birmingham Storm Water Drain

Deficiency: The overtopping of coal material over the concrete berm along 35th Avenue into the City of Birmingham's storm drain system is not an authorized permitted discharge point. This discharge occurring on December 12, 2011, is considered an unpermitted discharge event. Once this deficiency was identified during the inspection, Walter Coke immediately mobilized a crew to clean out the coal deposits on the ground and inside the storm drain. To prevent this from future occurrences, Walter Coke proposed to move a majority of the coal stockpile away from 35th Avenue and may store more coal in railroad cars. Please provide to the EPA a detailed plan and schedule for this remedial action.

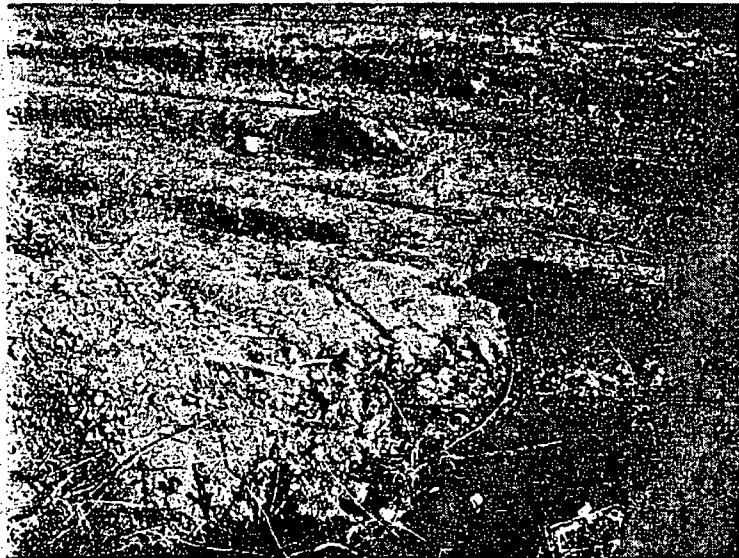
2. At the coke pile storage, stormwater runoff is designed to rout directly to a drainage ditch located in the center of the coke storage area. This drainage ditch carries stormwater along the railroad track directly into the EPA sewer and then to the Final Pond for treatment. The EPA observed numerous gullies cause by uncontrolled stormwater runoff directly to the railroad track bypassing the drainage ditch and treatment at the Final Pond. On December 13, 2011, a huge gully was observed from the coke pile storage leading to the railroad track area (Photo 23). Coke/coal material deposits were noted along the railroad track area (Photo 24).

Photo taken by Craig Mangham of the ADEM on December 14, 2011
Photo 23 - Gully Erosion caused by uncontrolled stormwater run-off near Coke pile

Photo taken on December 13, 2012 during neighboring property inspection
Photo 24 - Coke deposit along railroad track area

Deficiency: The coke pile storage at the eastside of the Facility is not adequate to contain coke material on-site. The EPA observed numerous gullies cause by uncontrolled stormwater runoff directly to the railroad track bypassing the drainage ditch and treatment at the Final Pond.

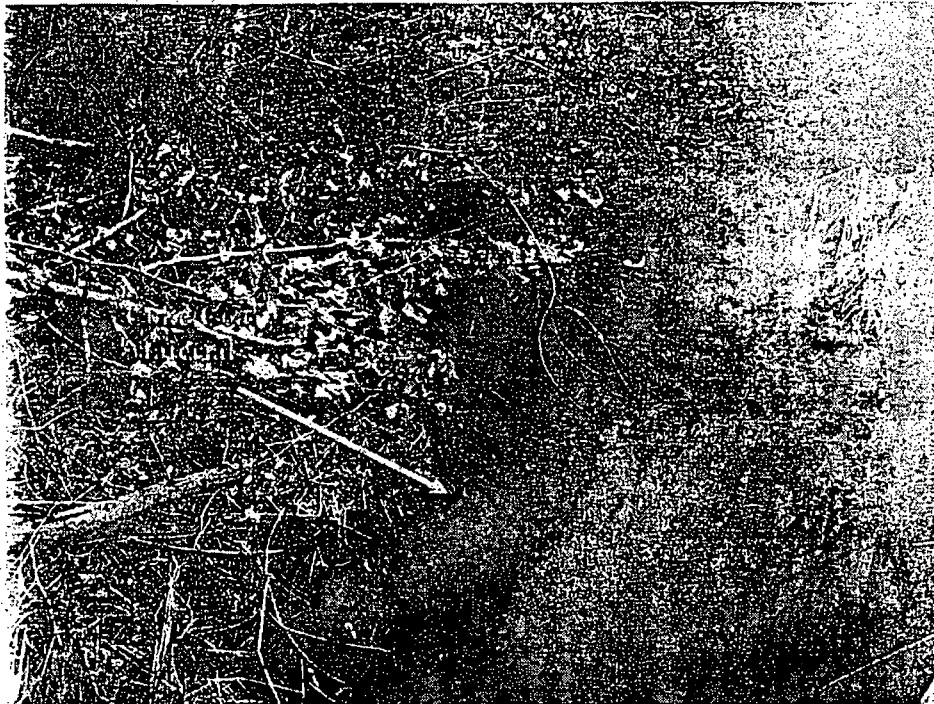
Photo 29 – Unpermitted ditch draining towards outfall 001 discharge channel

Photo 30 – Coke/Coal fines along unpermitted ditch bank

Photo 31 – Unpermitted ditch draining into culvert below F.L. Shuttlesworth Drive with coke/coal deposits

Photo 32 – Unpermitted ditch near Vulcan Materials entrance with coke/coal deposits

Photo 33 - Headwater of unpermitted ditch at Walter Coke's property

Deficiency: This drainage ditch is not listed in the NPDES Permit as a permitted outfall. The Facility should investigate the source of the flow and coke/coal fines deposits and obtain the necessary structural and nonstructural controls, and permit coverage for this drainage ditch.
