Section 319 Nonpoint Source National Monitoring Program Successes and Recommendations

Report prepared for
U.S. EPA
by

NCSU Water Quality Group
Biological and Agricultural
Engineering Department
North Carolina Cooperative
Extension Service
NC State University
Raleigh, North Carolina

November 2000 (pre-print)

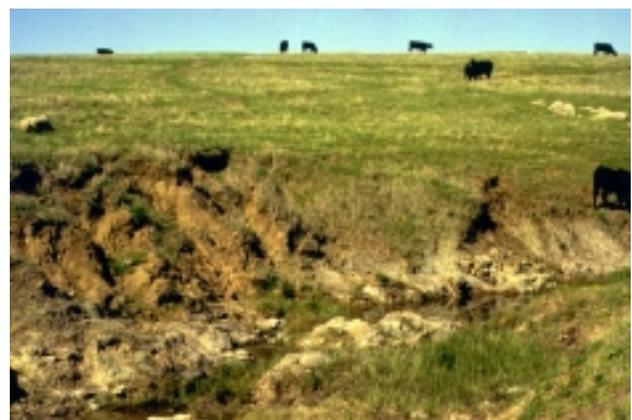
Degraded tributary due to over grazing (Morro Bay, California).

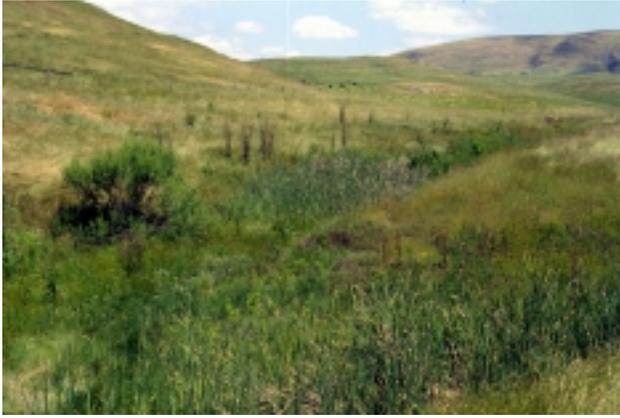
Tributary riparian area and watershed improvements after rangeland management, grazing rotation, and vegetative planting (Morro Bay, California).

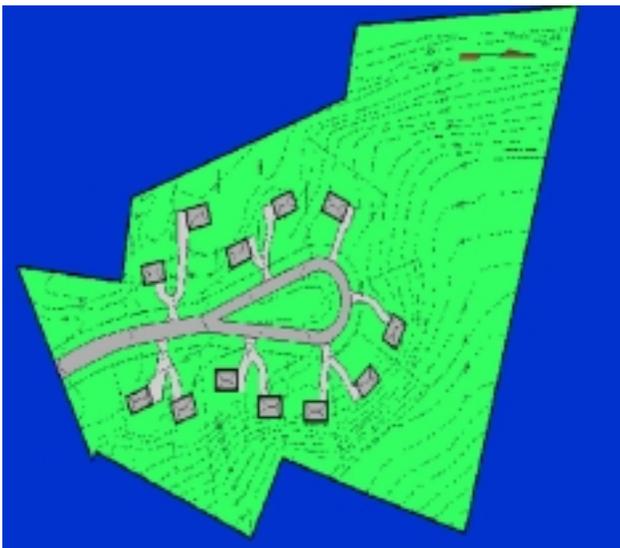
Treatment watershed site plan includes construction BMPs, shared driveways, pervious pavement and bioretention gardens (Jordan Cove, Connecticut).

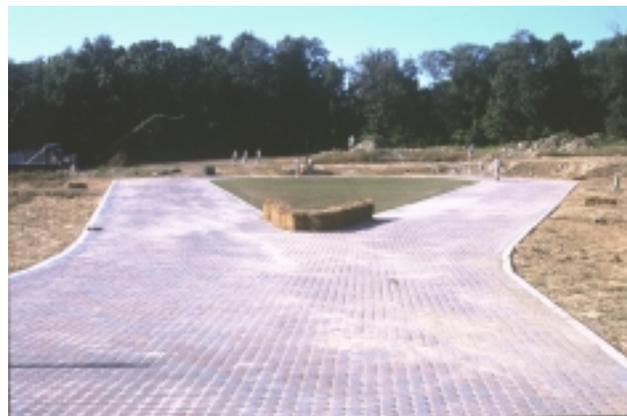
Pervious concrete pavers for roadway in BMP subdivision. Swales will be used instead of curb and gutter (Jordan Cove, Connecticut).

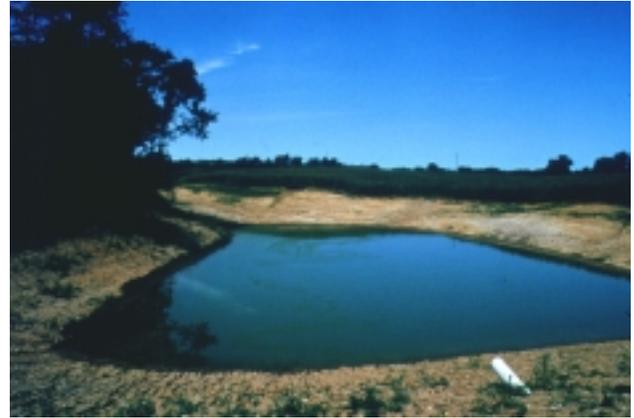
Sediment retention basin (Lake Pittsfield, Illinois).

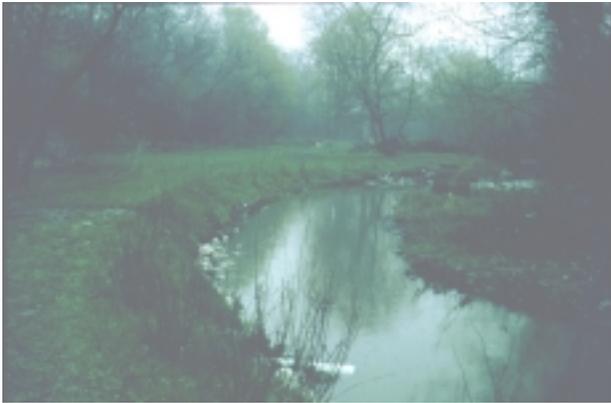
Streambank erosion (Waukegan River, Illinois).

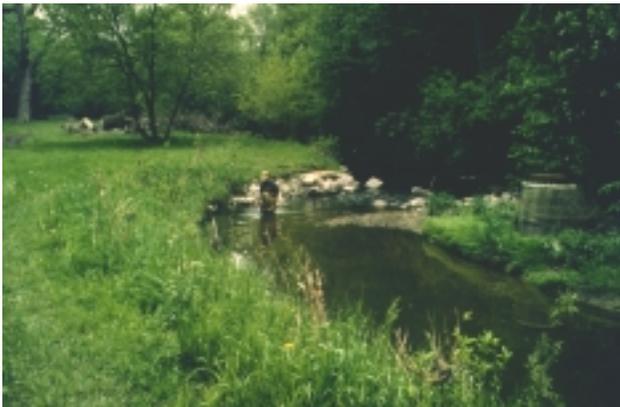
Riffles were installed downstream of lunkers to improve fish habitat (Waukegan River, Illinois).

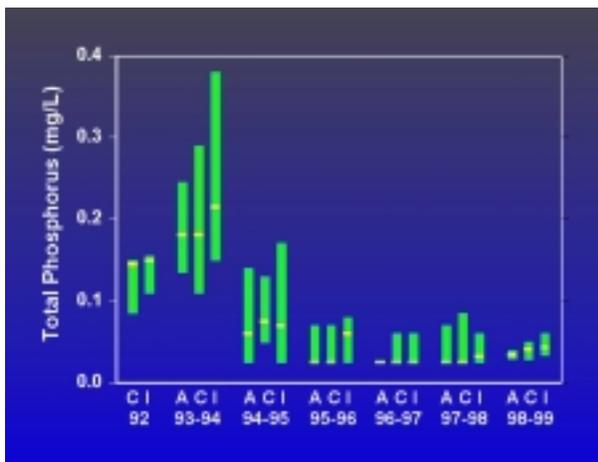
Reduction of phosphorus after implementation of nutrient and sediment erosion controls in watershed cropland and animal operations; Sites A, C, and I are an upstream to downstream sequence and are downstream of most BMPs (Long Creek, North Carolina).

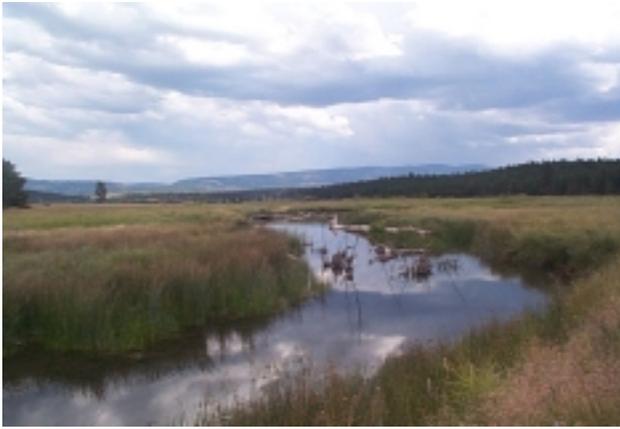
McCoy Creek after natural channel design restoration (Upper Grande Ronde Basin, Oregon).

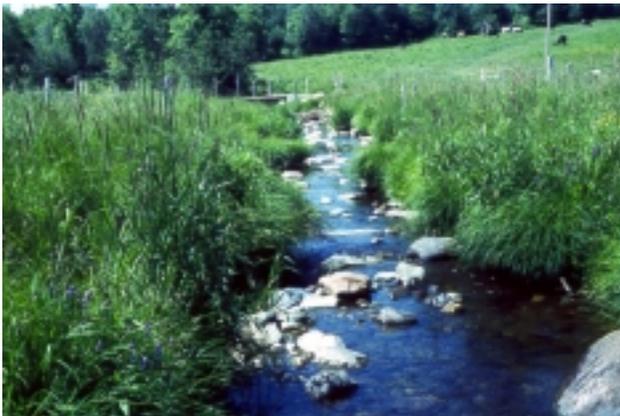
Riparian zone in Godin Brook after 1.5 years of livestock exclusion by fencing (Lake Champlain Basin, Vermont).

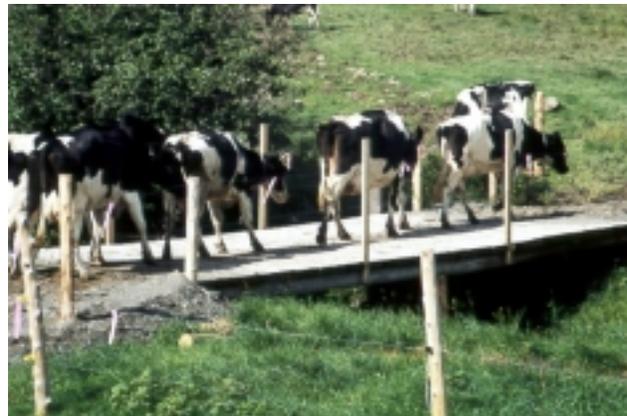
New stream crossing on Godin Brook (Lake Champlain Basin, Vermont).

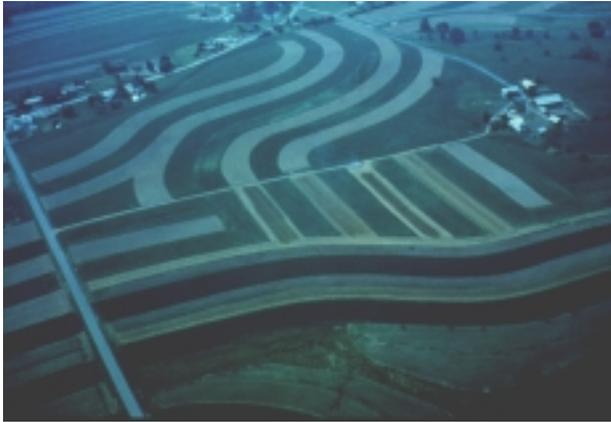
Strip cropping and contouring best management practices to control soil erosion (Otter Creek, Wisconsin).

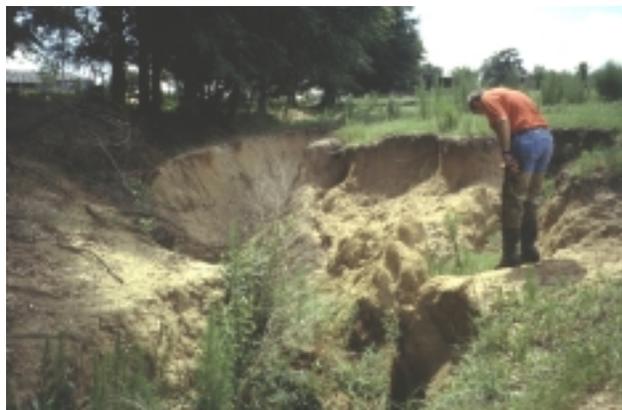
Headcut on a tributary to Lightwood Knot Creek (Lightwood Knot Creek, Alabama).

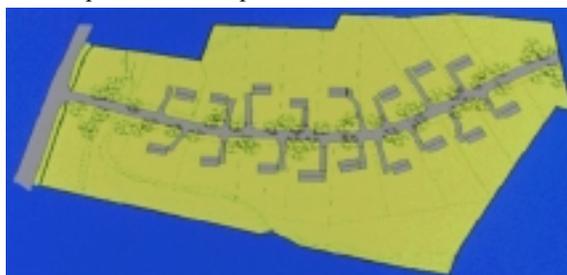
Traditional neighborhood site plan serves as a control comparison (Jordan Cove, Connecticut).

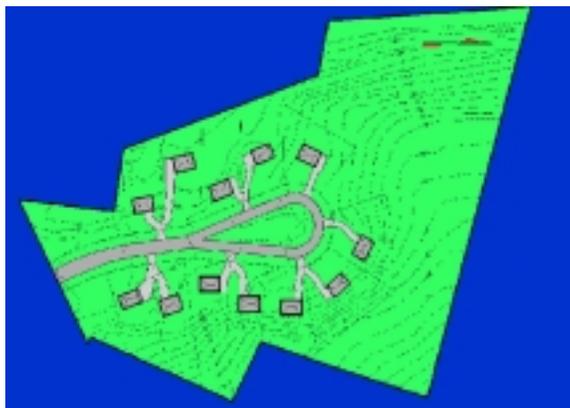
Treatment watershed site plan includes construction BMPs, shared driveways, pervious pavement and bioretention gardens (Jordan Cove, Connecticut).

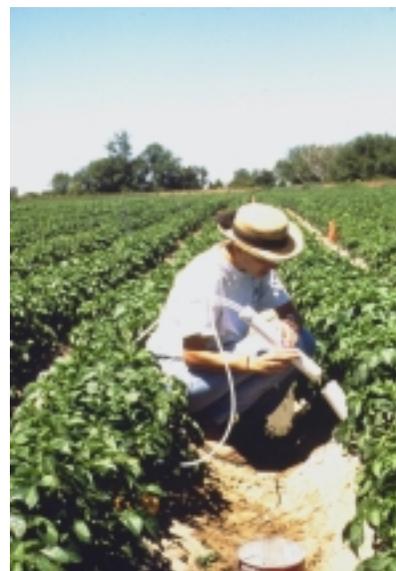
Lysimeter installation in potato crops (Eastern Snake River Plain, Idaho).

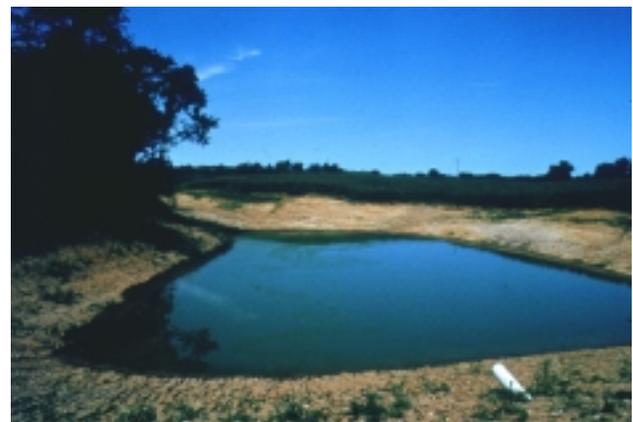
Sediment retention basin (Lake Pittsfield, Illinois).

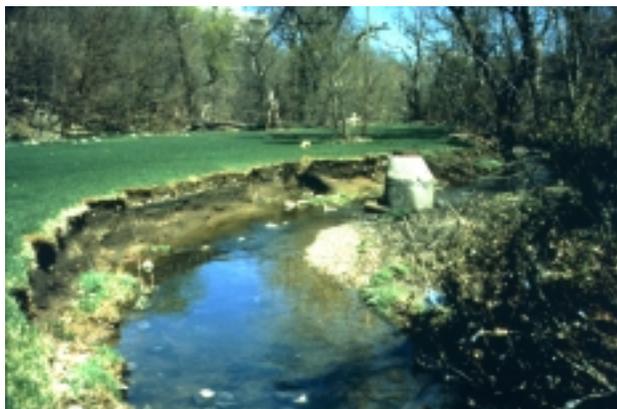
Streambank erosion, 1994 (Waukegan River, Illinois).

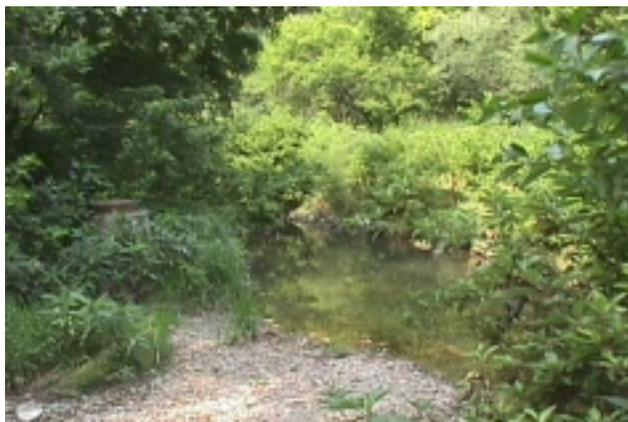
Waukegan River after riparian revegetation and installation of lunkers and riffles, July 2000 (Waukegan River, Illinois).

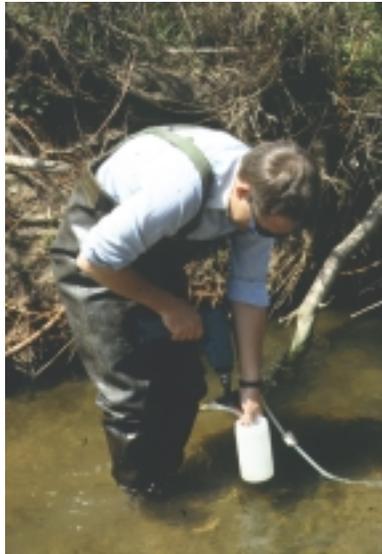
Intergravel dissolved oxygen monitoring (Elm Creek, Nebraska).

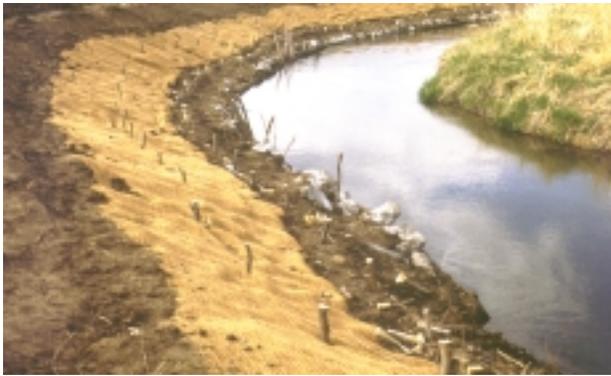
Installation of willow stakes (Elm Creek, Nebraska).

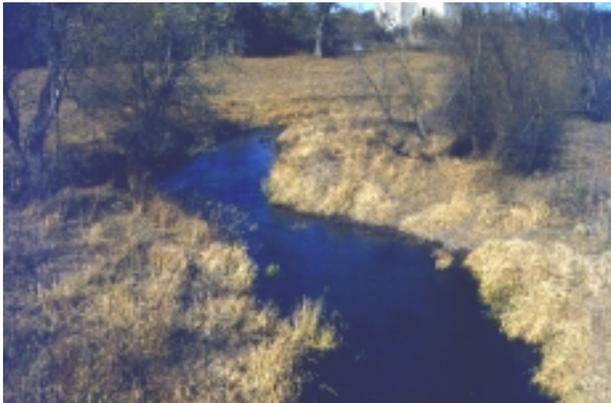
Elm Creek after installation of lunkers to stabilize the toe, fascine and willow stakes for riparian revegetation (Elm Creek, Nebraska).

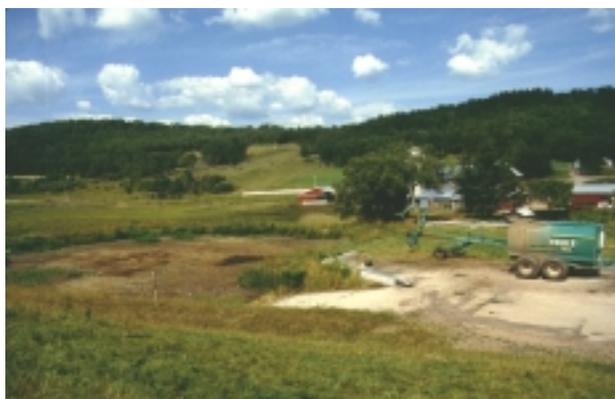
Manure storage at the treatment farm (New York City Watershed, New York).

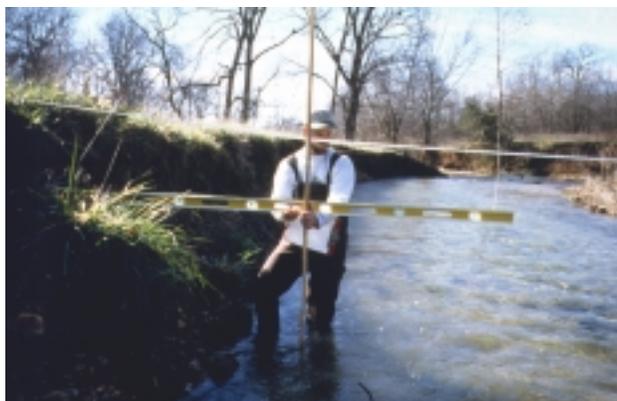
Measuring streambank erosion (Peach eater Creek, Oklahoma).

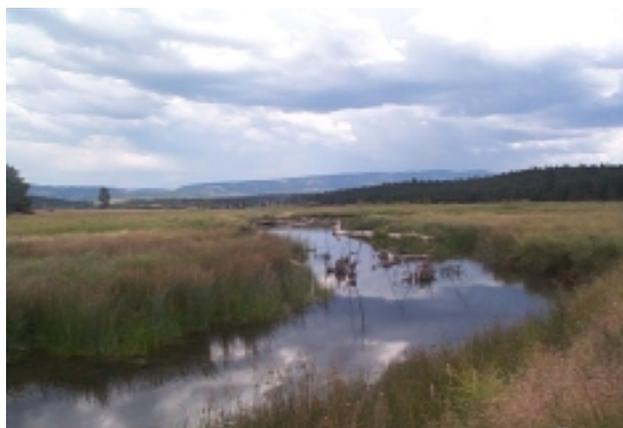
McCoy Creek after natural channel design restoration (Upper Grande Ronde Basin, Oregon).

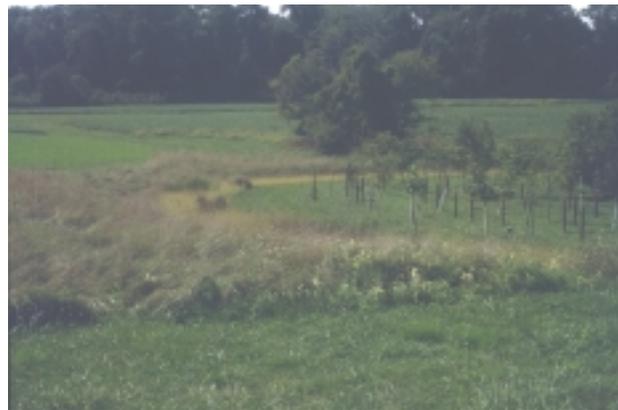
Revegetated buffer and level spreader (Stroud Preserve Watershed, Pennsylvania).

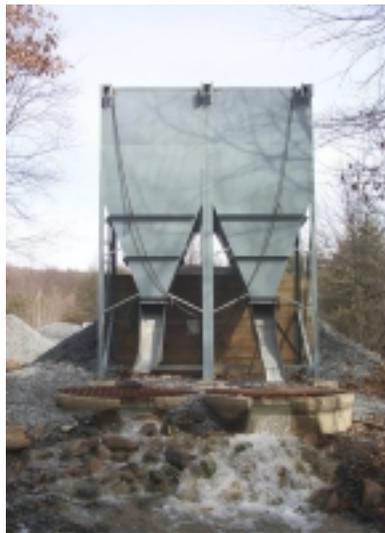
Limestone diversion wells to neutralize acidic coal mine drainage (Swatara Creek, Pennsylvania).

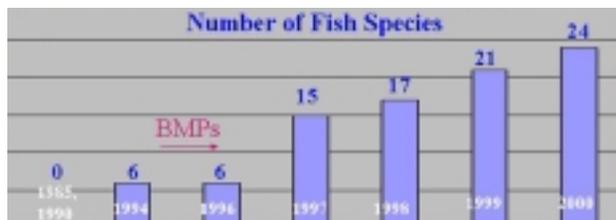
Observed increase in fish species since BMP implementation (Swatara Creek, Pennsylvania).

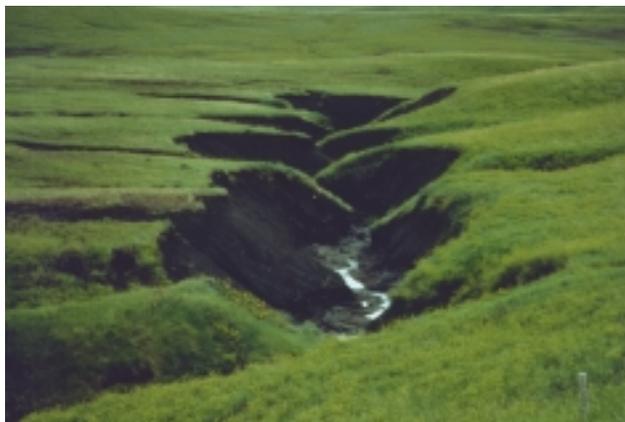
Incised stream through rangeland (Bad River, South Dakota).

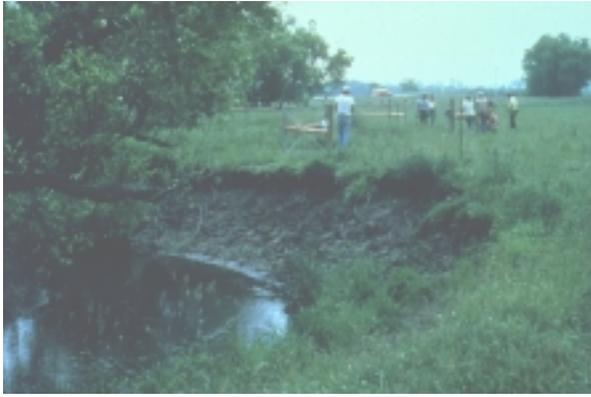
Installation of stream fencing for livestock exclusion (Otter Creek, Wisconsin).

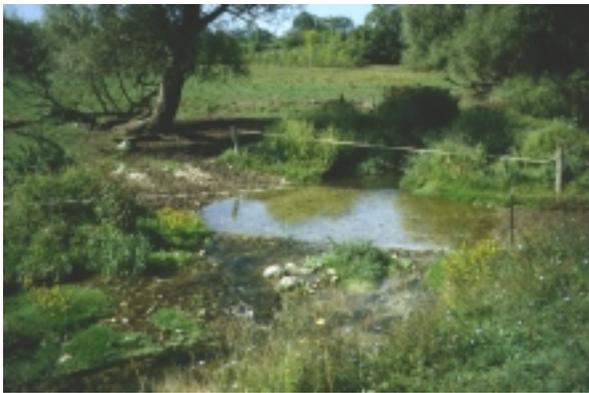
Improved cattle crossing (Otter Creek, Wisconsin).

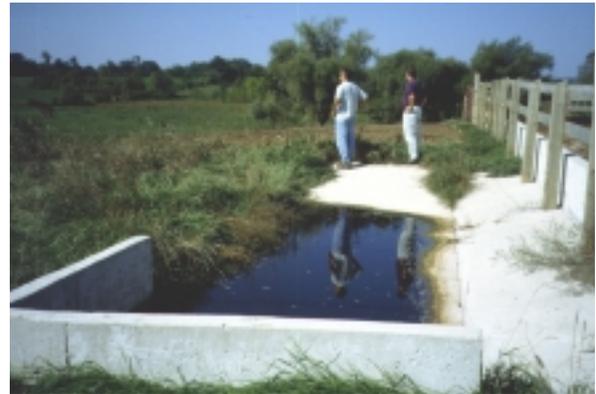
Level spreader for treated barnyard runoff (Otter Creek, Wisconsin).
