Yurok Tribe's NPS Implementation and Monitoring Programs

1st Annual National Tribal CWA

106 and 319 Conference

November 16, 2011

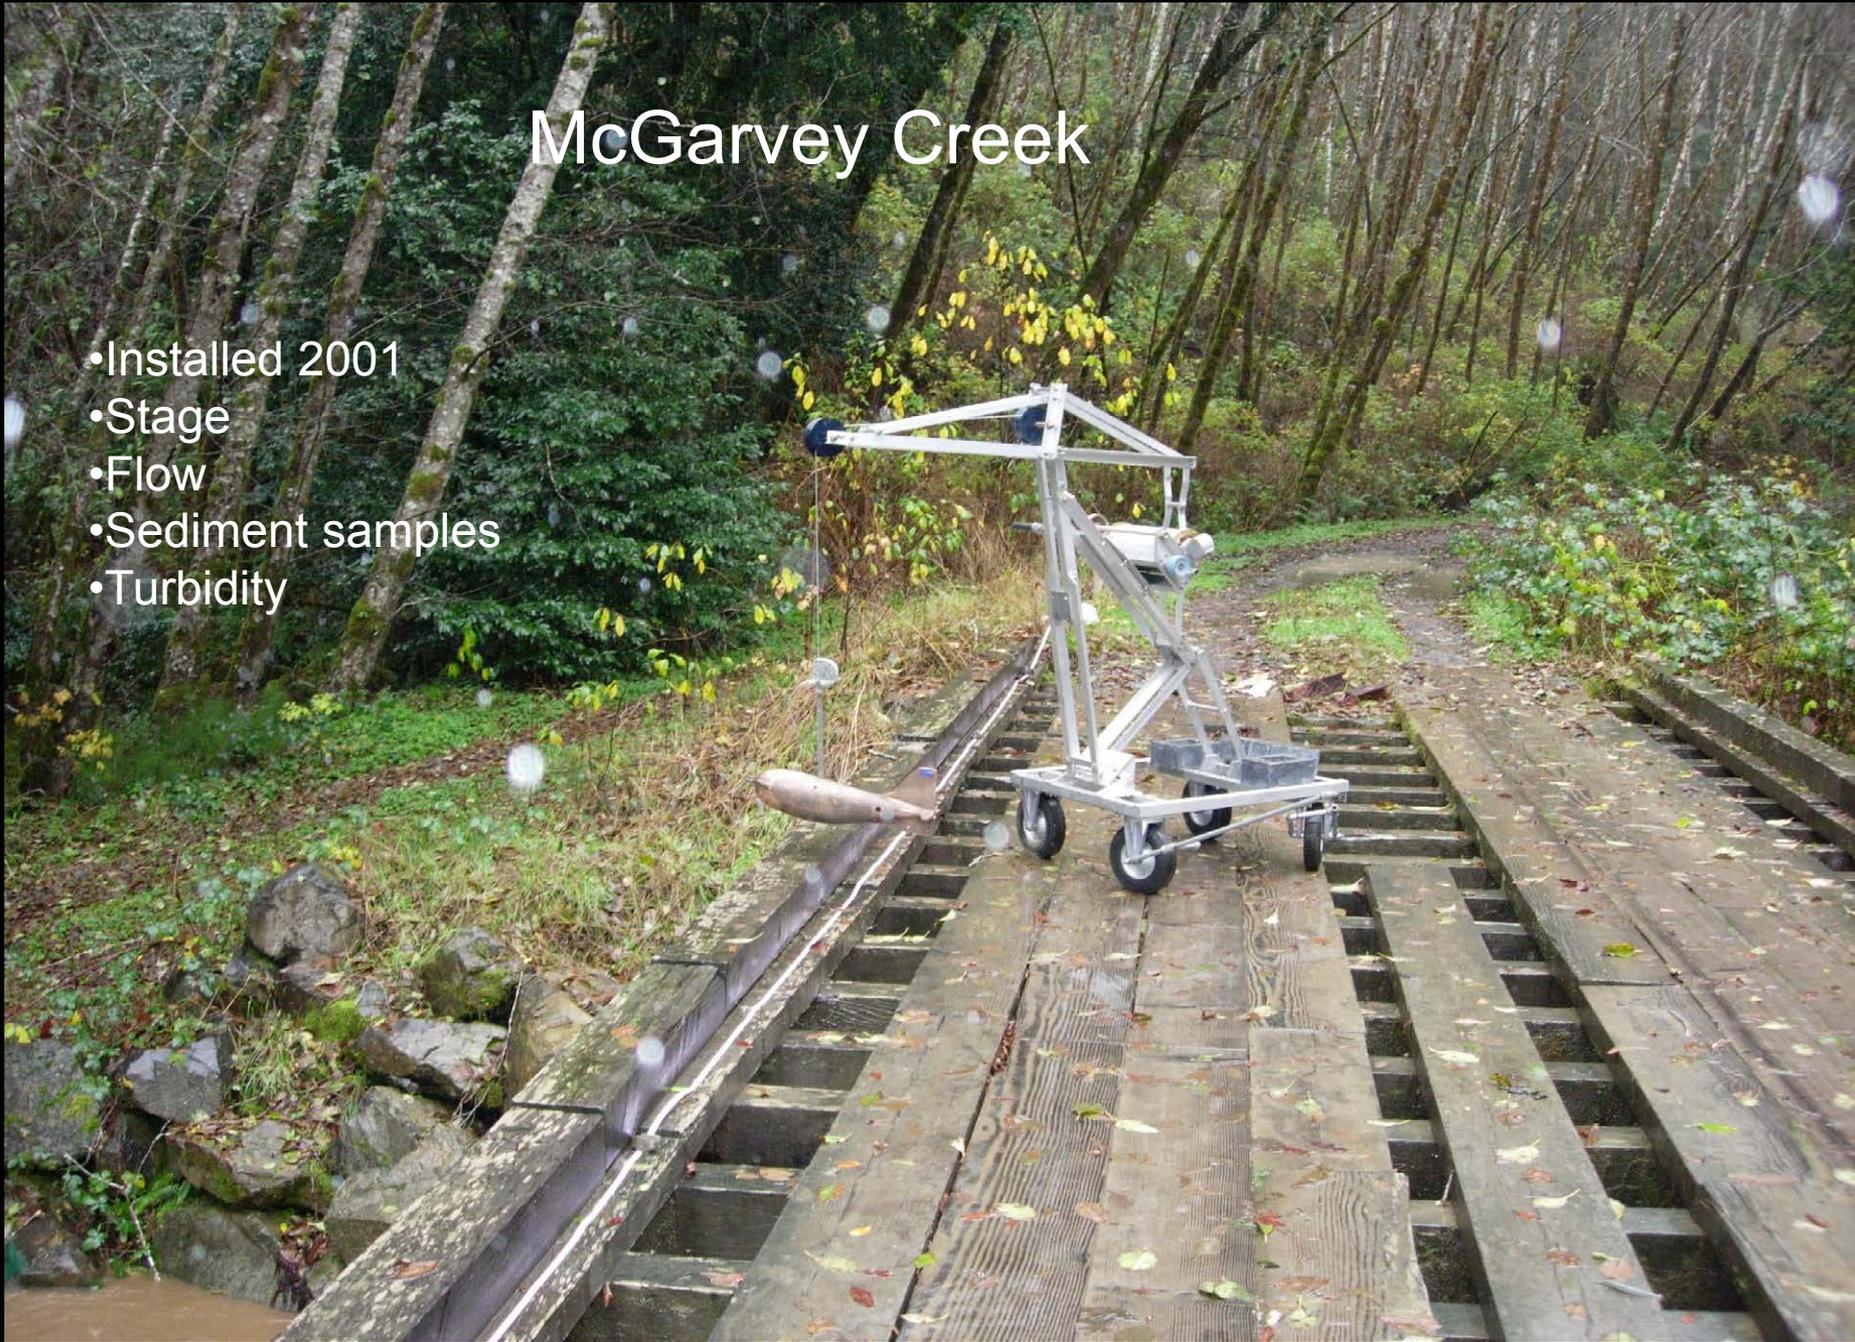
McGarvey Creek

- Installed 2001
- Stage
- Flow
- Sediment samples
- Turbidity

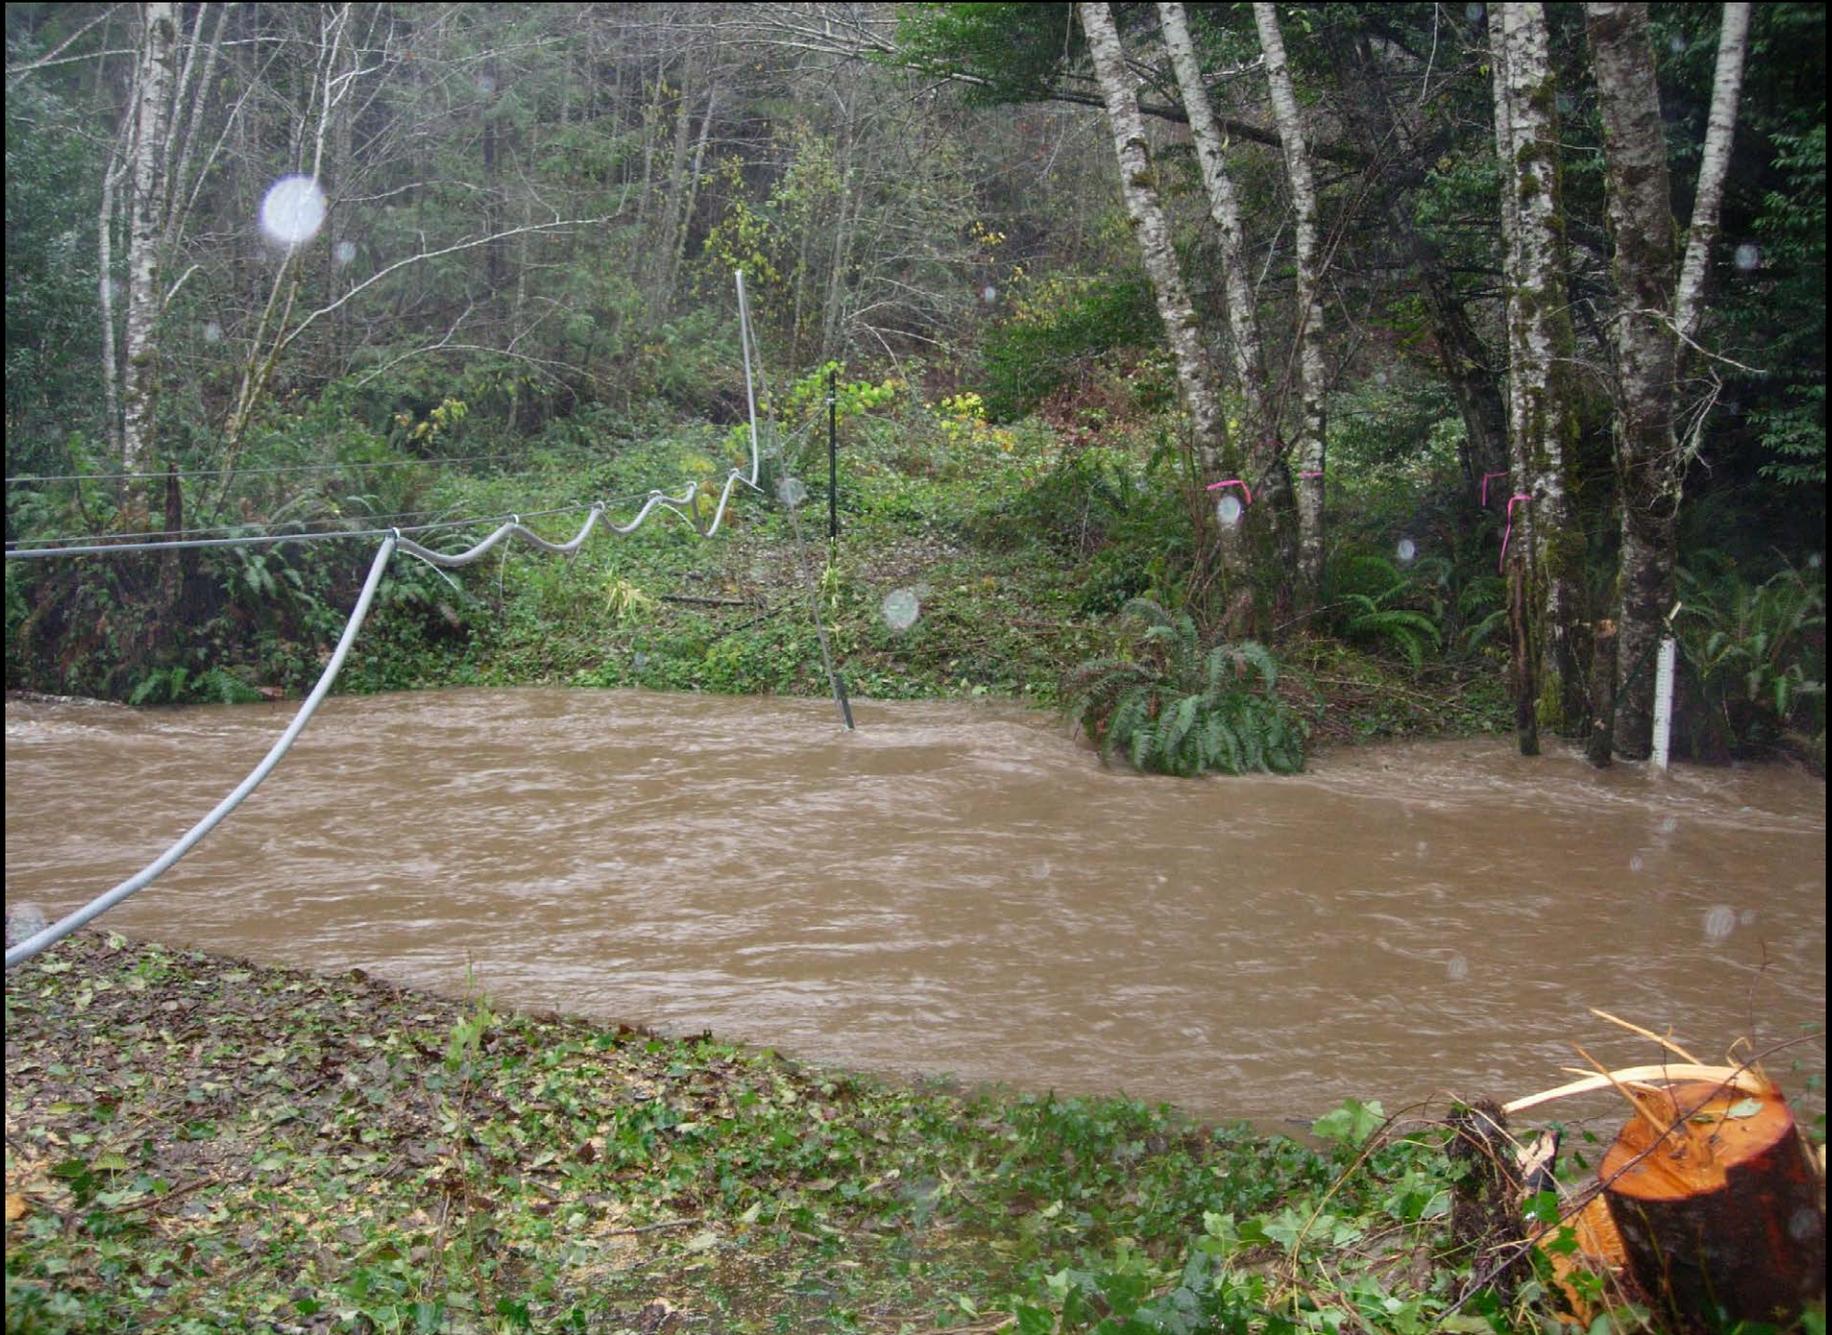
Laser Based Optics

The DTS-12 uses optical backscatter technology with a 780-nm laser emitter with automatic power control. It measures suspended solids with an infrared measurement system incorporating optical feedback and synchronous detection to reject ambient light. The DTS-12 features high accuracy, excellent thermal and long-term stability, and nearly linear response over three orders of magnitude.

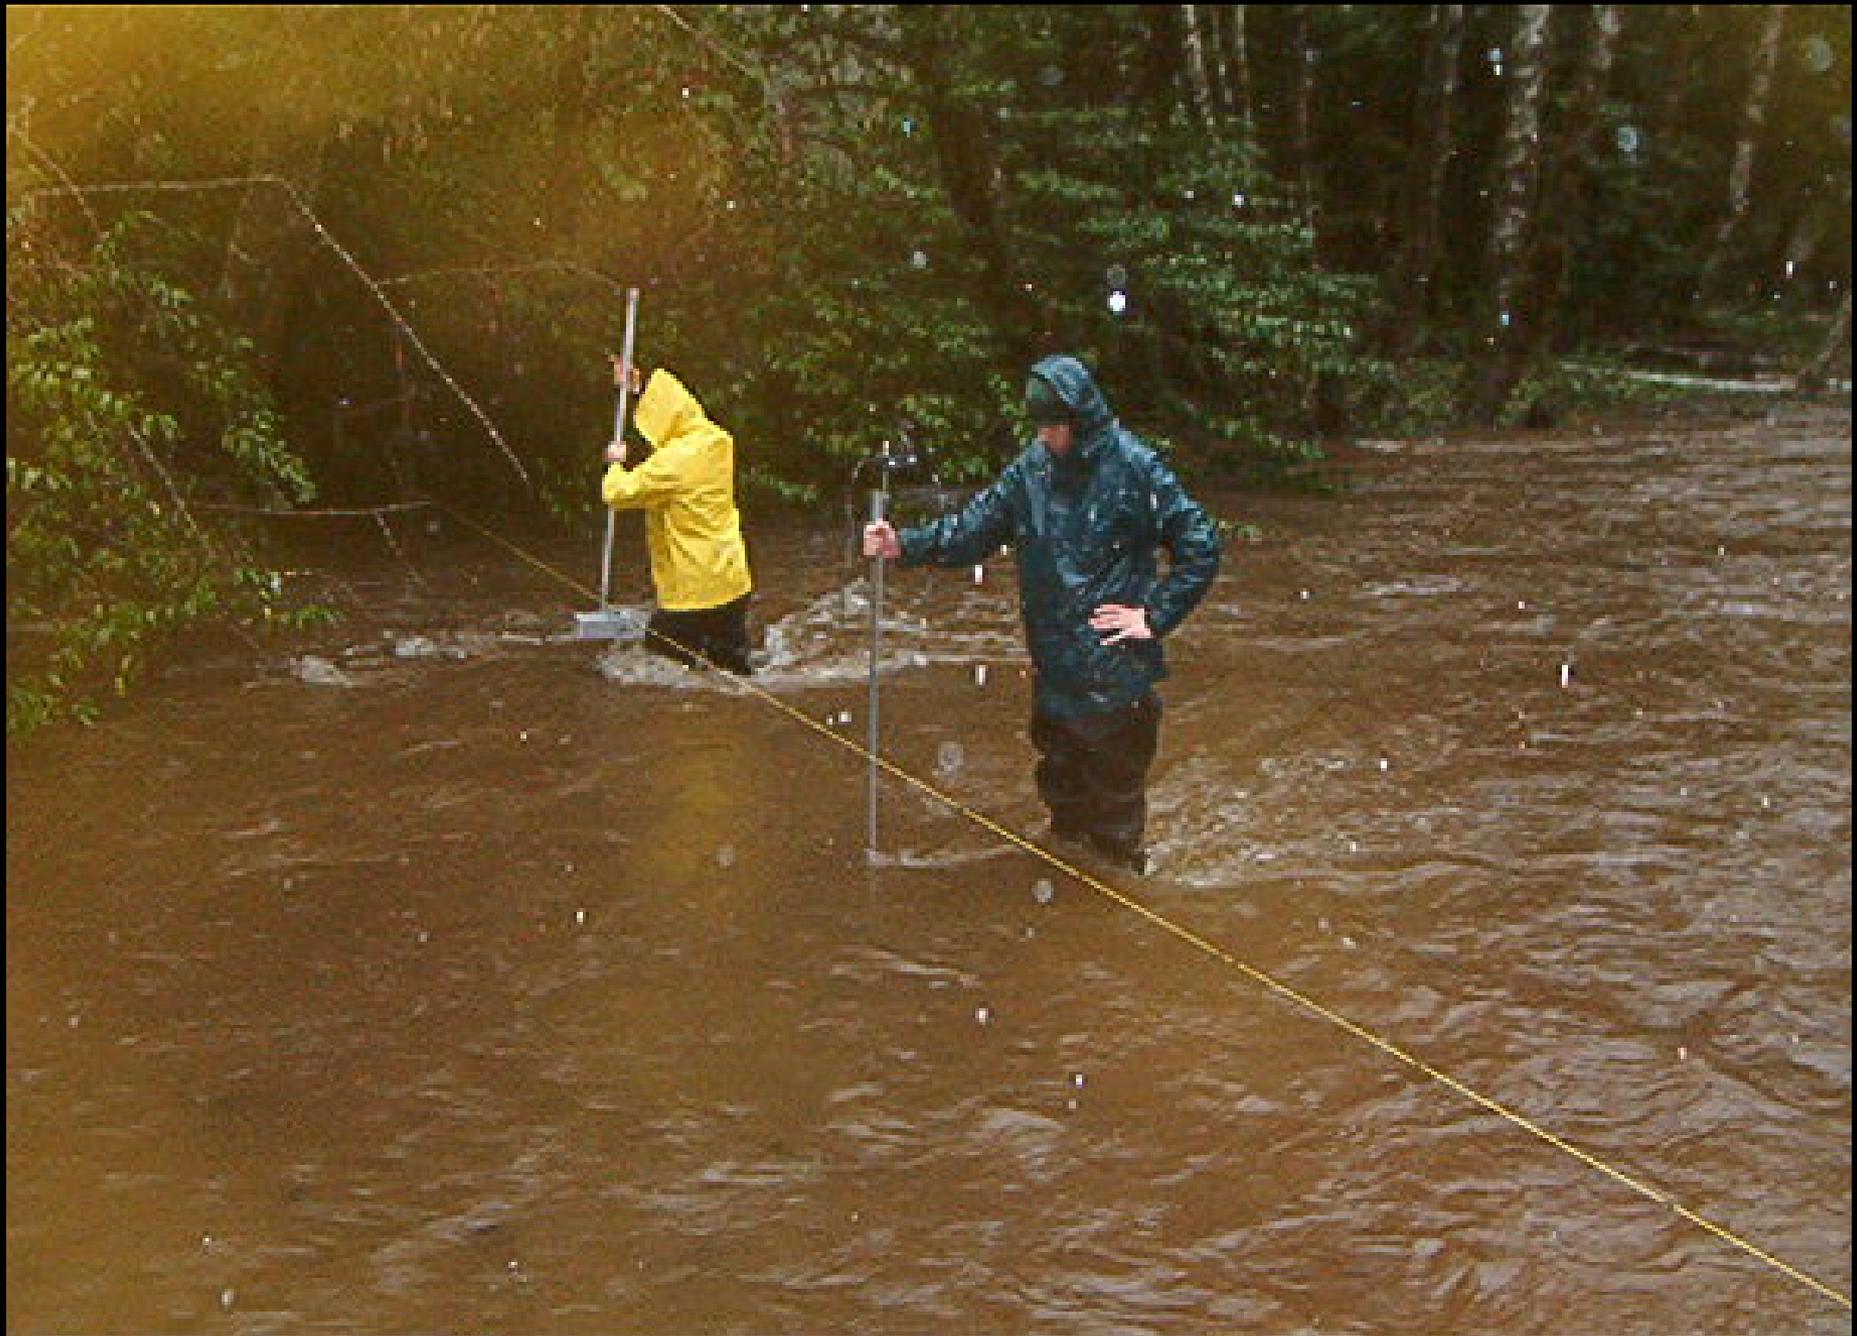
Blue Creek

- 2002
- Stage
- Flow
- Suspended sediment

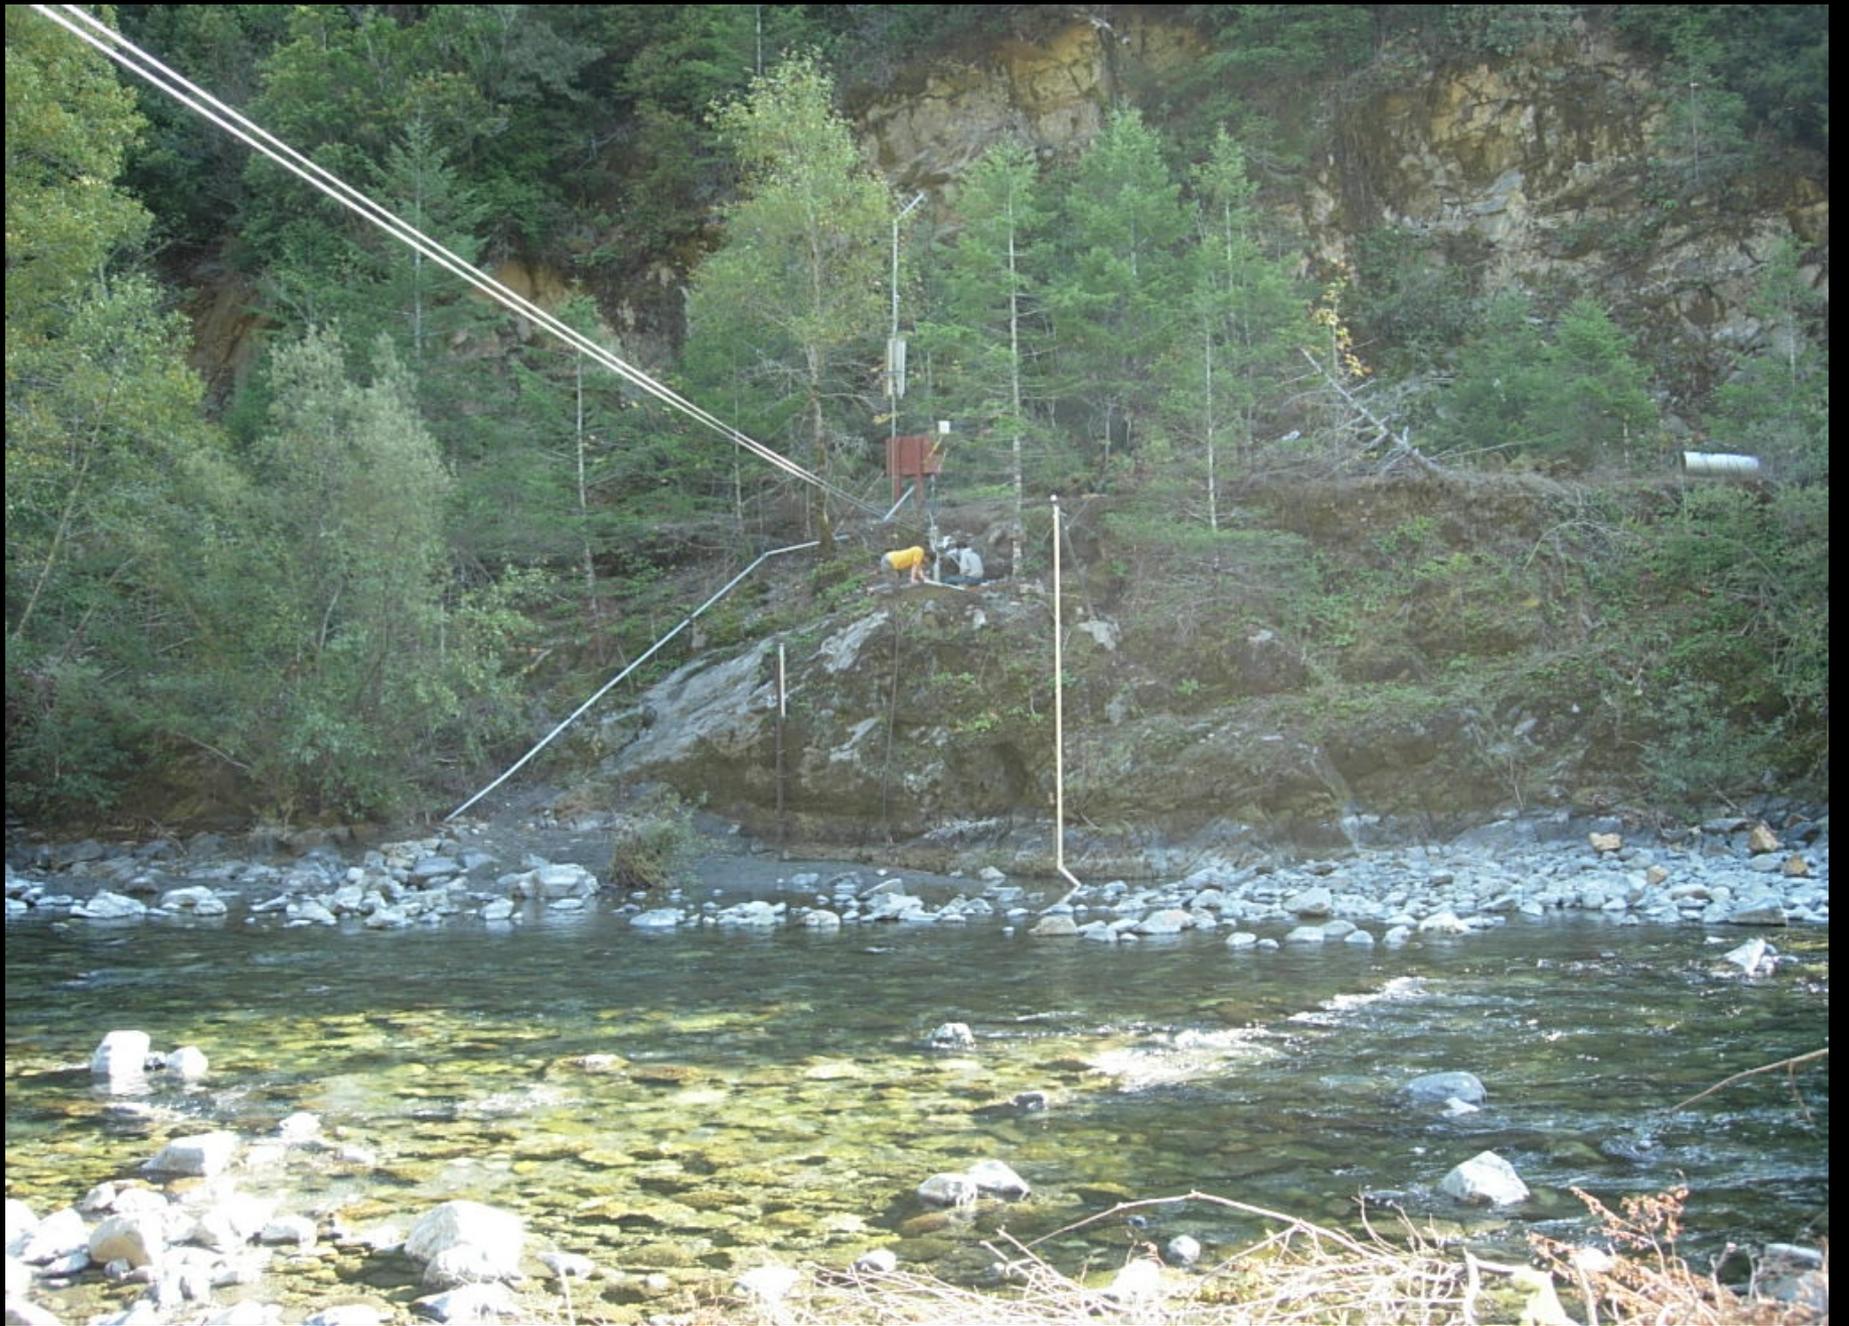
Upper Turwar Creek

- Installed 2002
- Stage
- Turbidity w/DTS on orifice

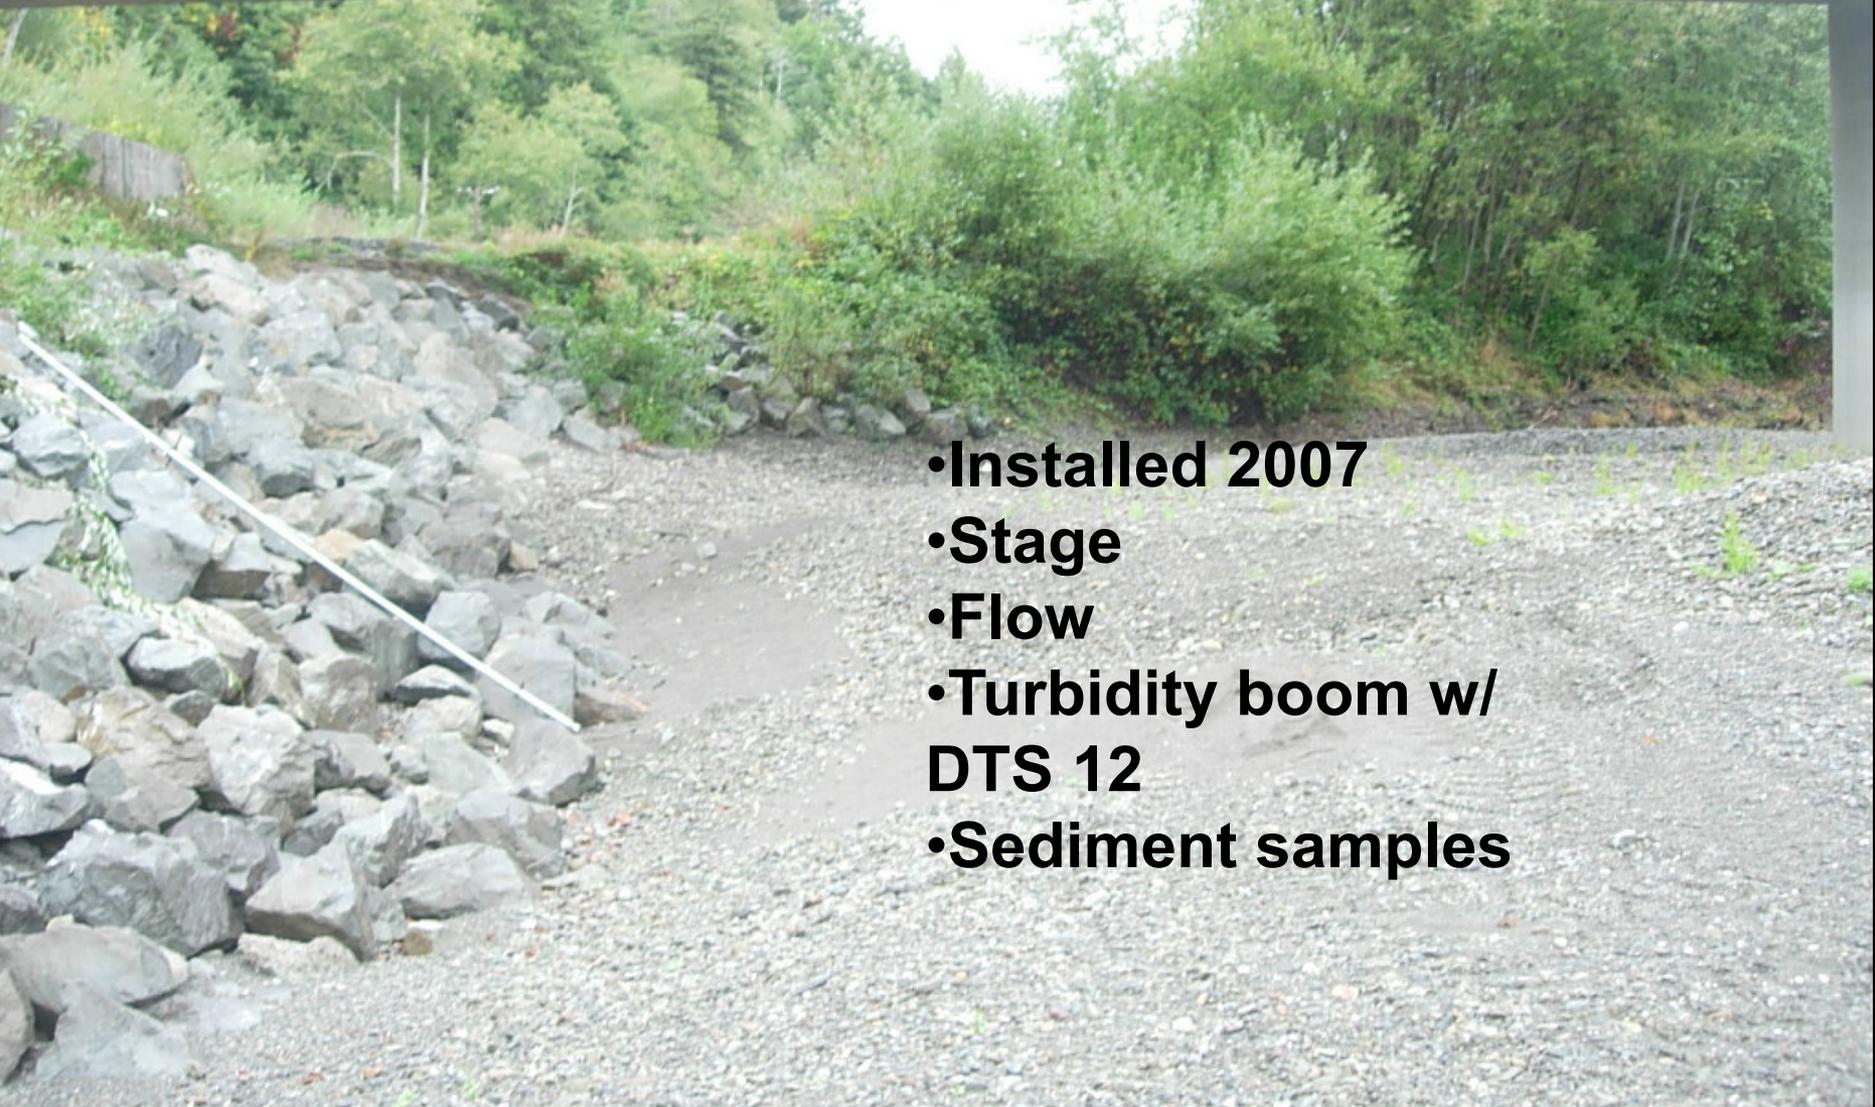
Lower Turwar

- A photograph showing a stream bed composed of grey rocks and gravel. On the left side, a white measuring pole is placed vertically against the rocks. The background is filled with dense green trees and bushes. The scene is viewed from under a concrete bridge structure.
- Installed 2007
 - Stage
 - Flow
 - Turbidity boom w/
DTS 12
 - Sediment samples

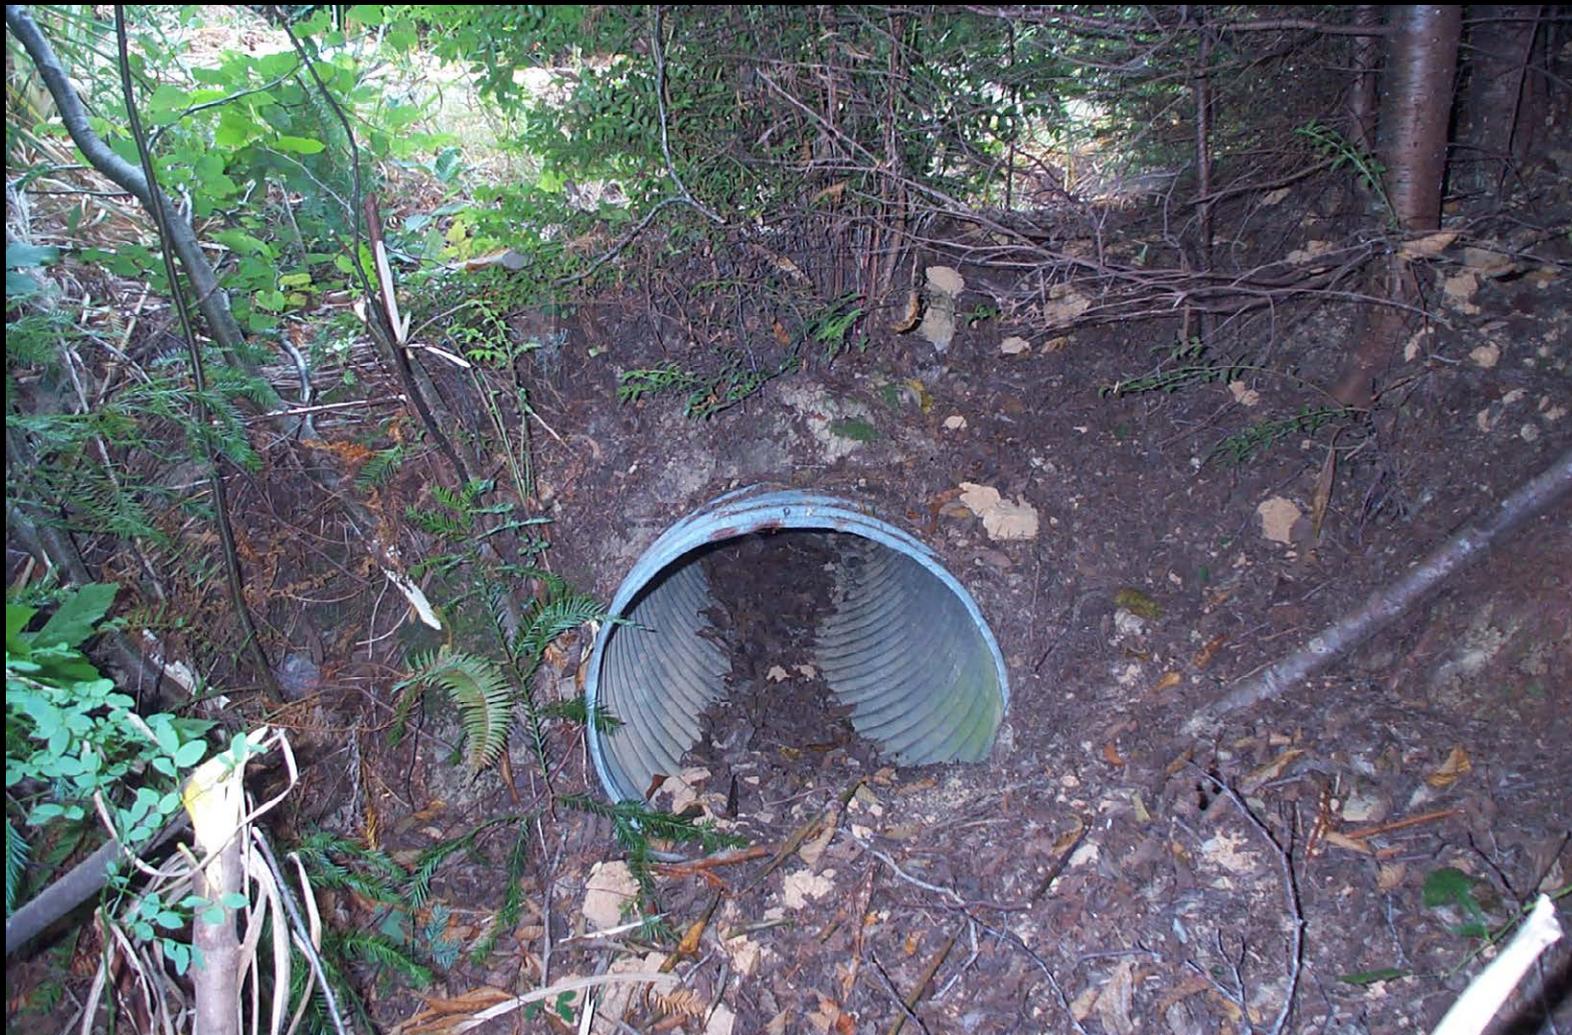
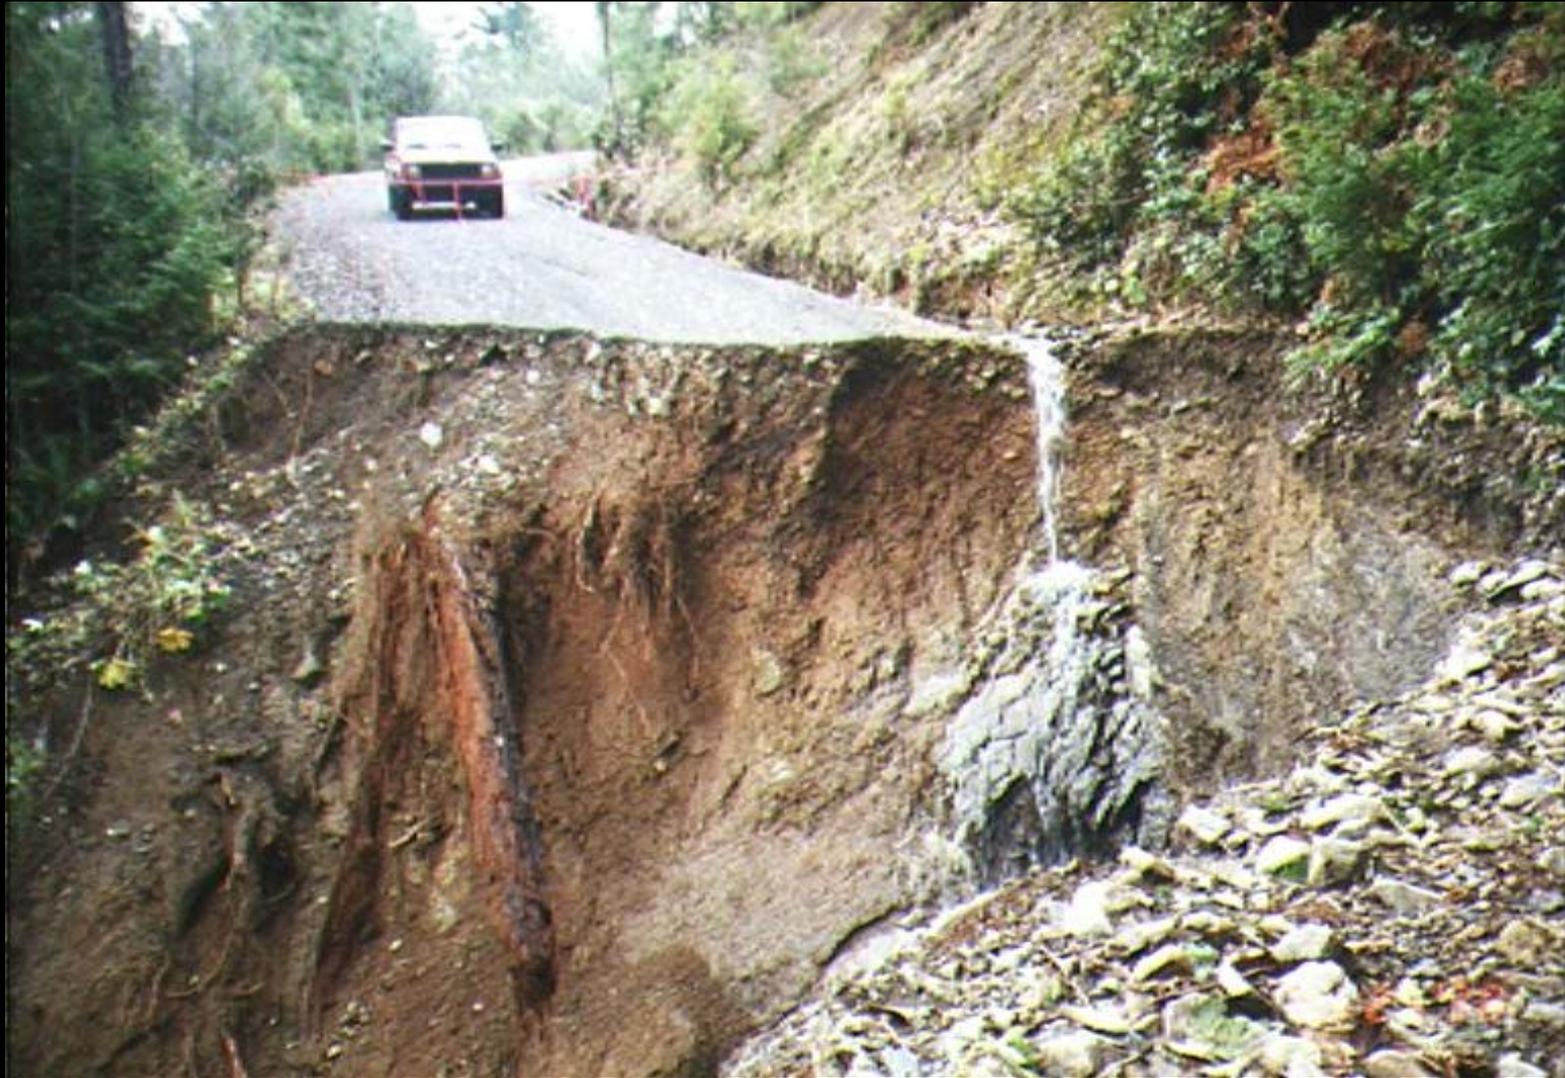
...Are Fish Barriers

Old Culverts...

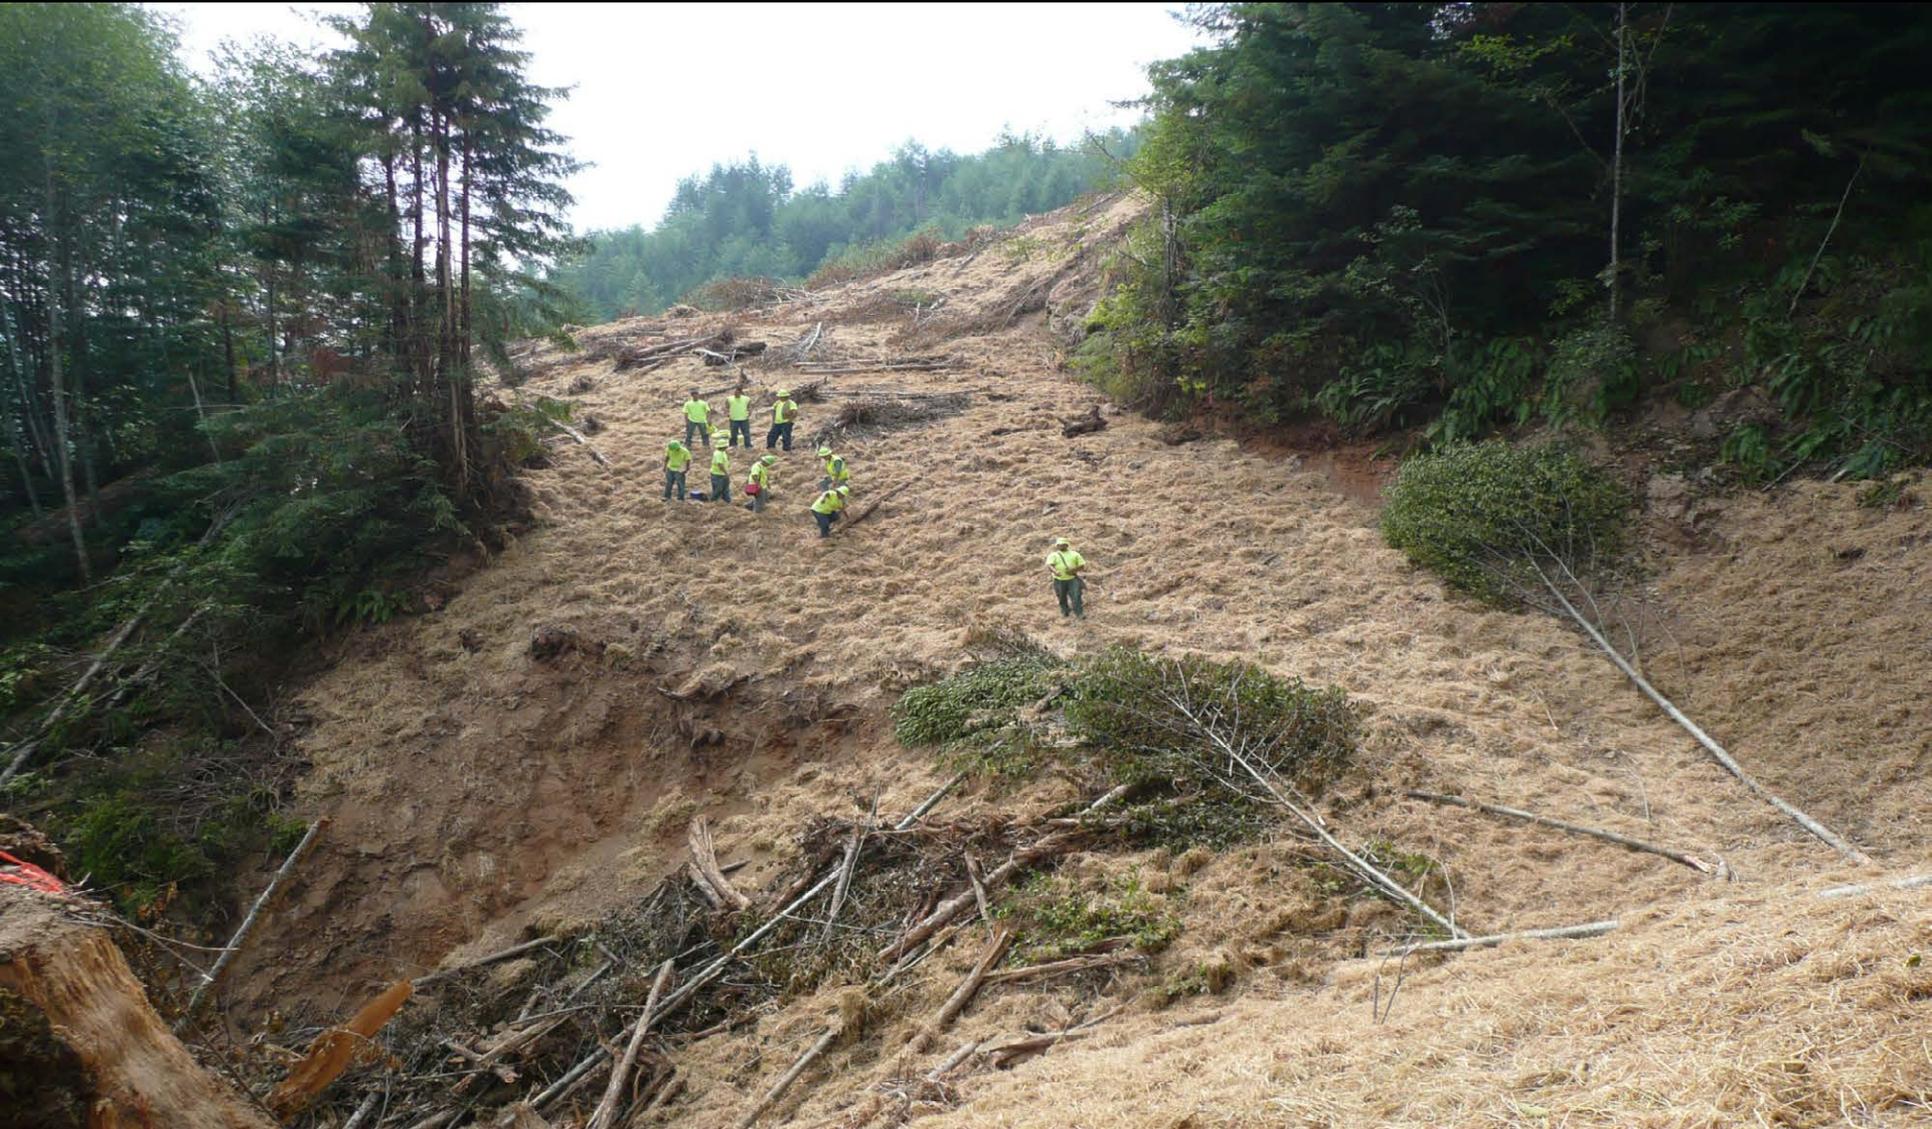
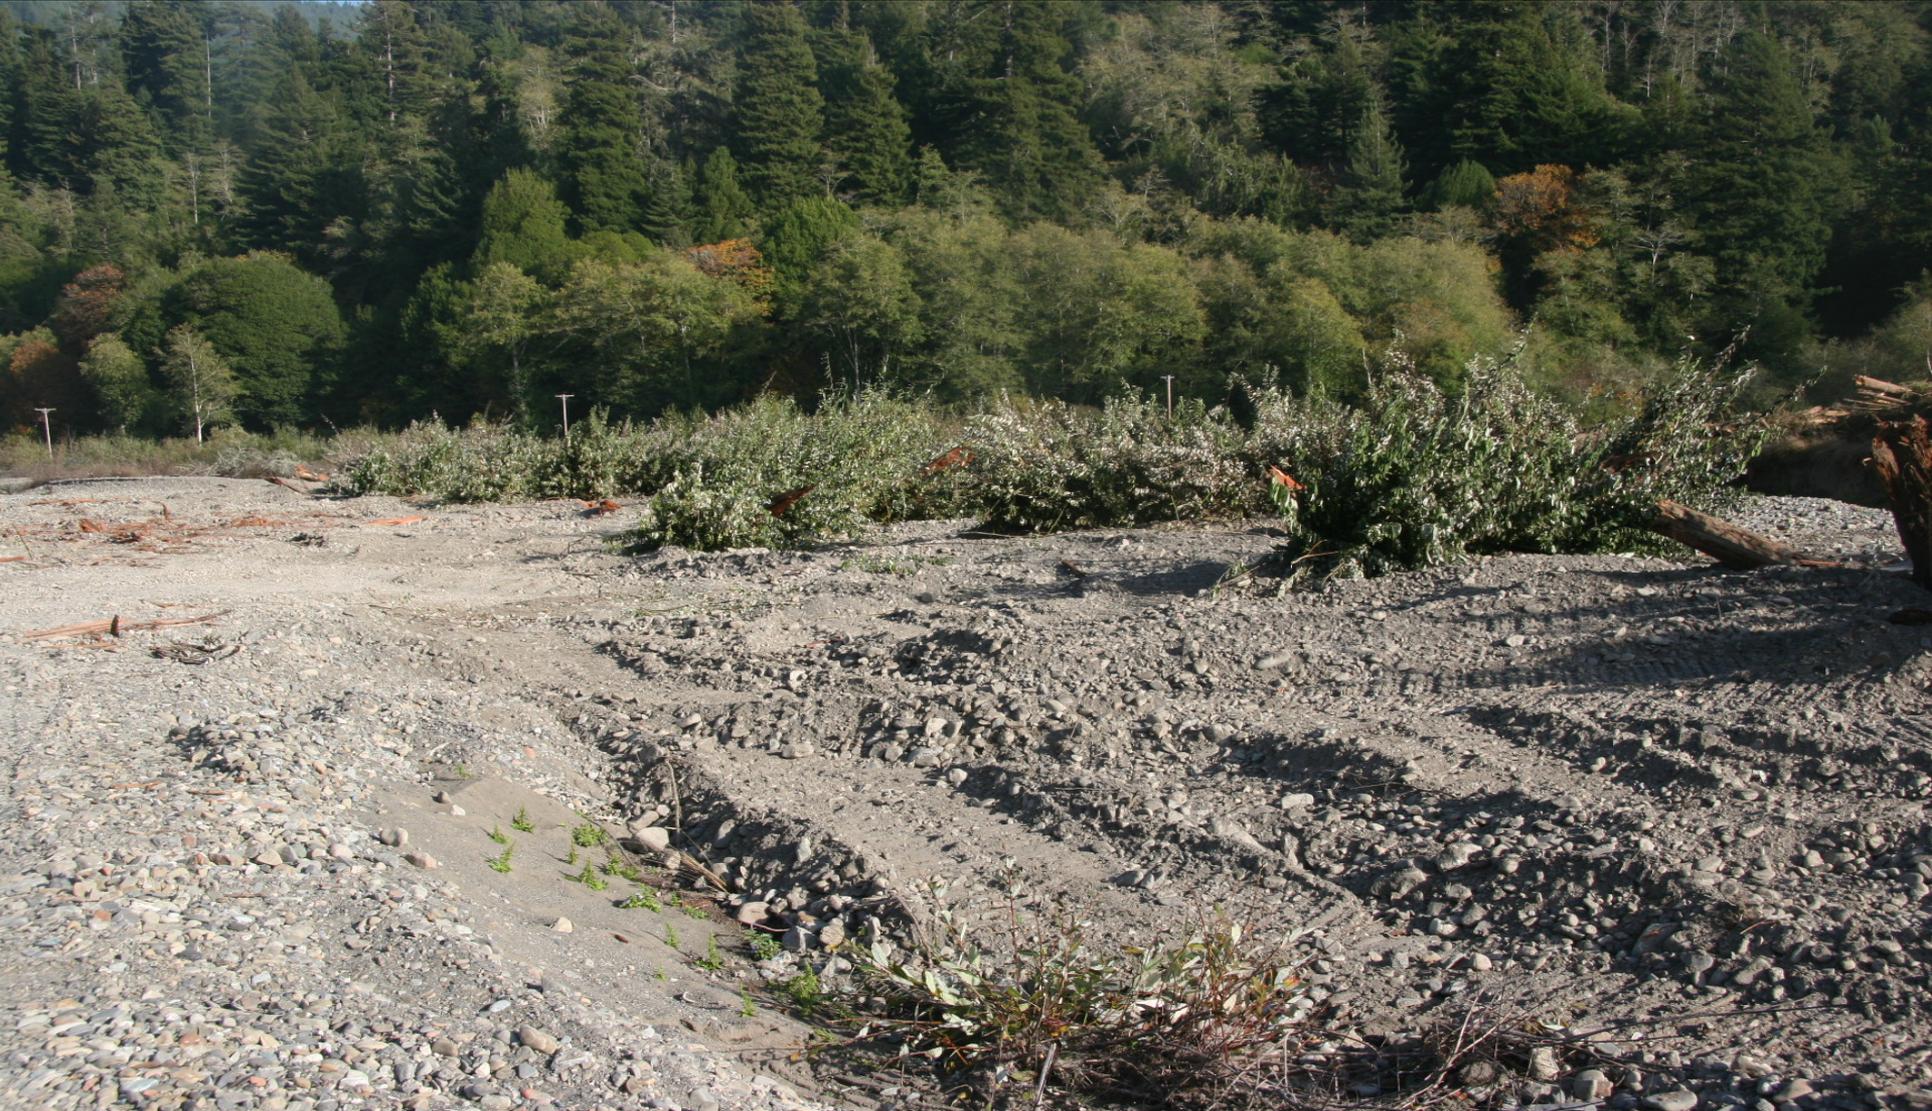
Instream work – willow baffles

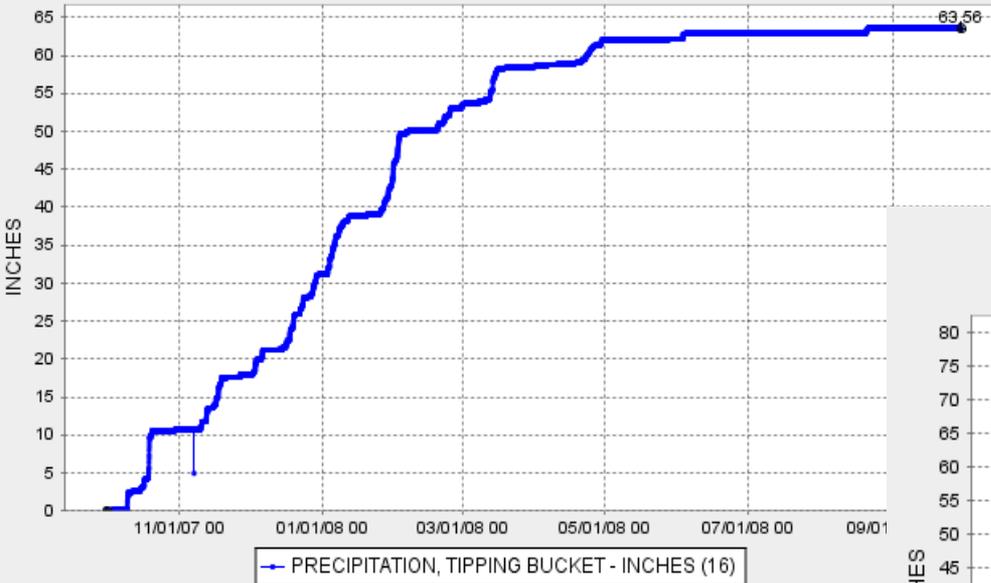
KLAMATH R NR KLAMATH (TURWAR CREEK) (TUR)

Date from 10/01/2007 01:00 through 09/30/2008 00:00 Duration : 364 days

Max of period : (09/30/2008 00:00, 63.56) Min of period: (10/01/2007 01:00, 0.0)

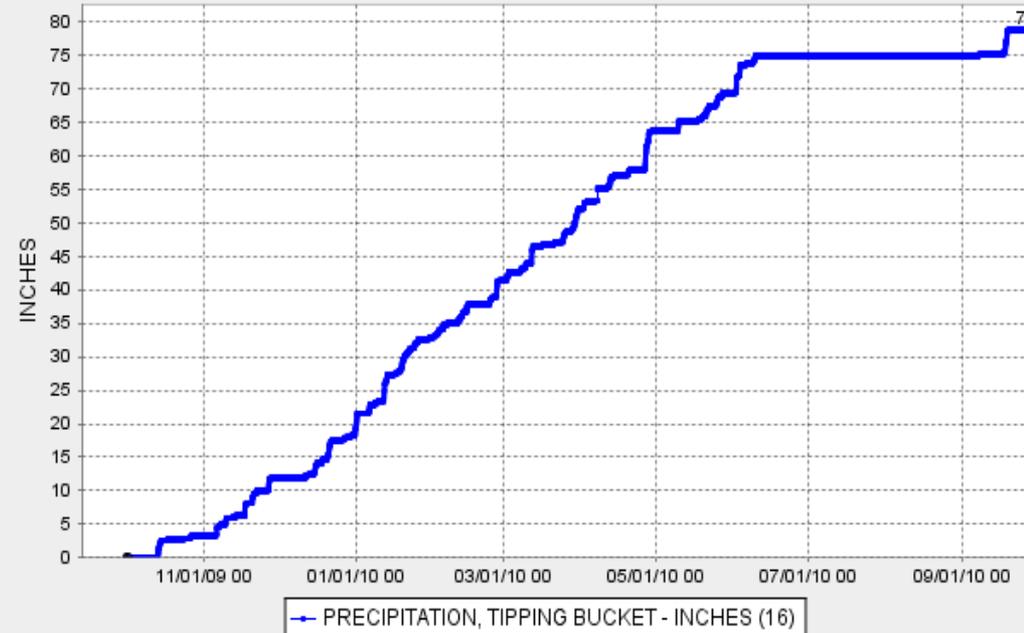
KLAMATH R NR KLAMATH (TURWAR CREEK) (TUR)

Date from 10/01/2009 01:00 through 09/30/2010 00:00 Duration : 363 days

Max of period : (09/30/2010 00:00, 78.8) Min of period: (10/01/2009 01:00, 0.0)

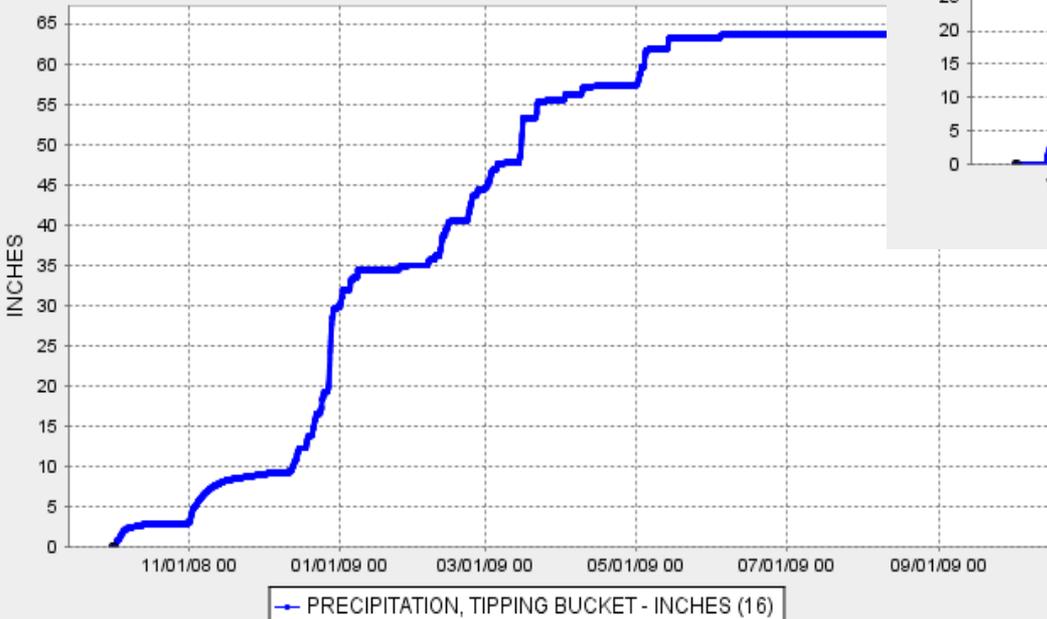
KLAMATH R NR KLAMATH (TURWAR CREEK) (TUR)

Date from 10/01/2008 01:00 through 09/30/2009 00:00 Duration : 363 days

Max of period : (09/30/2009 00:00, 64.12) Min of period: (10/01/2008 01:00, 0.0)
