Yurok Tribe's NPS Implementation and Monitoring Programs

1st Annual National Tribal CWA

106 and 319 Conference

November 16, 2011

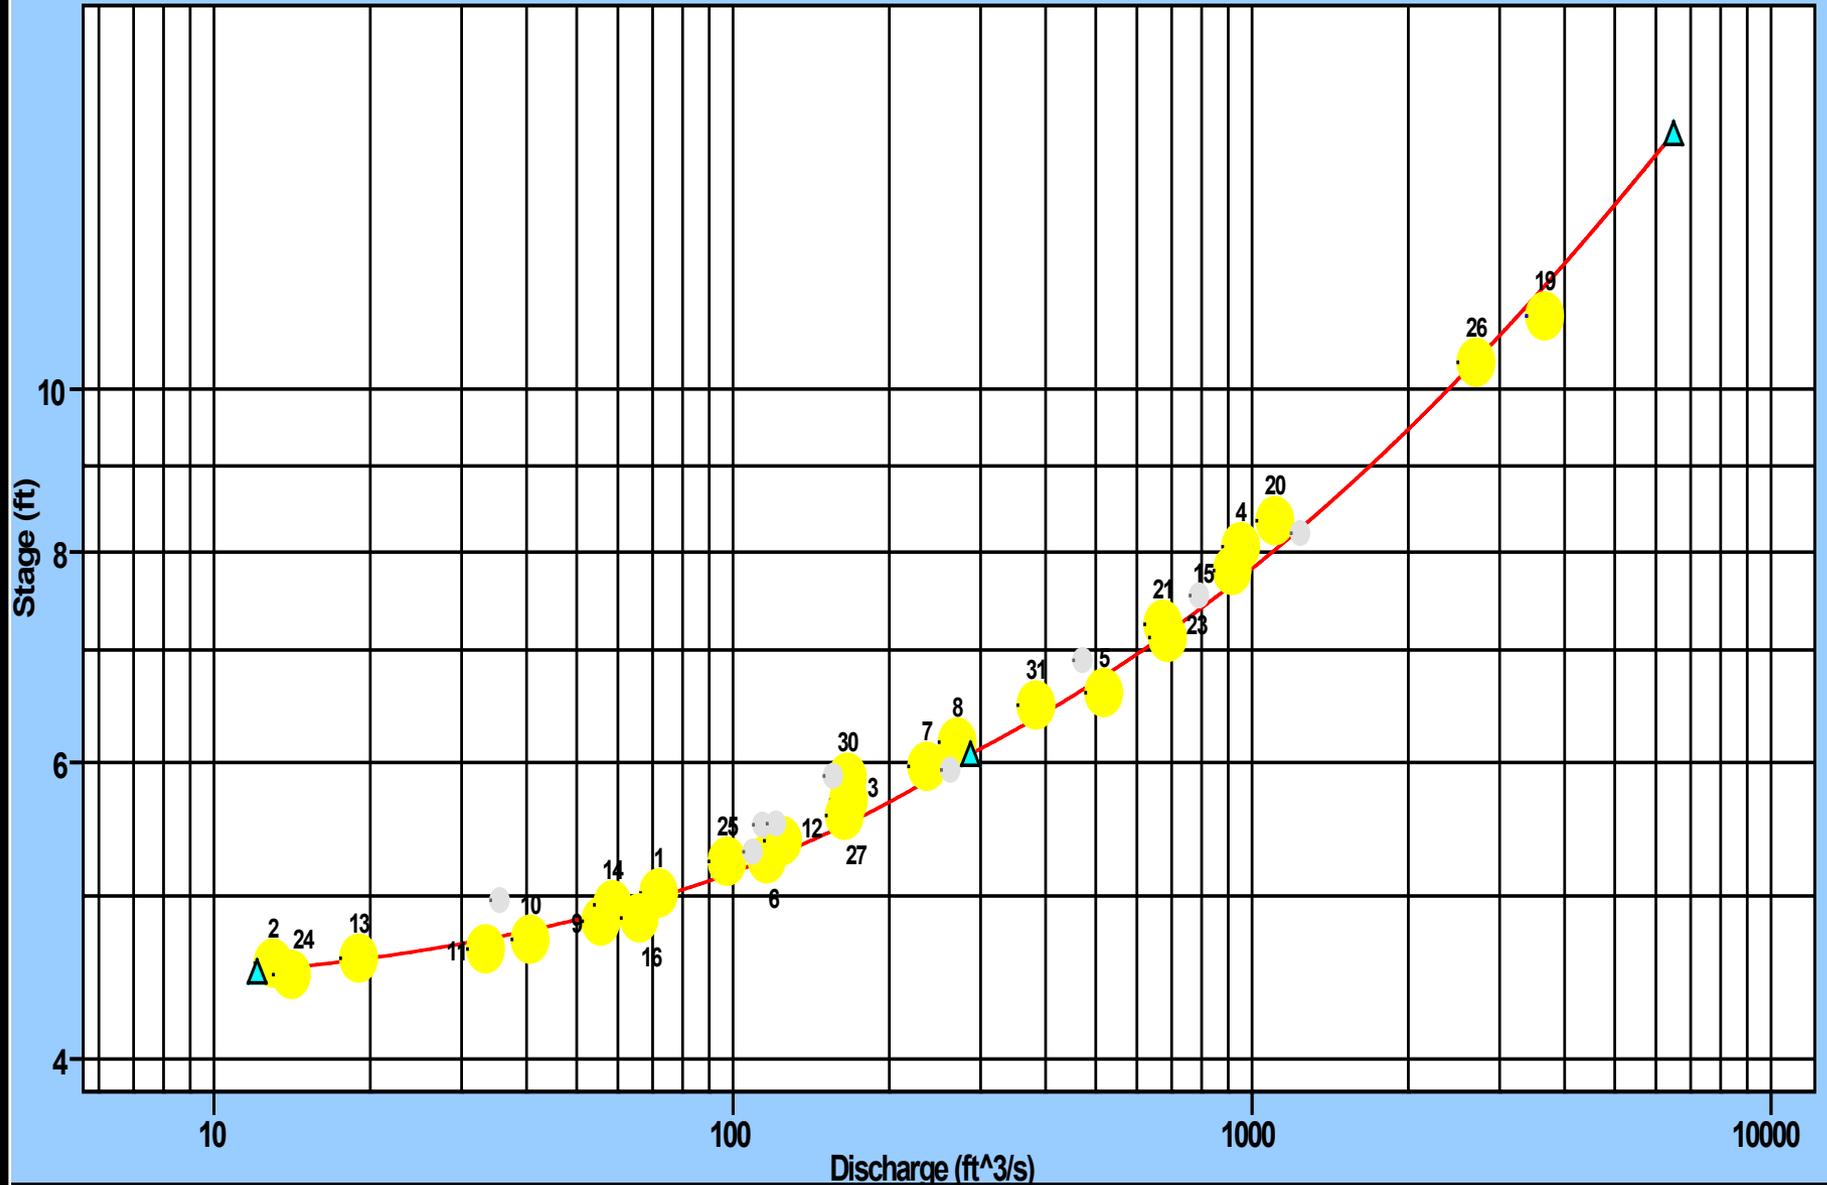
001 - Lower Turwar Creek - DD: 1 Rating: 001

Rating period from 10/01/2007 to 10/01/2010

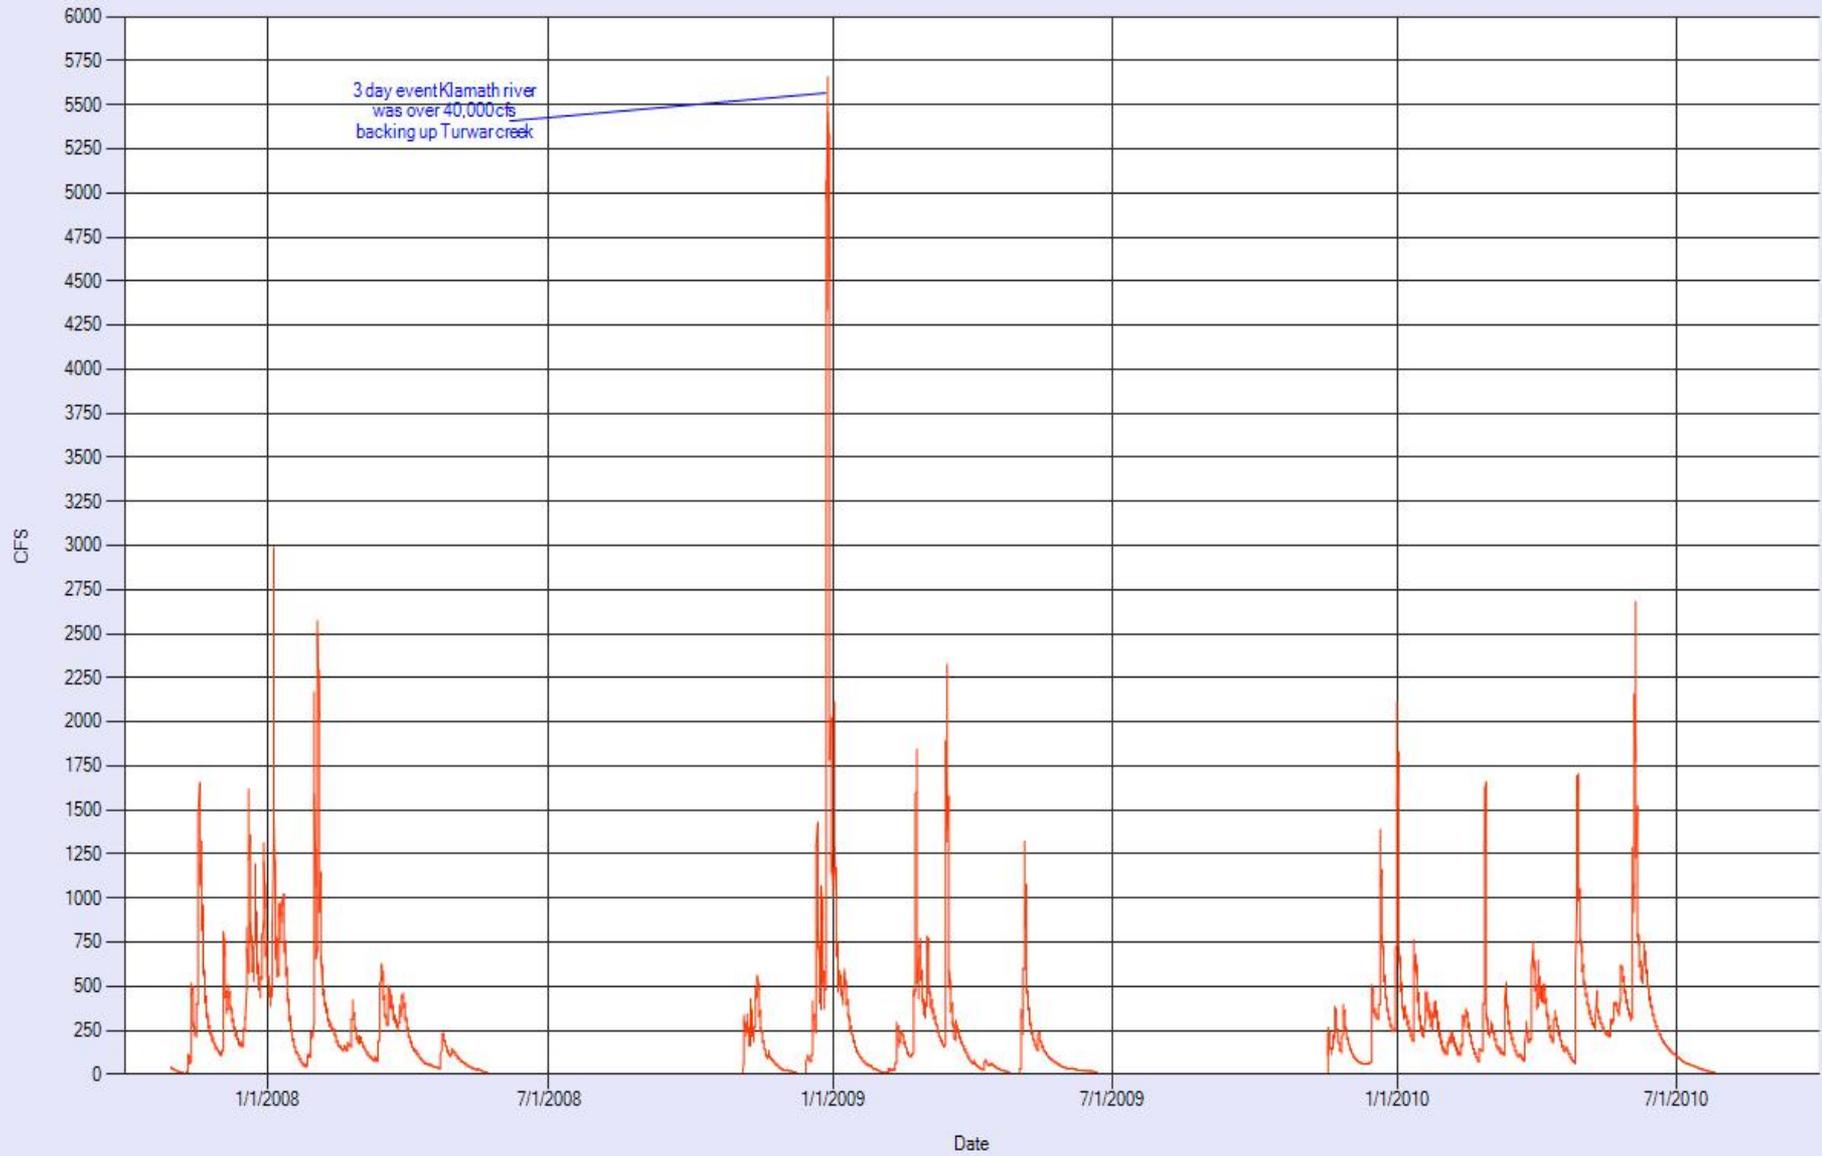
Lower Turwar discharge 2008_2010

Discharge

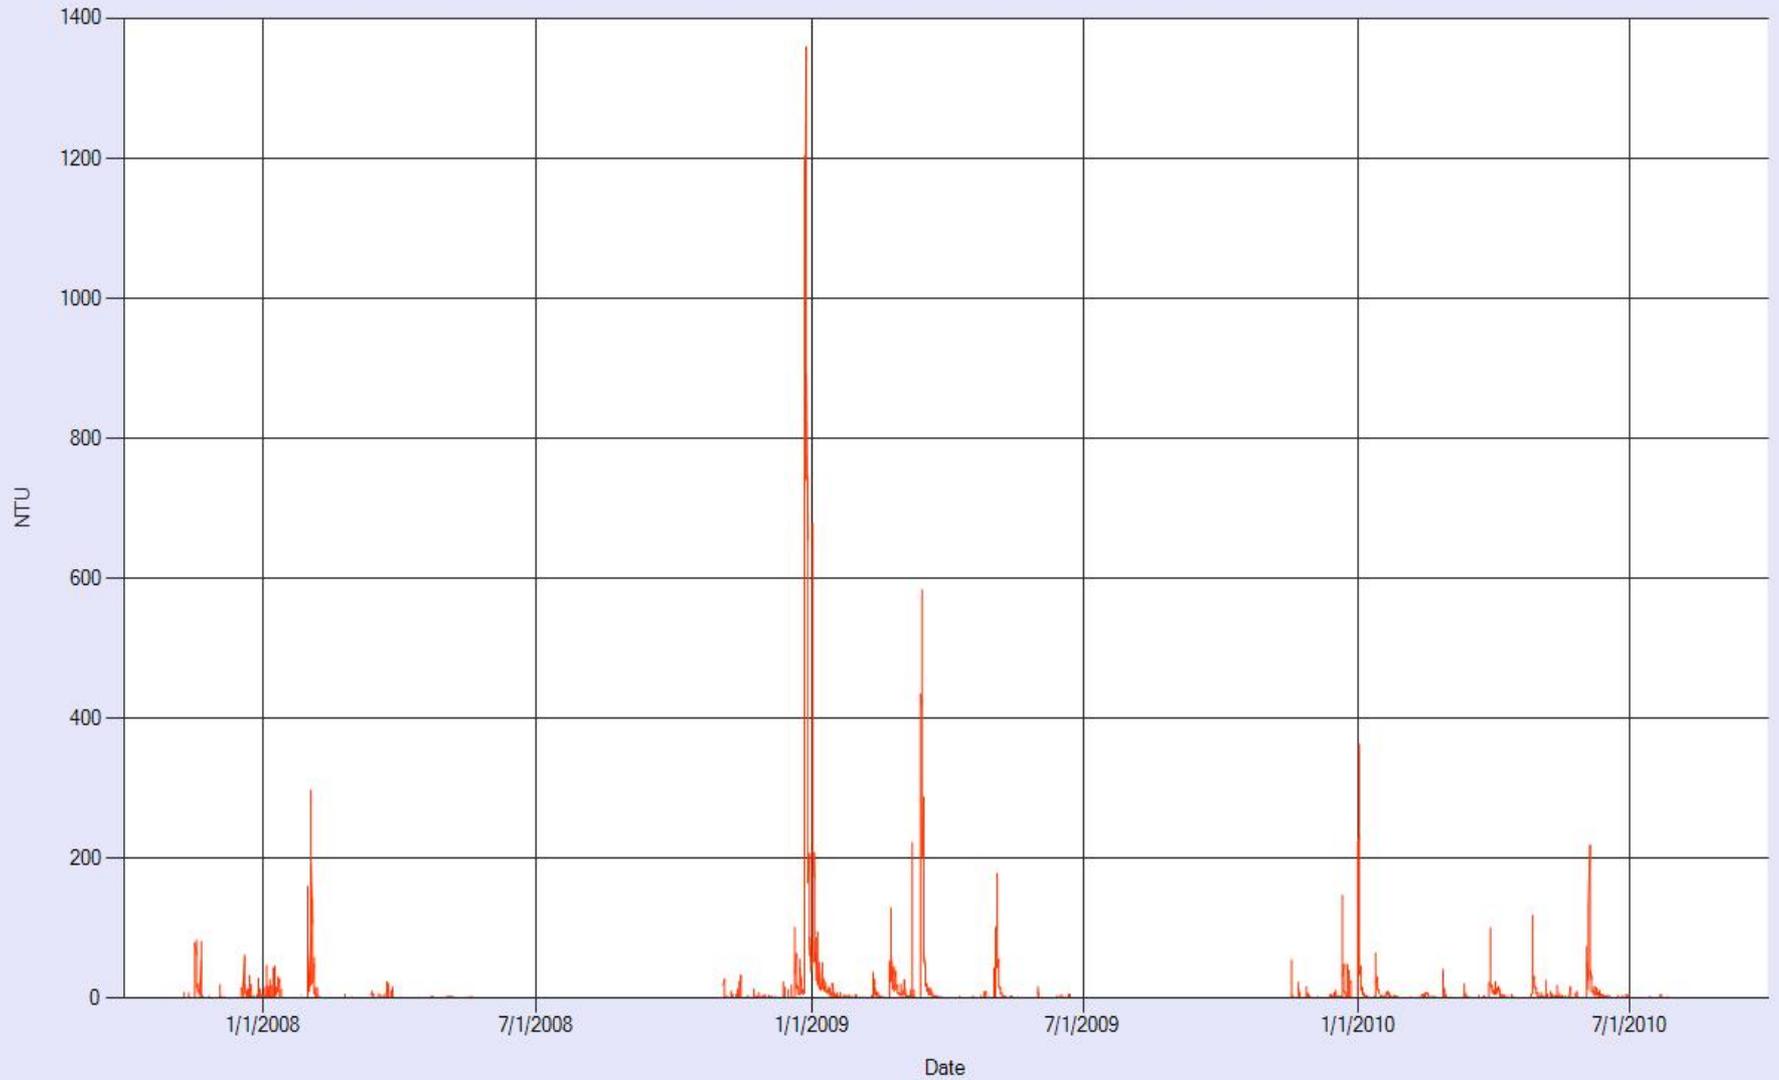
Lower Turwar Creek WY 2008-2010 Turbidity

Turbidity LTturb07_10 Turbidity
- Corrections
