# U.S. Environmental Protection Agency and Tennessee Valley Authority Kingston Coal Ash Release Site Project Completion Fact Sheet

Harriman, Roane County, Tennessee

December 2014

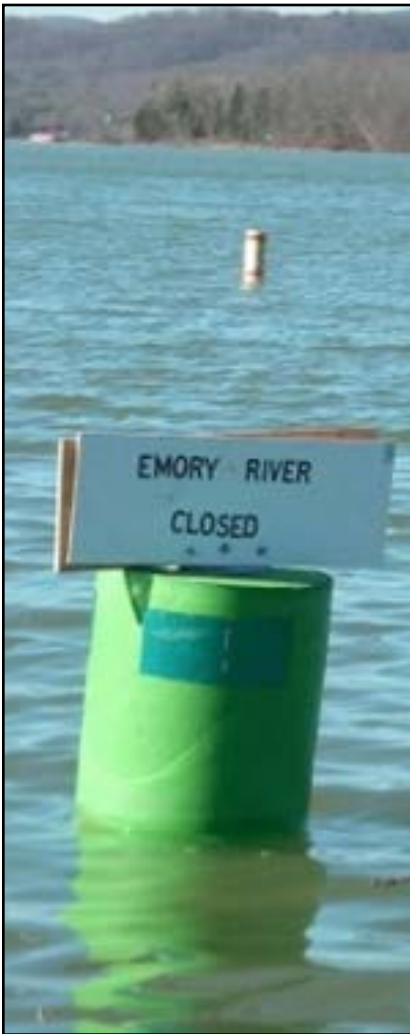
Emory River closed

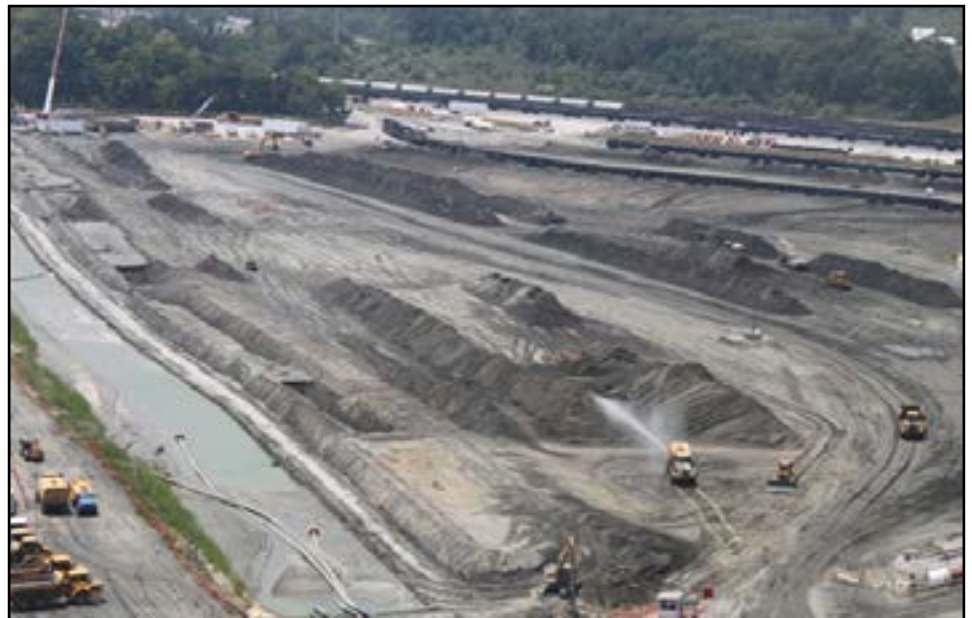
On-site ash dewatering

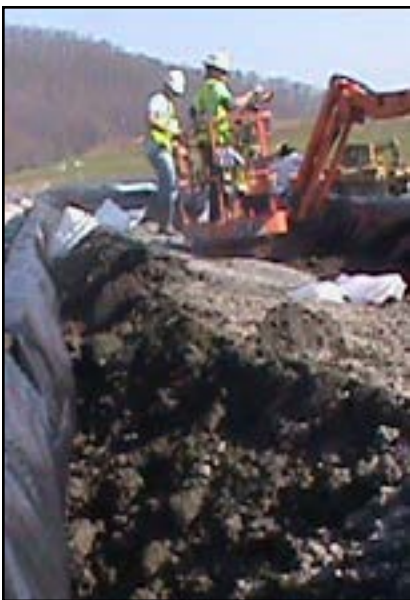
Loading ash onto rail car

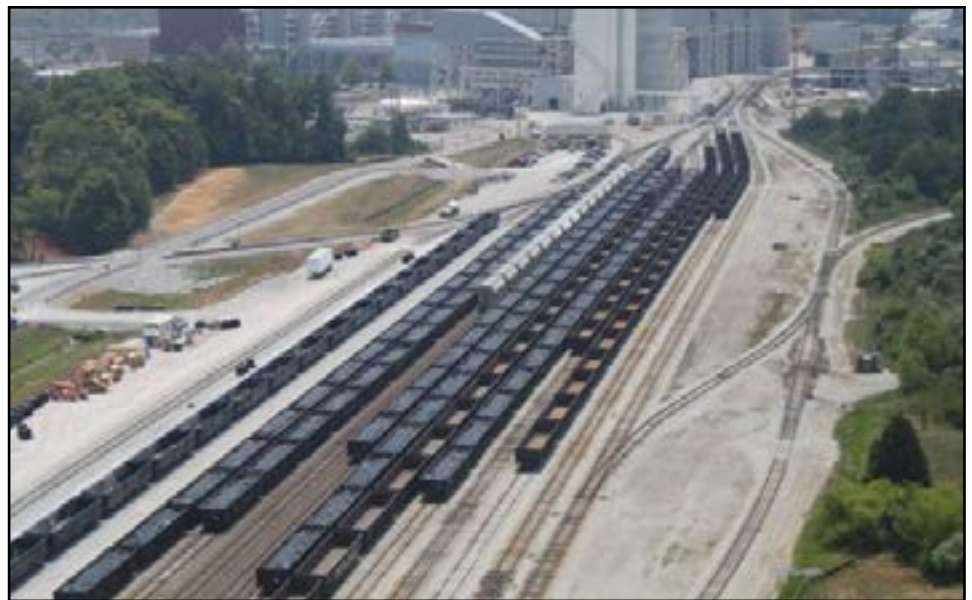
Dewatered ash loaded onto rail cars and ready for shipment

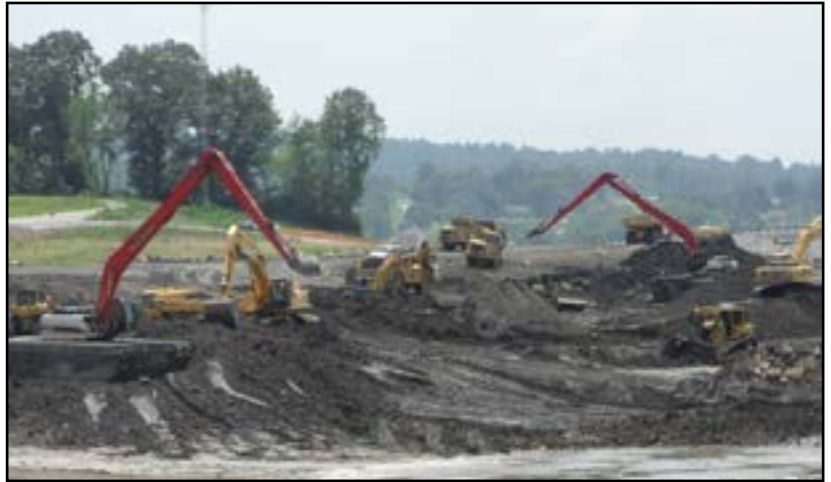
On-site excavation

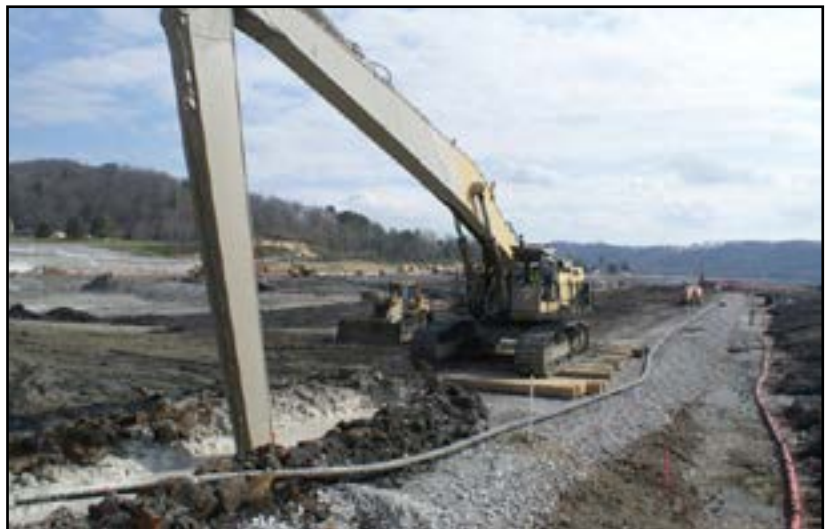
Construction of the slurry wall

**Total length of 4-foot wide slurry trench**  
69,000 linear feet  
**13 miles – longest ever constructed in United States**

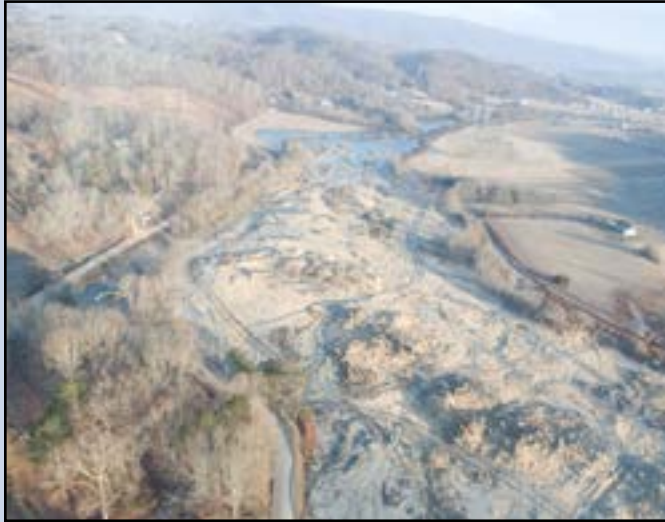
North Embayment then

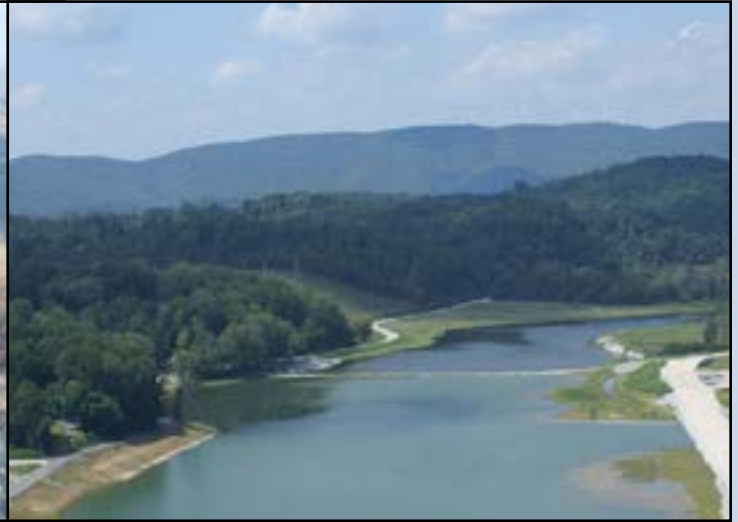
North Embayment now

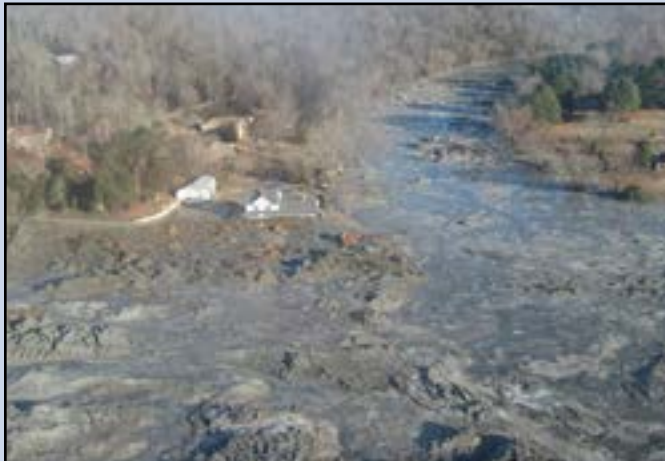
East Embayment then

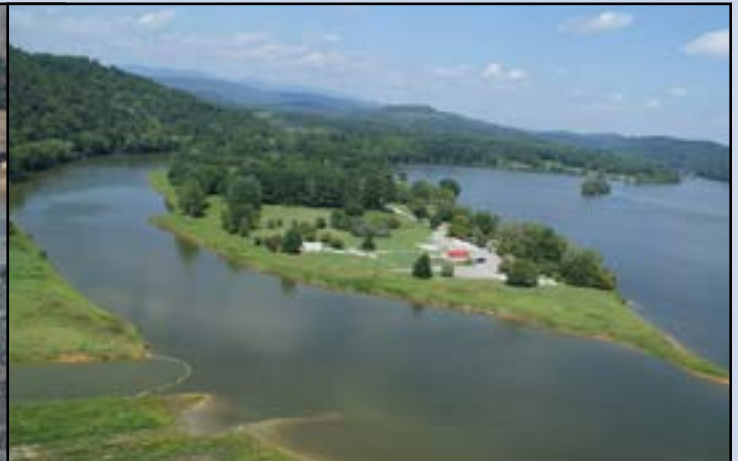
East Embayment now

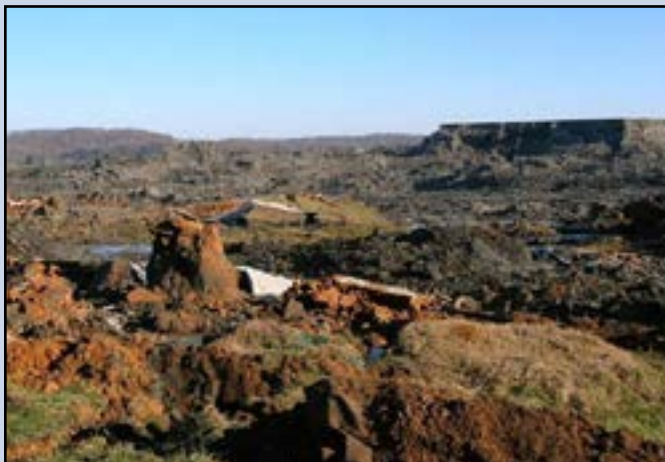
Swan Pond Circle then

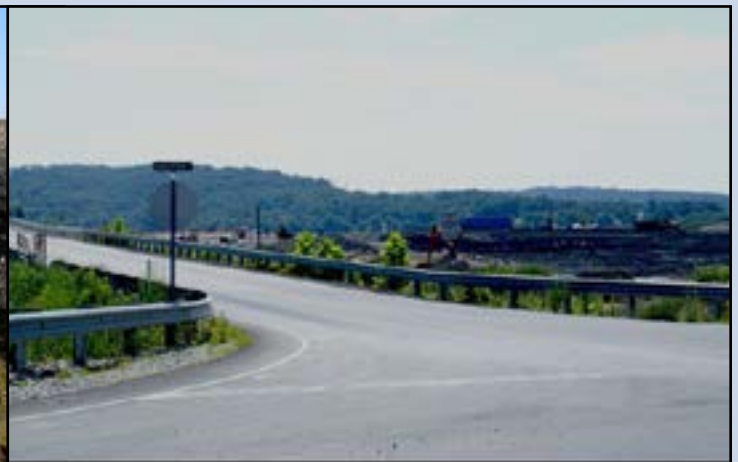
Swan Pond Circle now

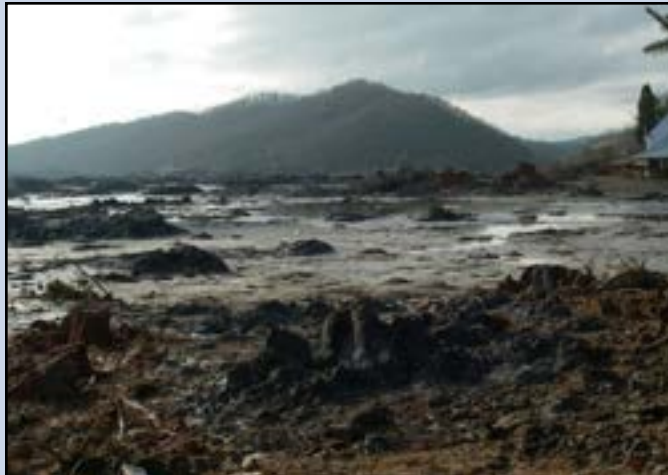
Middle Embayment then

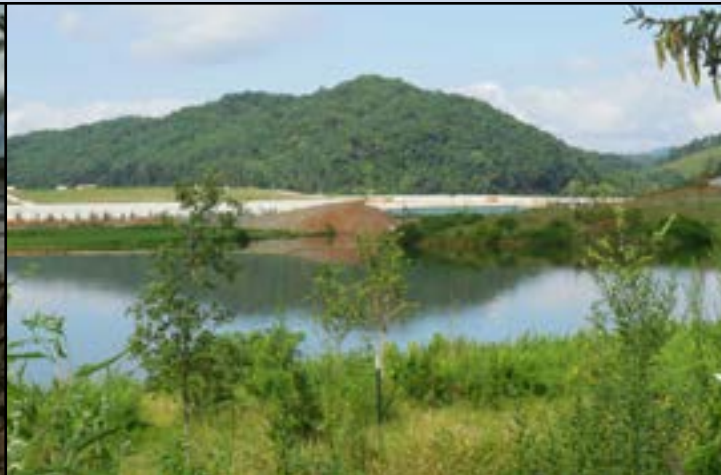
Middle Embayment now
