Navajo Abandoned Uranium Mine Site Screen Report

Rats Nest AUM Site

Navajo AUM Eastern Region

May 2009

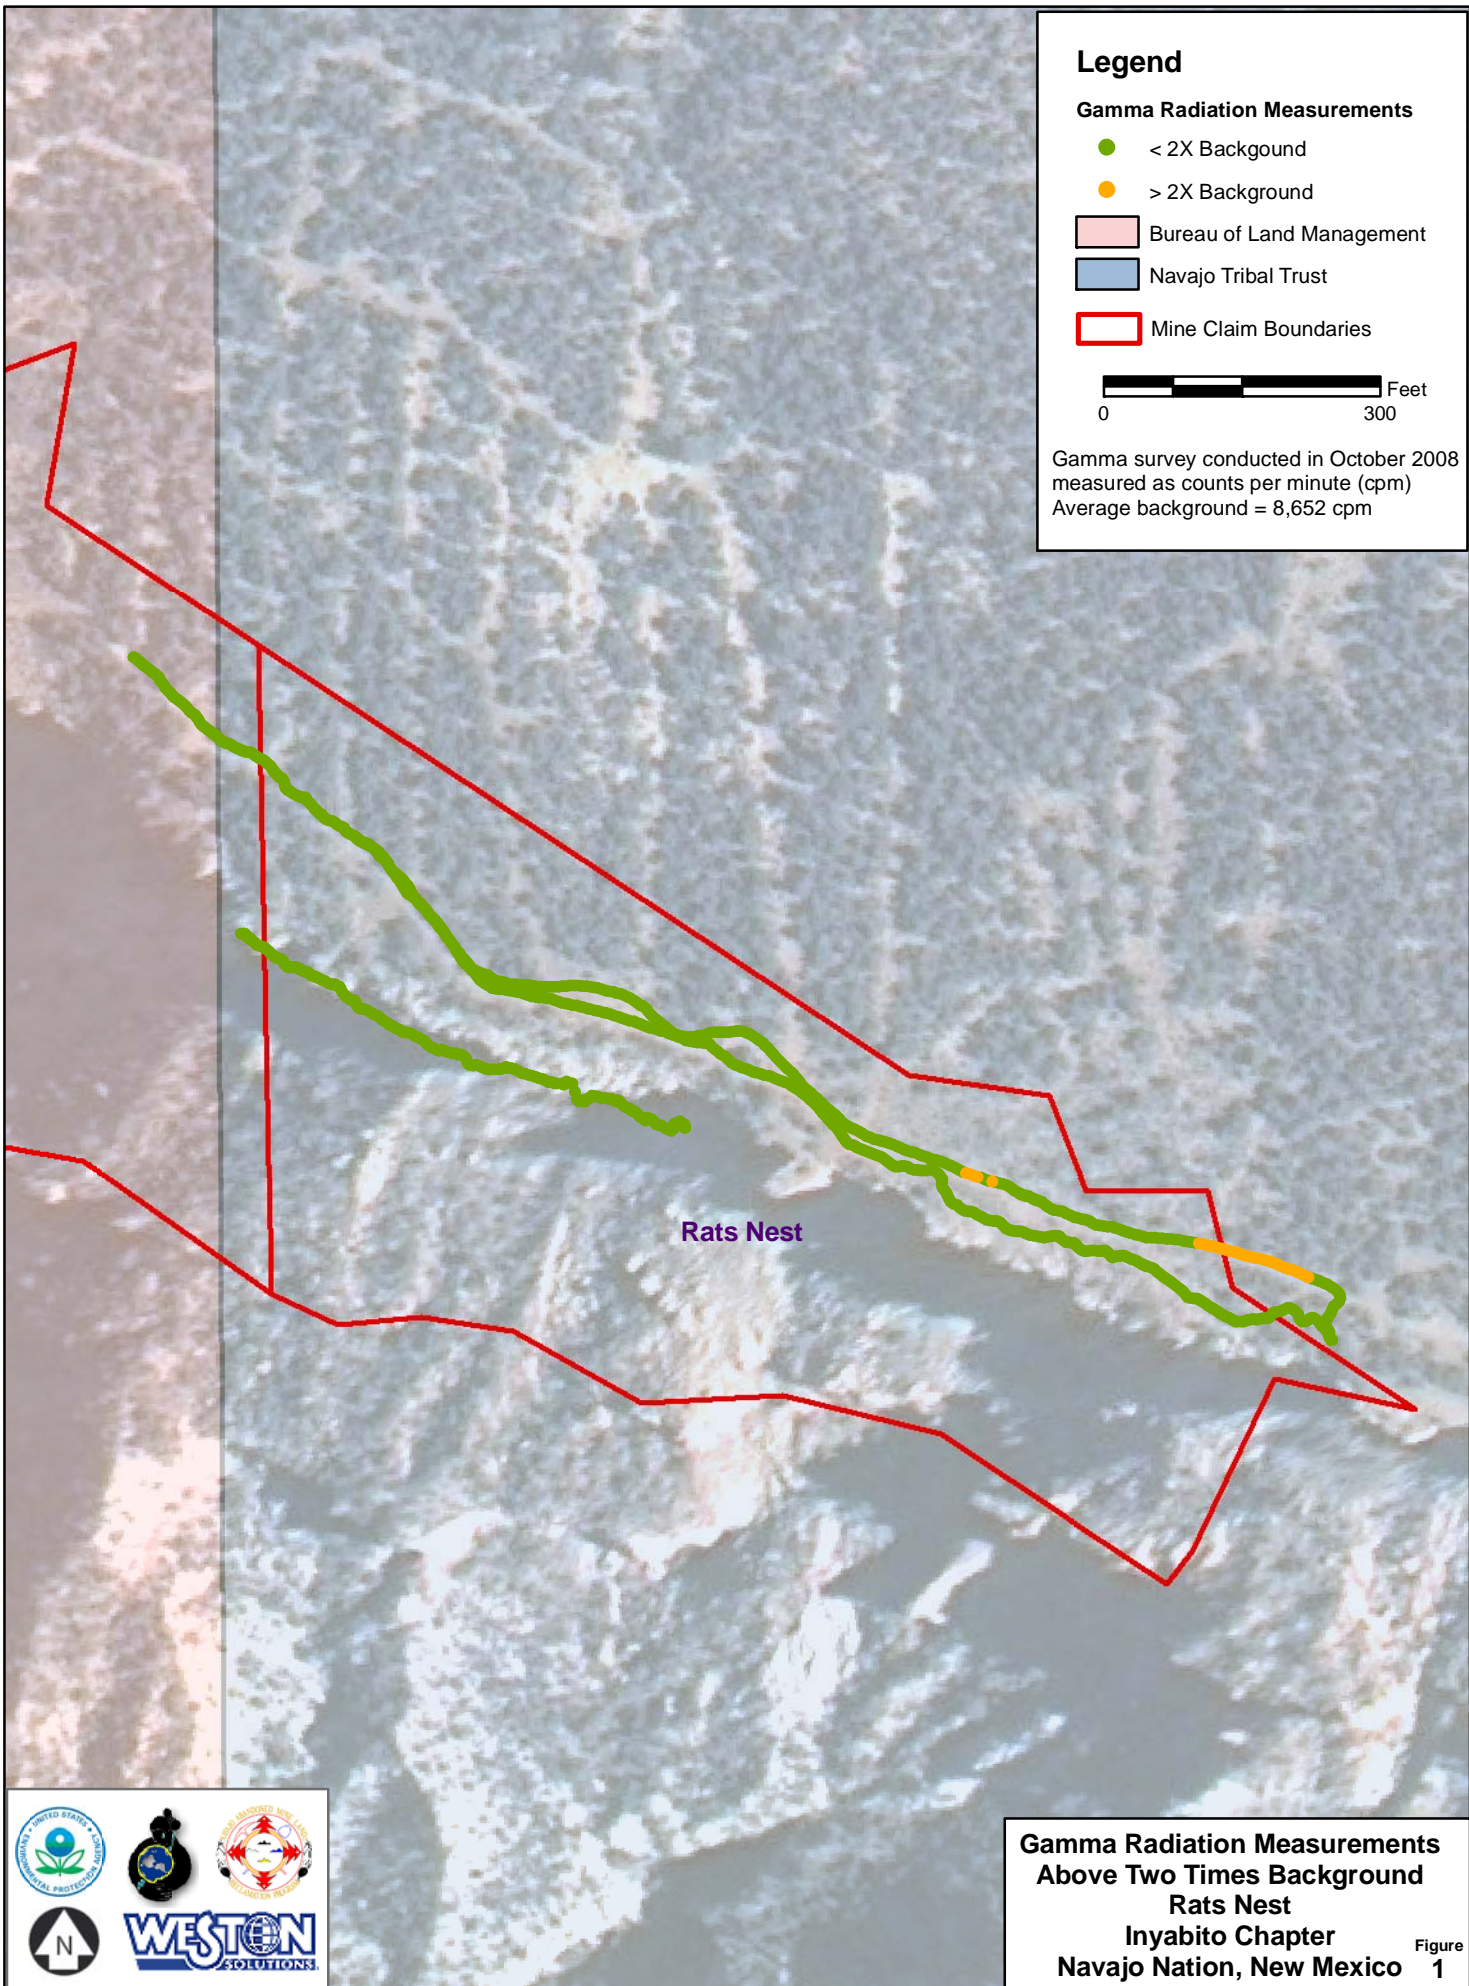
Gamma survey conducted in October 2008
 measured as counts per minute (cpm)
 Average background = 8,652 cpm

**Gamma Radiation Measurements
 Above Two Times Background
 Rats Nest
 Inyabito Chapter
 Navajo Nation, New Mexico** Figure 1

A total of 976 gamma radiation measurements were collected from mine sites, ranging from 5,374 cpm to 37,489 cpm. The measurements are represented in Figures 1 and 2.
