Navajo Abandoned Uranium Mine Site Screen Report

Section 29 – Conoco AUM Site

Navajo AUM Eastern Region

Weston Solutions, Inc.

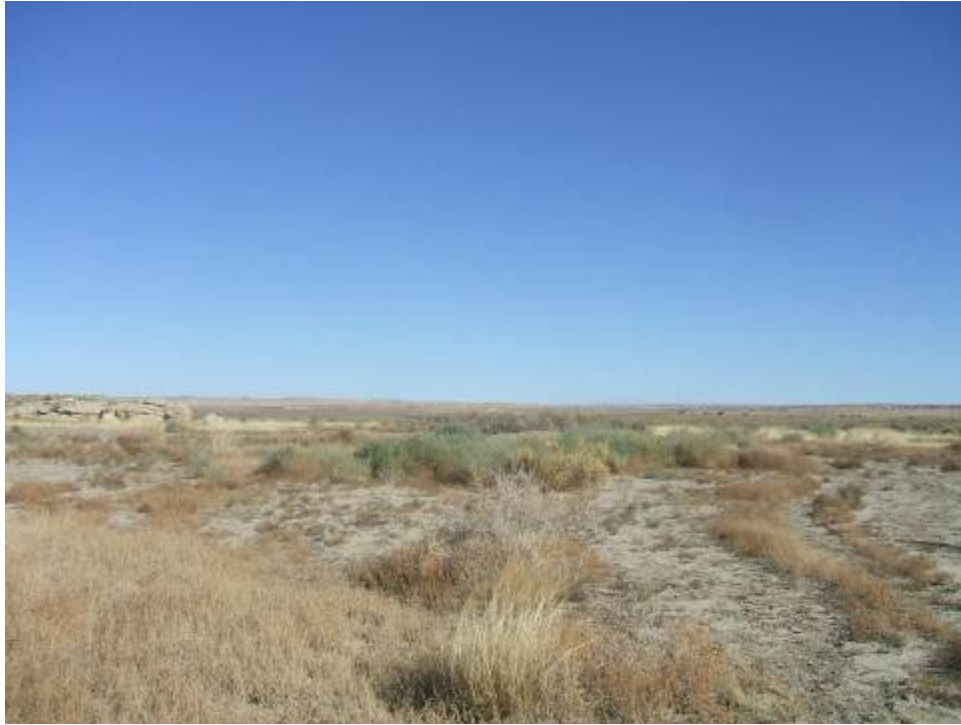
Reclamation status of the mine site is currently unknown. No visible signs of reclamation were observed. No waste piles, adits, or other mine features were observed during the site visit.

Photo 1. Section 29 – Conoco mine site, towards the east

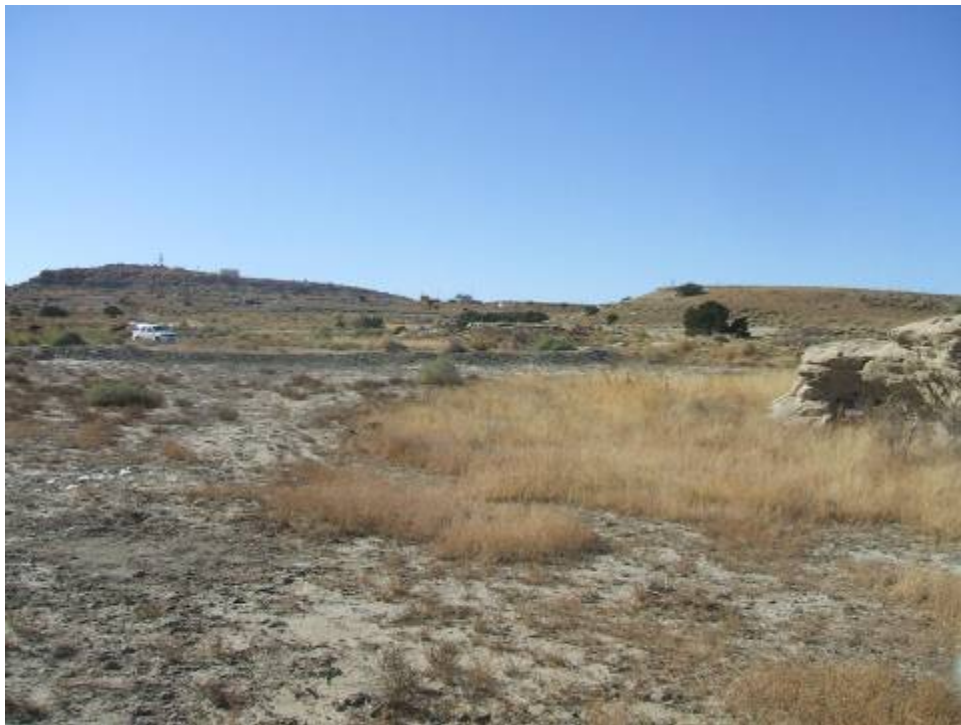
Photo 2. Section 29 – Conoco mine site, towards the west
