Navajo Abandoned Uranium Mine Site Screen Report

Section 22 AUM Site

Navajo AUM Eastern Region

May 2009

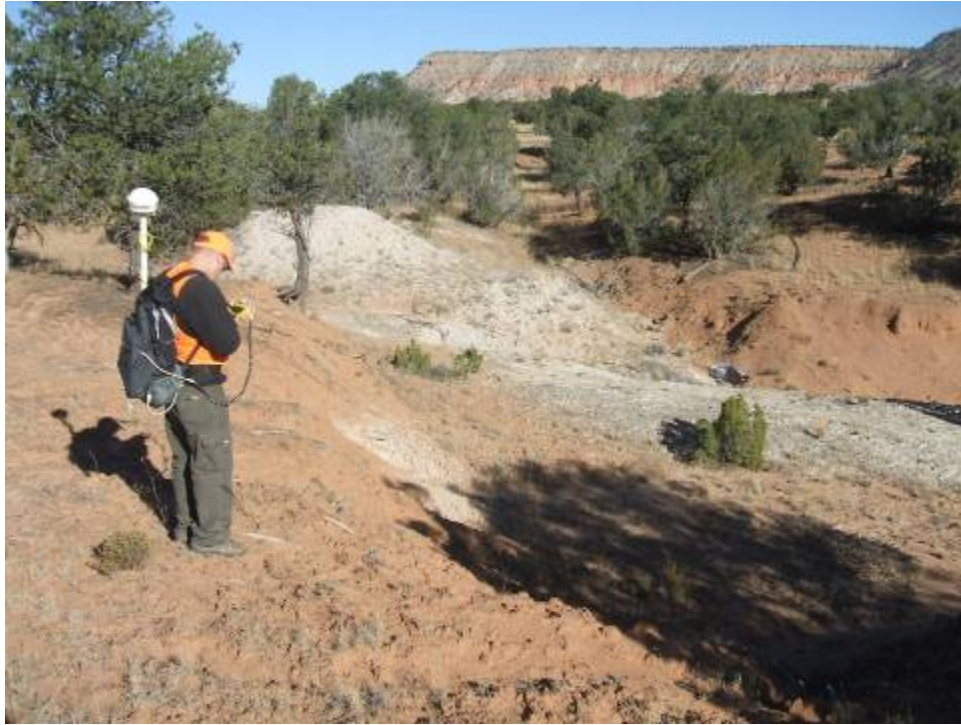
Photo 1. Section 22 mine site and gravel pile and ditch, towards the northwest

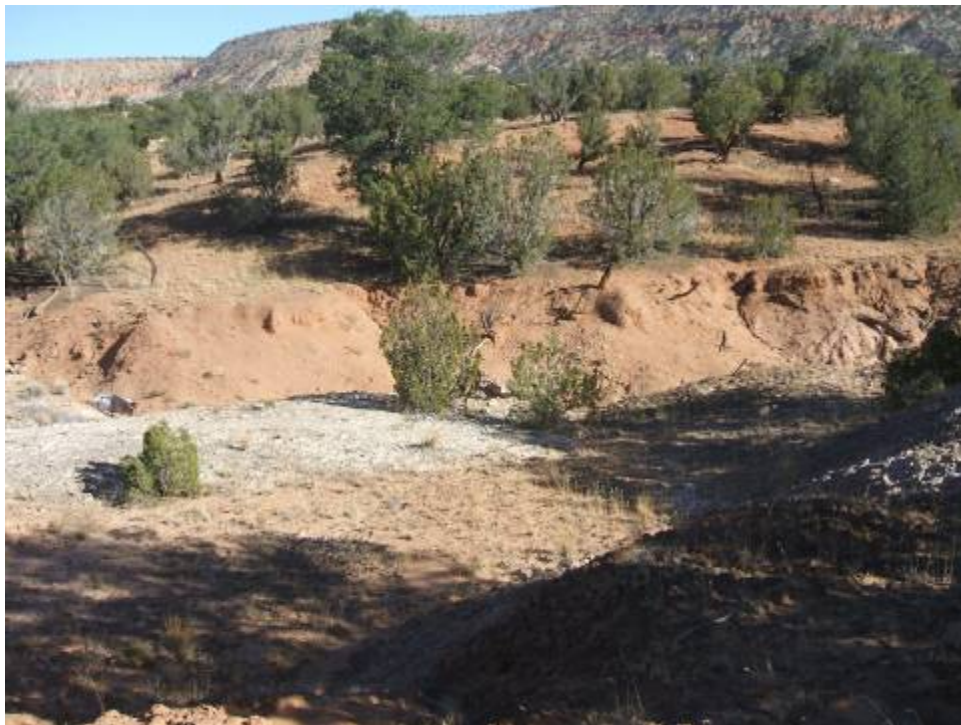
Reclamation status of the mine site is currently unknown. A small gravel pile was observed in the center of the site property (Photo 2). No adits or other mine features were observed during the site visit.

Photo 2. Section 22 mine site and gravel pile and ditch, towards the northeast
