Navajo Abandoned Uranium Mine

Site Screen Report

Hosteen Nez AUM Site

January 2011

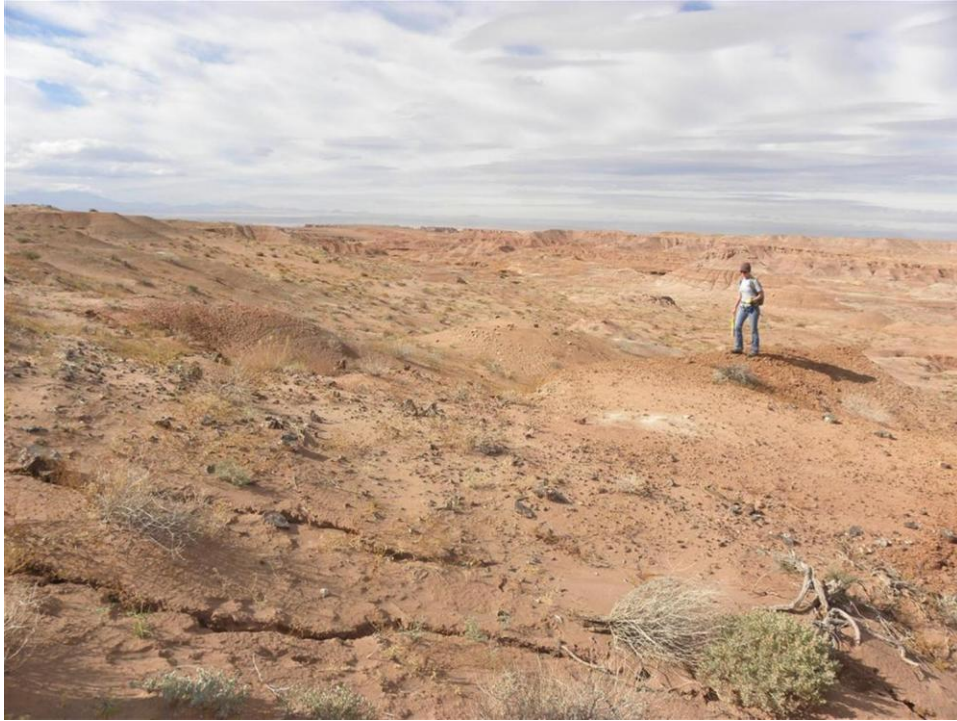
Mound in center of mining area northwest of 1043 site boundary, appeared to be a reclamation cap; some scattered petrified wood around cap

Photo 9. Hosteen Nez (northwest area), reclamation cap area

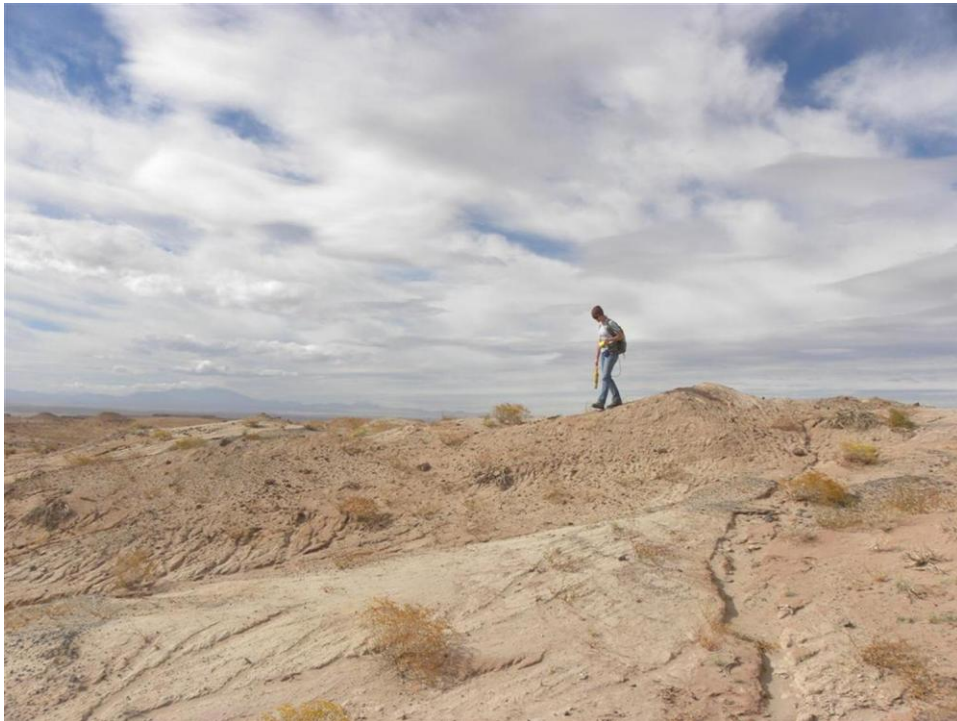
Photo 10. Hosteen Nez (northwest area), reclamation cap area

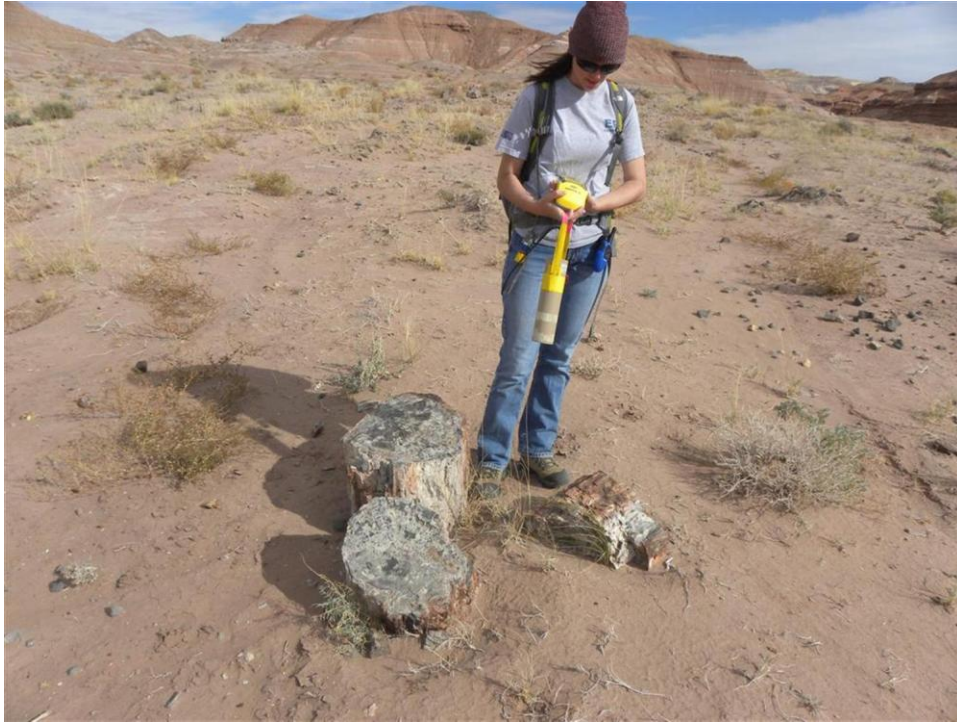
A total of 5,548 gamma radiation measurements were collected from the mine site, ranging from 4,607 cpm to 216,614 cpm. The measurements collected within the mine site boundaries were all near background levels. Measurements were also collected from the area approximately 0.75 miles to the northwest, identified by Kenneth Nez as the mine location. Measurements collected in the northwest area reclamation cap were found at a maximum level of approximately 215,000 cpm, at a petrified wood pile at a maximum level of approximately 40,000 cpm, and in the drainage below the cap leading towards the cliffs at a level of approximately 20,000 cpm. The measurements are represented in Figures 1 and 2.

Photo 11. Hosteen Nez (northwest area), petrified wood with elevated gamma readings

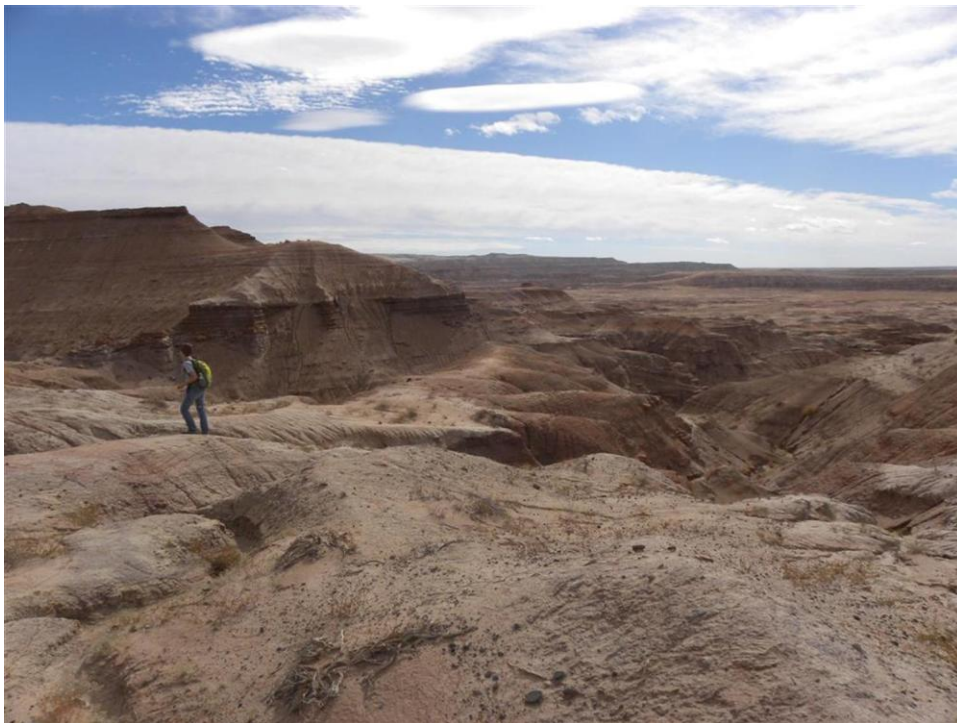
Photo 12. Hosteen Nez (northwest area), canyons leading offsite
