Navajo Abandoned Uranium Mine

Site Screen Report

Mine Name: Charles Huskon No. 7 (MP-357)

August 2011

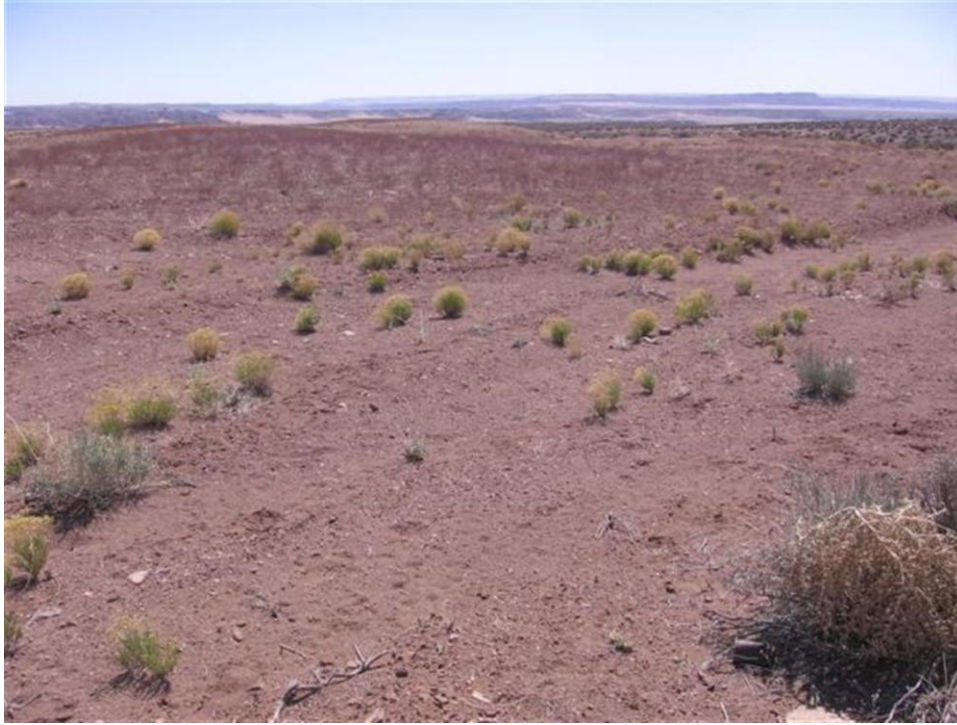
Photo 1: Mine Site #172; Reclamation area

4 reclamation caps: Cap 1, Cap 2, and Cap 3 - comprised of 600'x300'x12' tan sandy area with little vegetation in southeast corner of site; Cap 4 - 450'x250'x10' irregular shape split by wide drainage in northwest portion of site

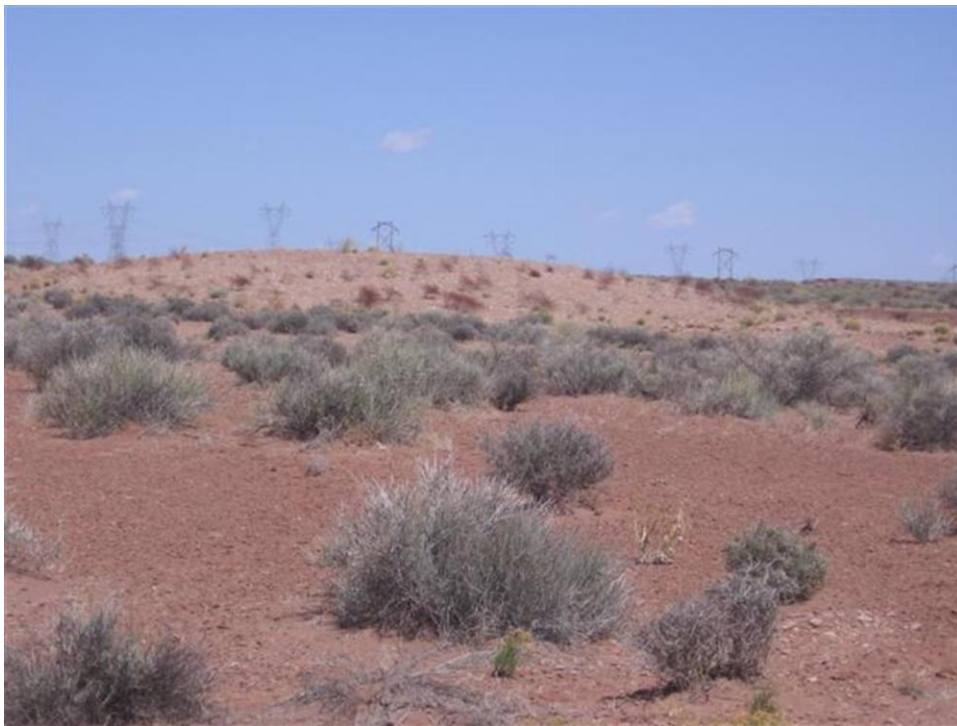
Photo 2: Mine Site #172; Reclamation area

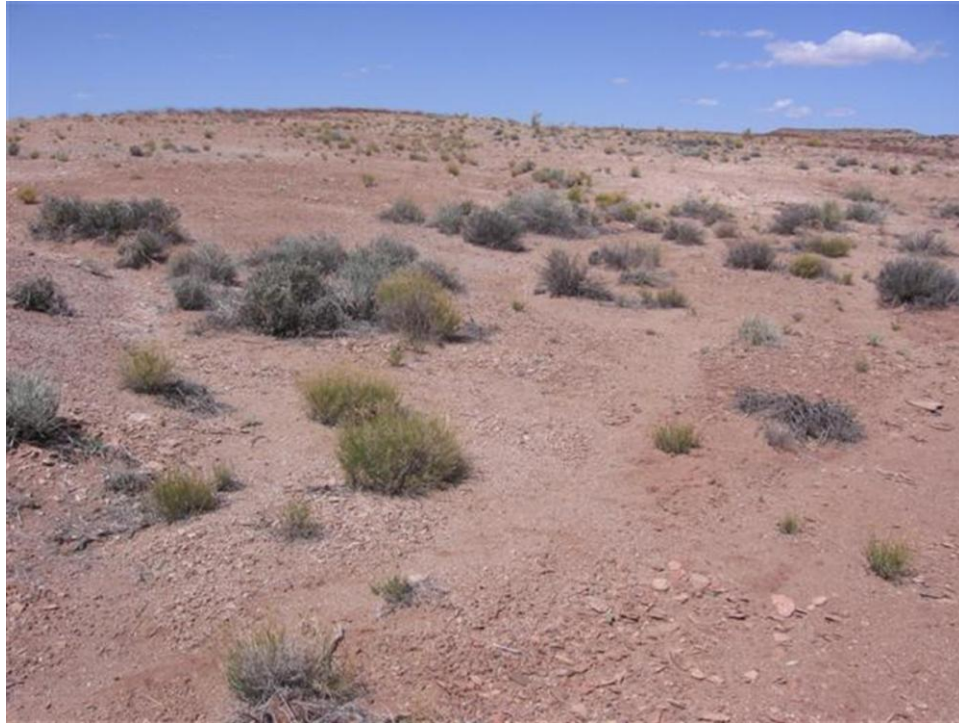
Photo 3: Mine Site #172; Reclamation area

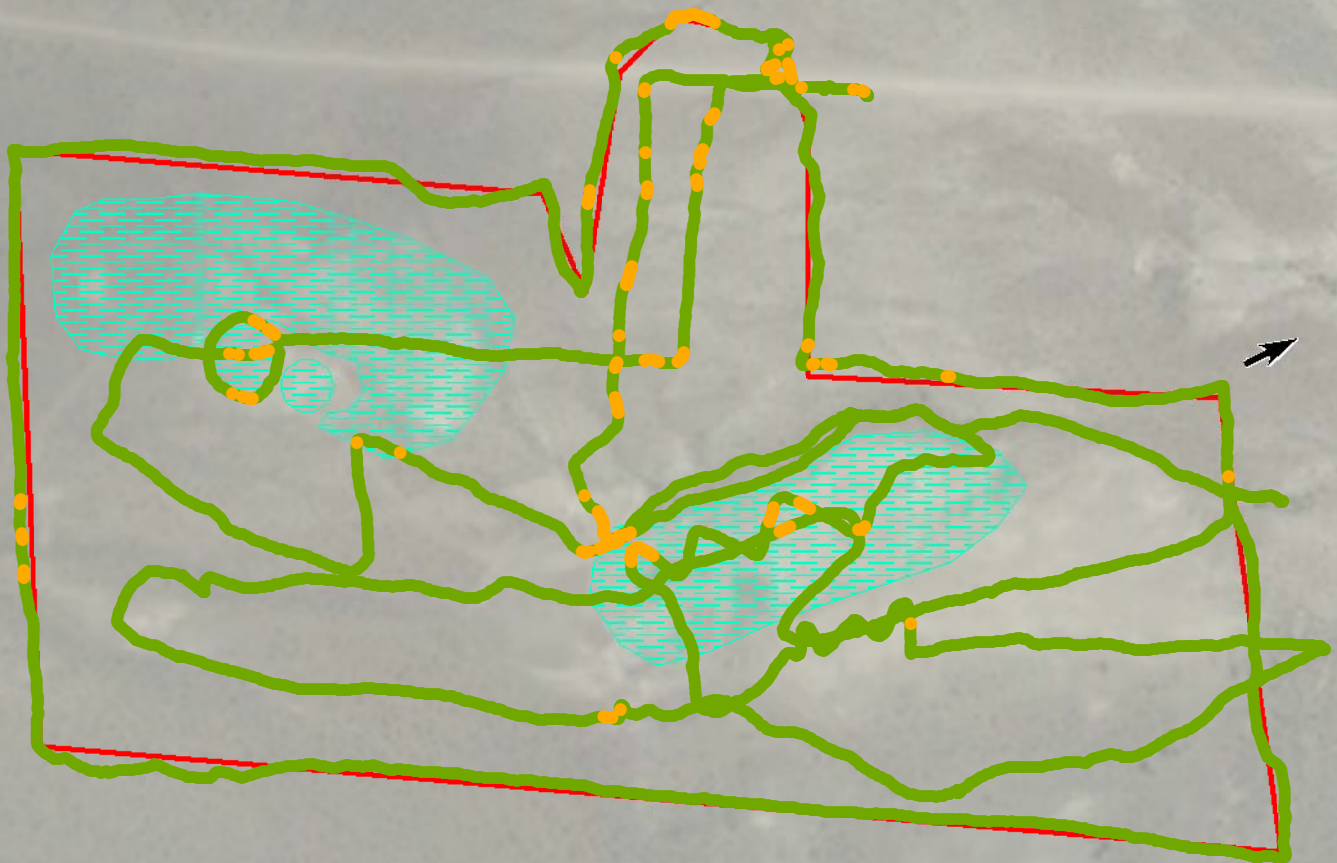
**Figure 1 - Gamma Radiation Measurements, Above Two Times Background
Charles Huskon No. 7 (MP-357) (172)
Bodaway / Gap Chapter, Navajo Nation**

A total of 4,140 gamma radiation measurements were collected from the mine site, ranging from 11,923 cpm to 105,814 cpm. Measurements collected in the vicinity of the reclamation areas were found at a maximum level of approximately 60,000 cpm. The measurements are represented in Figures 1 and 2.

Average background 18,044 cpm

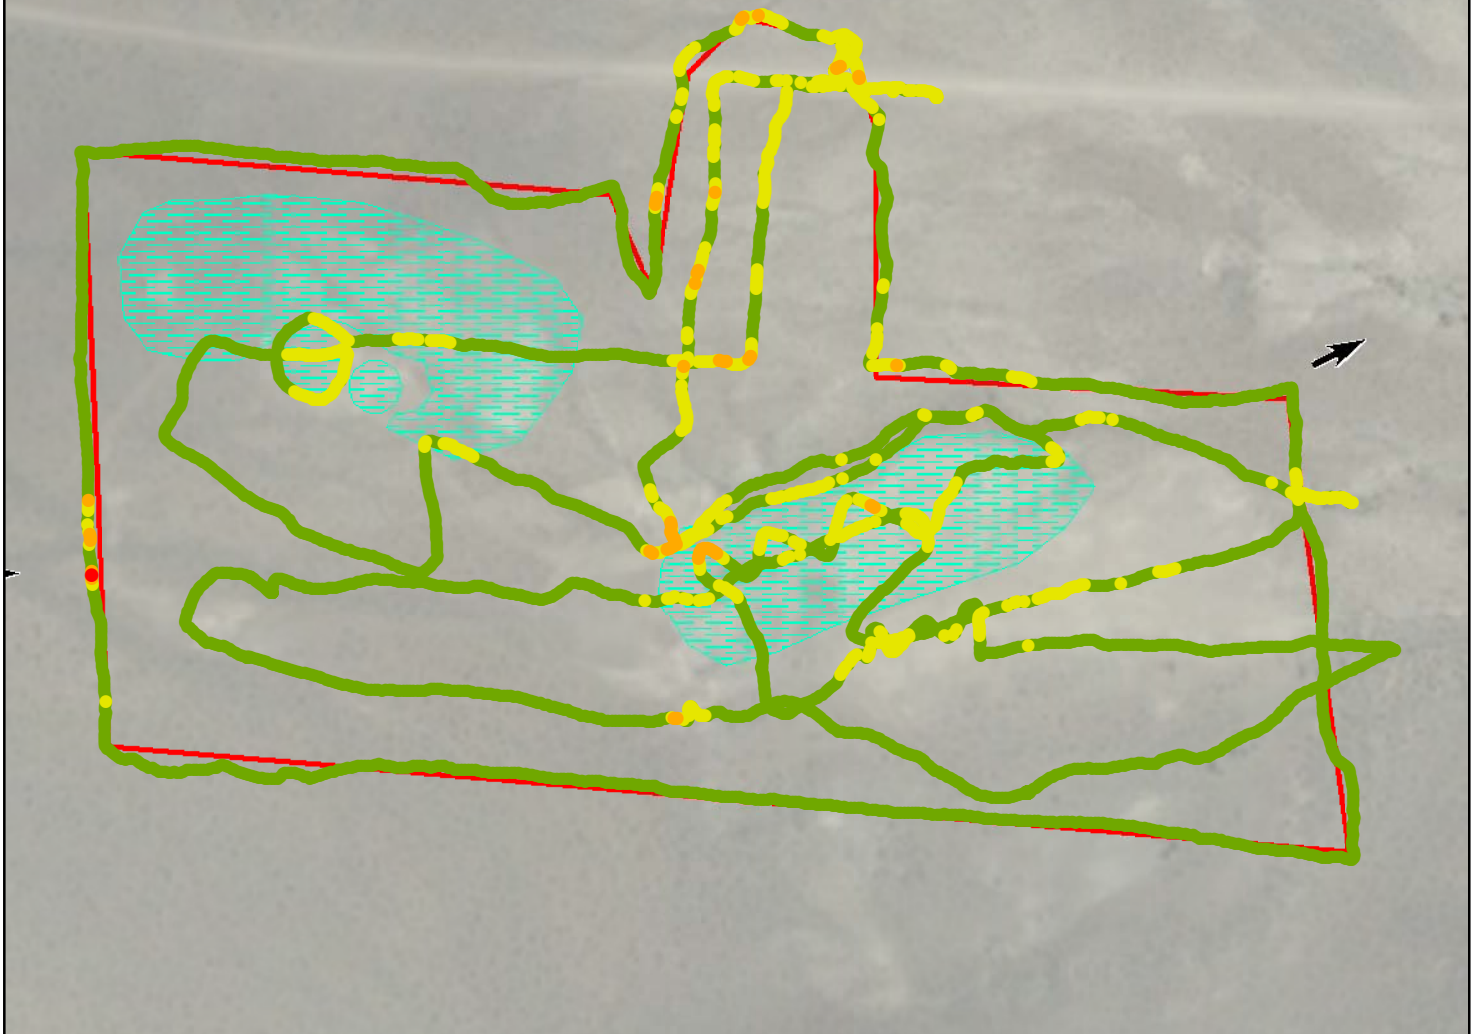
**Figure 2 - Gamma Radiation Measurements
Charles Huskon No. 7 (MP-357) (172)
Bodaway / Gap Chapter, Navajo Nation**

Measured as counts per minute (cpm) Average background 18,044 cpm
