Navajo Abandoned Uranium Mine

Site Screen Report

Charles Huskon No. 11 AUM Site

January 2011

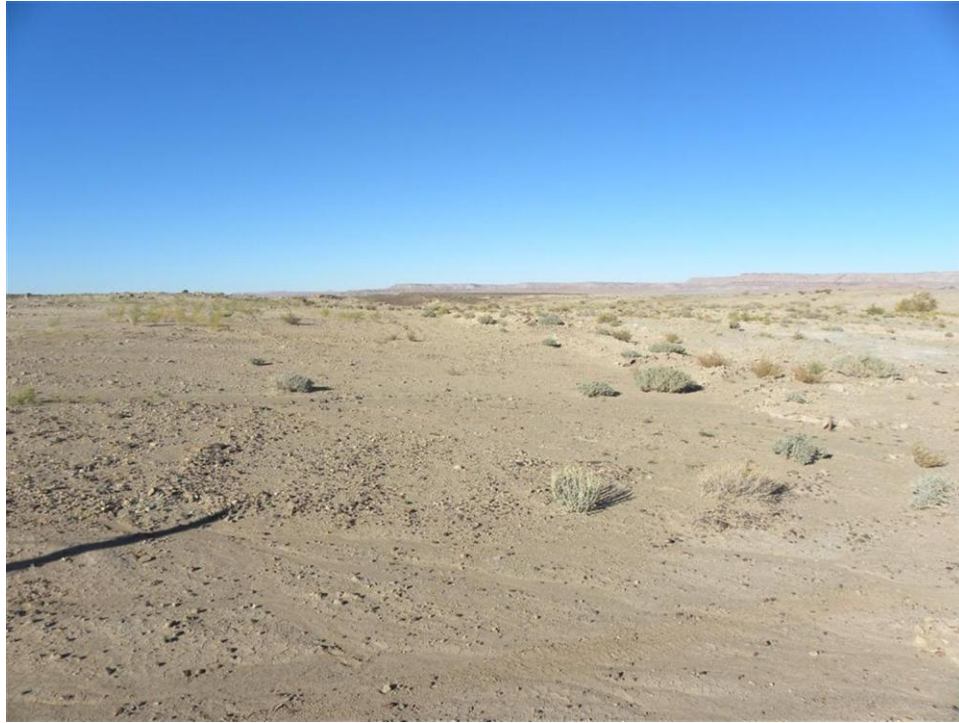
Majority of N end site appeared to be reclamation caps/furrows

Photo 1. Charles Huskon No. 11 mine site

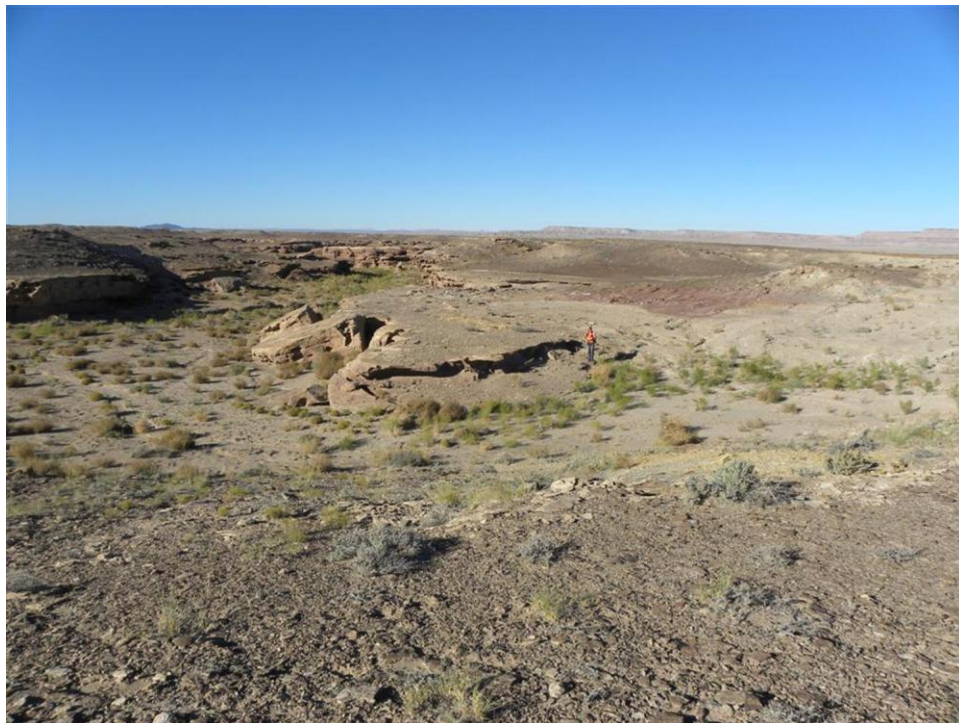
A total of 1,556 gamma radiation measurements were collected from the mine site, ranging from 15,192 cpm to 174,004 cpm. The measurements collected at the reclamation area were found at maximum levels ranging from approximately 25,000 cpm to 40,000 cpm, and at an isolated hot spot in the center of the site at a maximum level of approximately 175,000 cpm. The measurements are represented in Figures 1 and 2.

Photo 2. Charles Huskon No. 11 mine site, area of elevated gamma readings
