Navajo Abandoned Uranium Mine

Site Screen Report

Yazzie No. 2 AUM Site

January 2011

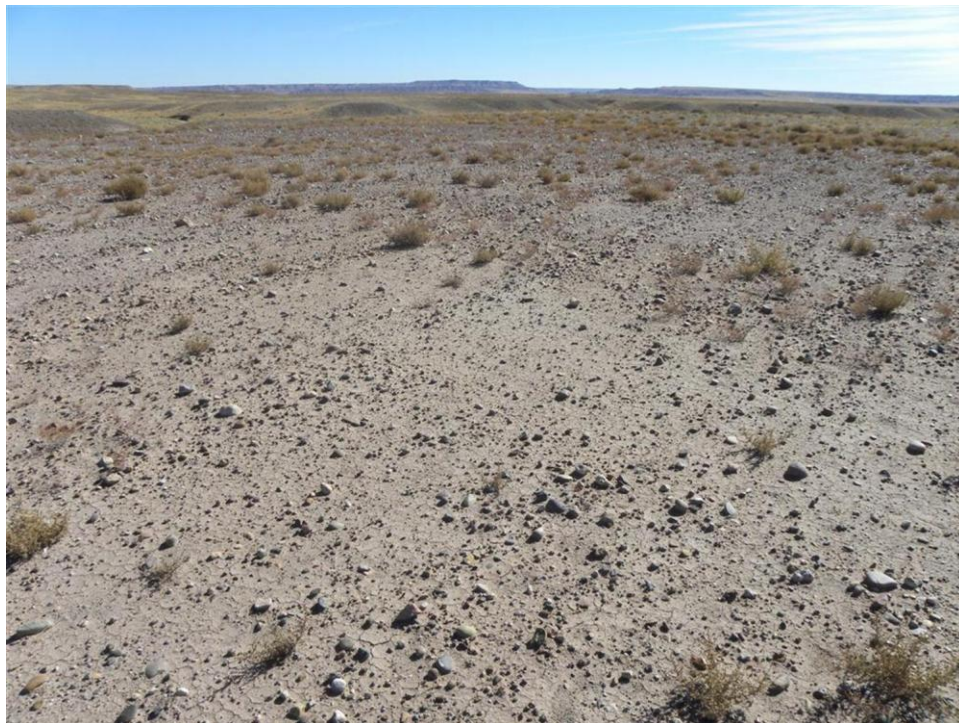
Large graded reclamation cap, uniform grey granular soil, 800' x 600', flat

Photo 2. Yazzie No. 2 mine site, reclamation cap

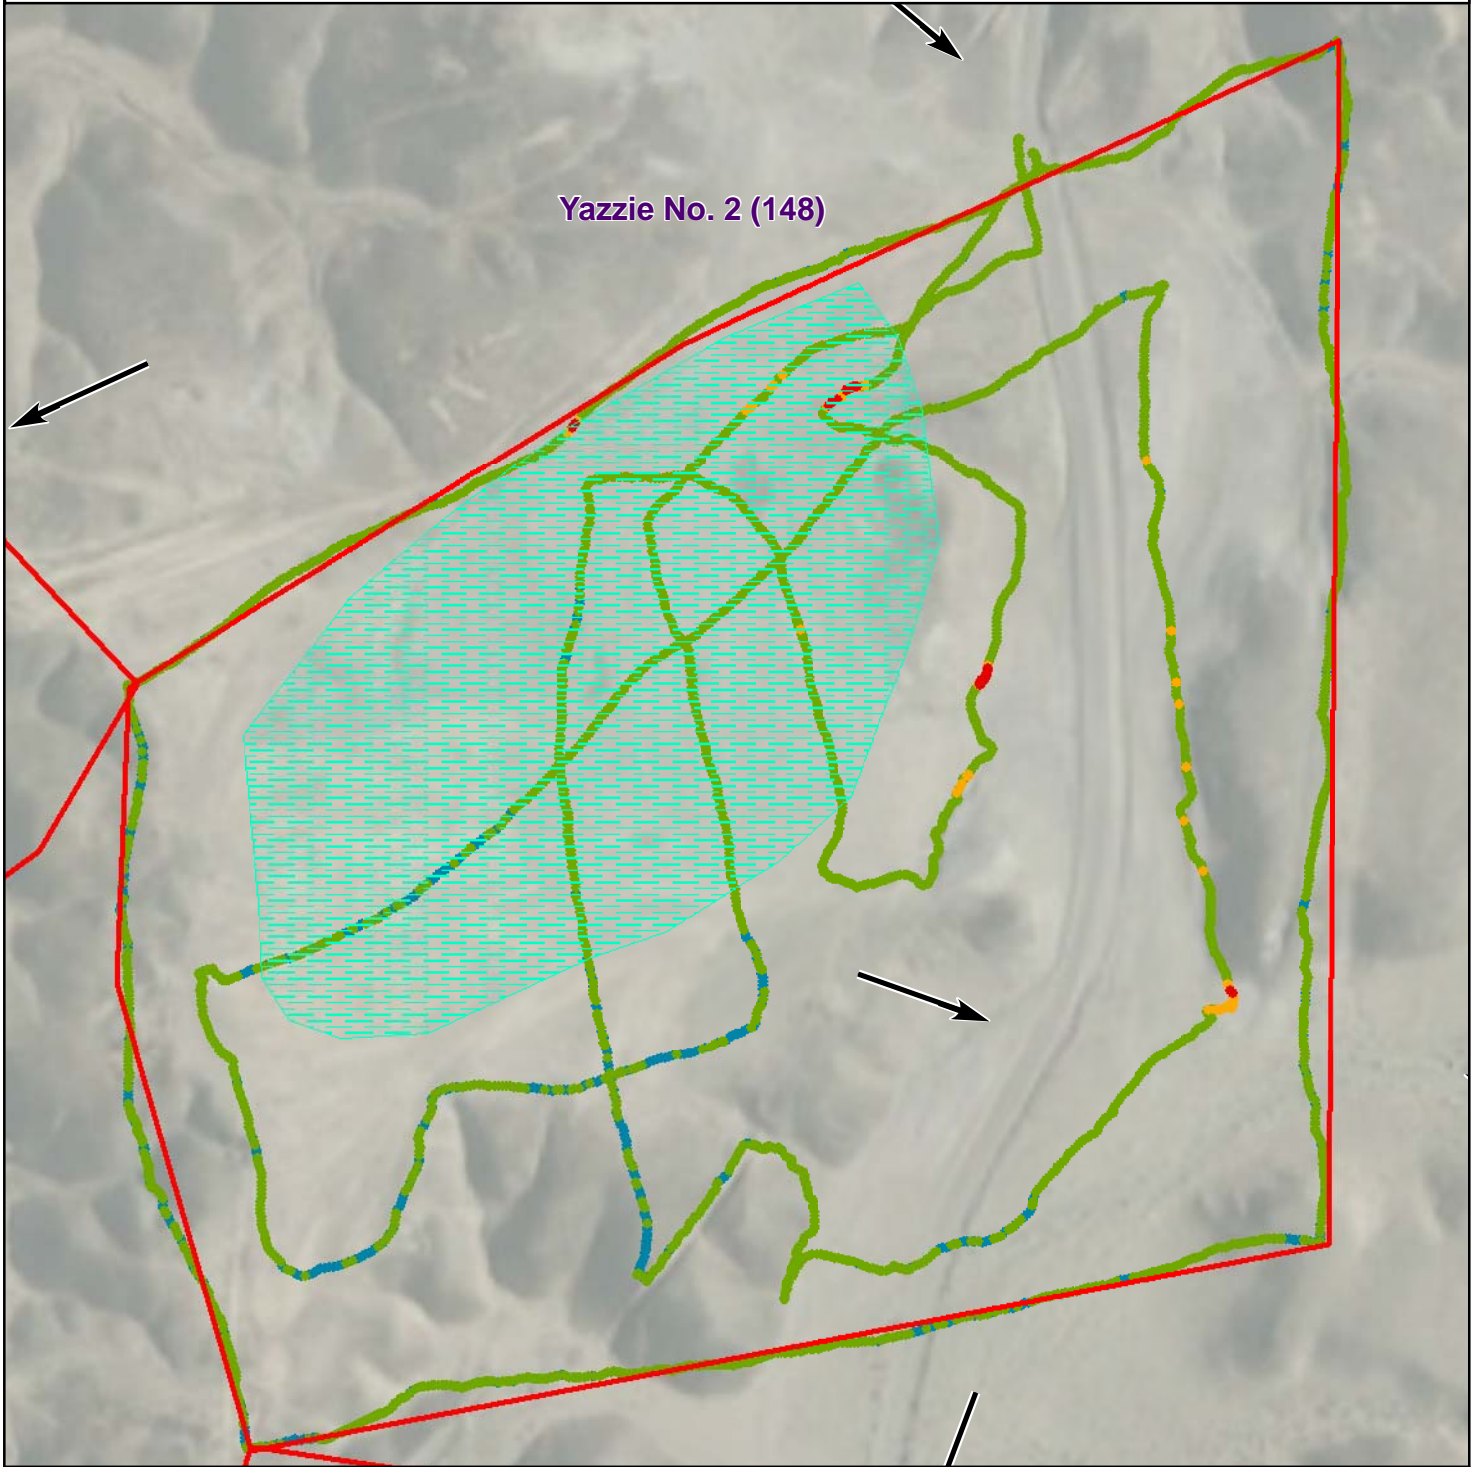
A total of 3,977 gamma radiation measurements were collected from the mine site, ranging from 8,009 cpm to 38,013 cpm. The measurements are represented in Figures 1 and 2.

**Figure 2 - Gamma Radiation Measurements
Yazzie No. 2 (148)
Coalmine Mesa Chapter, Navajo Nation**

**Gamma survey conducted 11/2010
Measured as counts per minute (cpm)**

Average background 11,250 cpm
