Navajo Abandoned Uranium Mine

Site Screen Report

Yazzie No. 1 AUM Site

January 2011

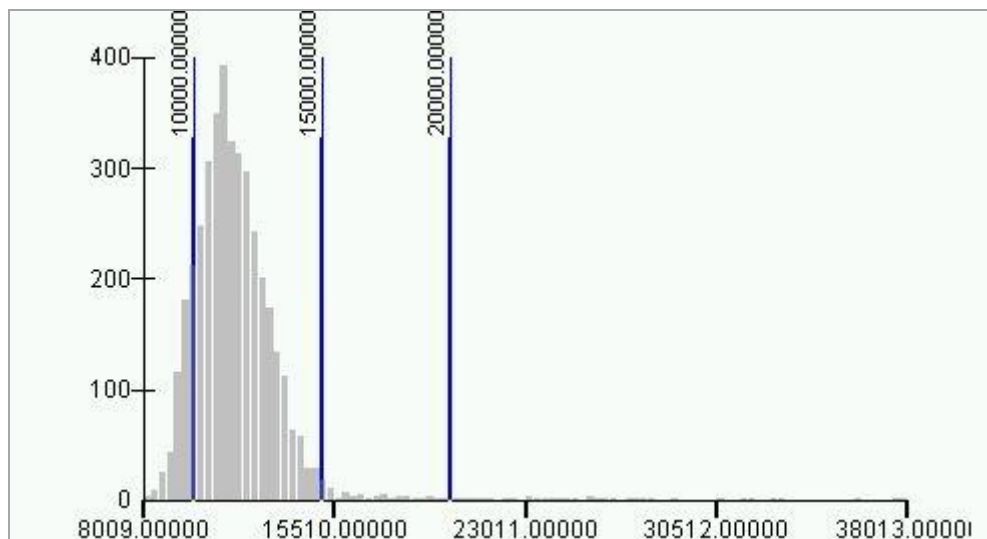
The following chart and statistics were generated by ESRI ArcGIS 9.3.1, and show the general distribution of the site gamma radiation measurements. The horizontal X axis represents the gamma radiation reading levels in cpm (lowest levels to the left). The vertical Y axis represents the frequency of each gamma radiation level.

| Count: | 2452 |
| Minimum: | 8167.00000 |
| Maximum: | 63576.00000 |
| Mean: | 13985.83442 |
| Median: | 11928.50000 |
| Standard Deviation: | 6128.09942 |

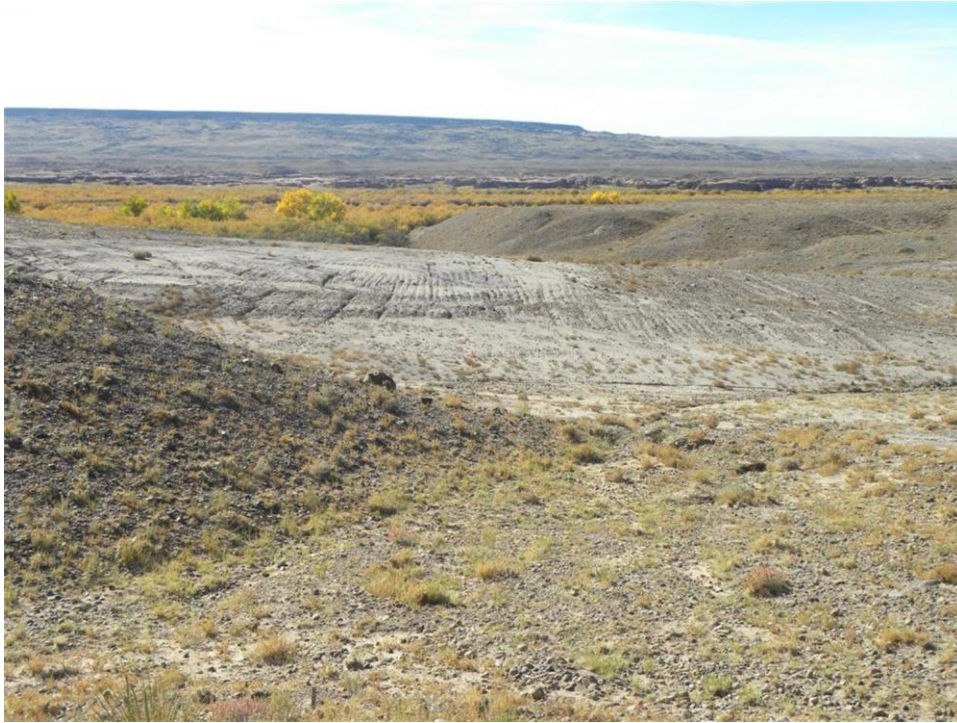
Photo 1. Yazzie No. 1 mine site

Large reclamation cap stretching downgradient, fine grey material, moderate cuts due to erosion

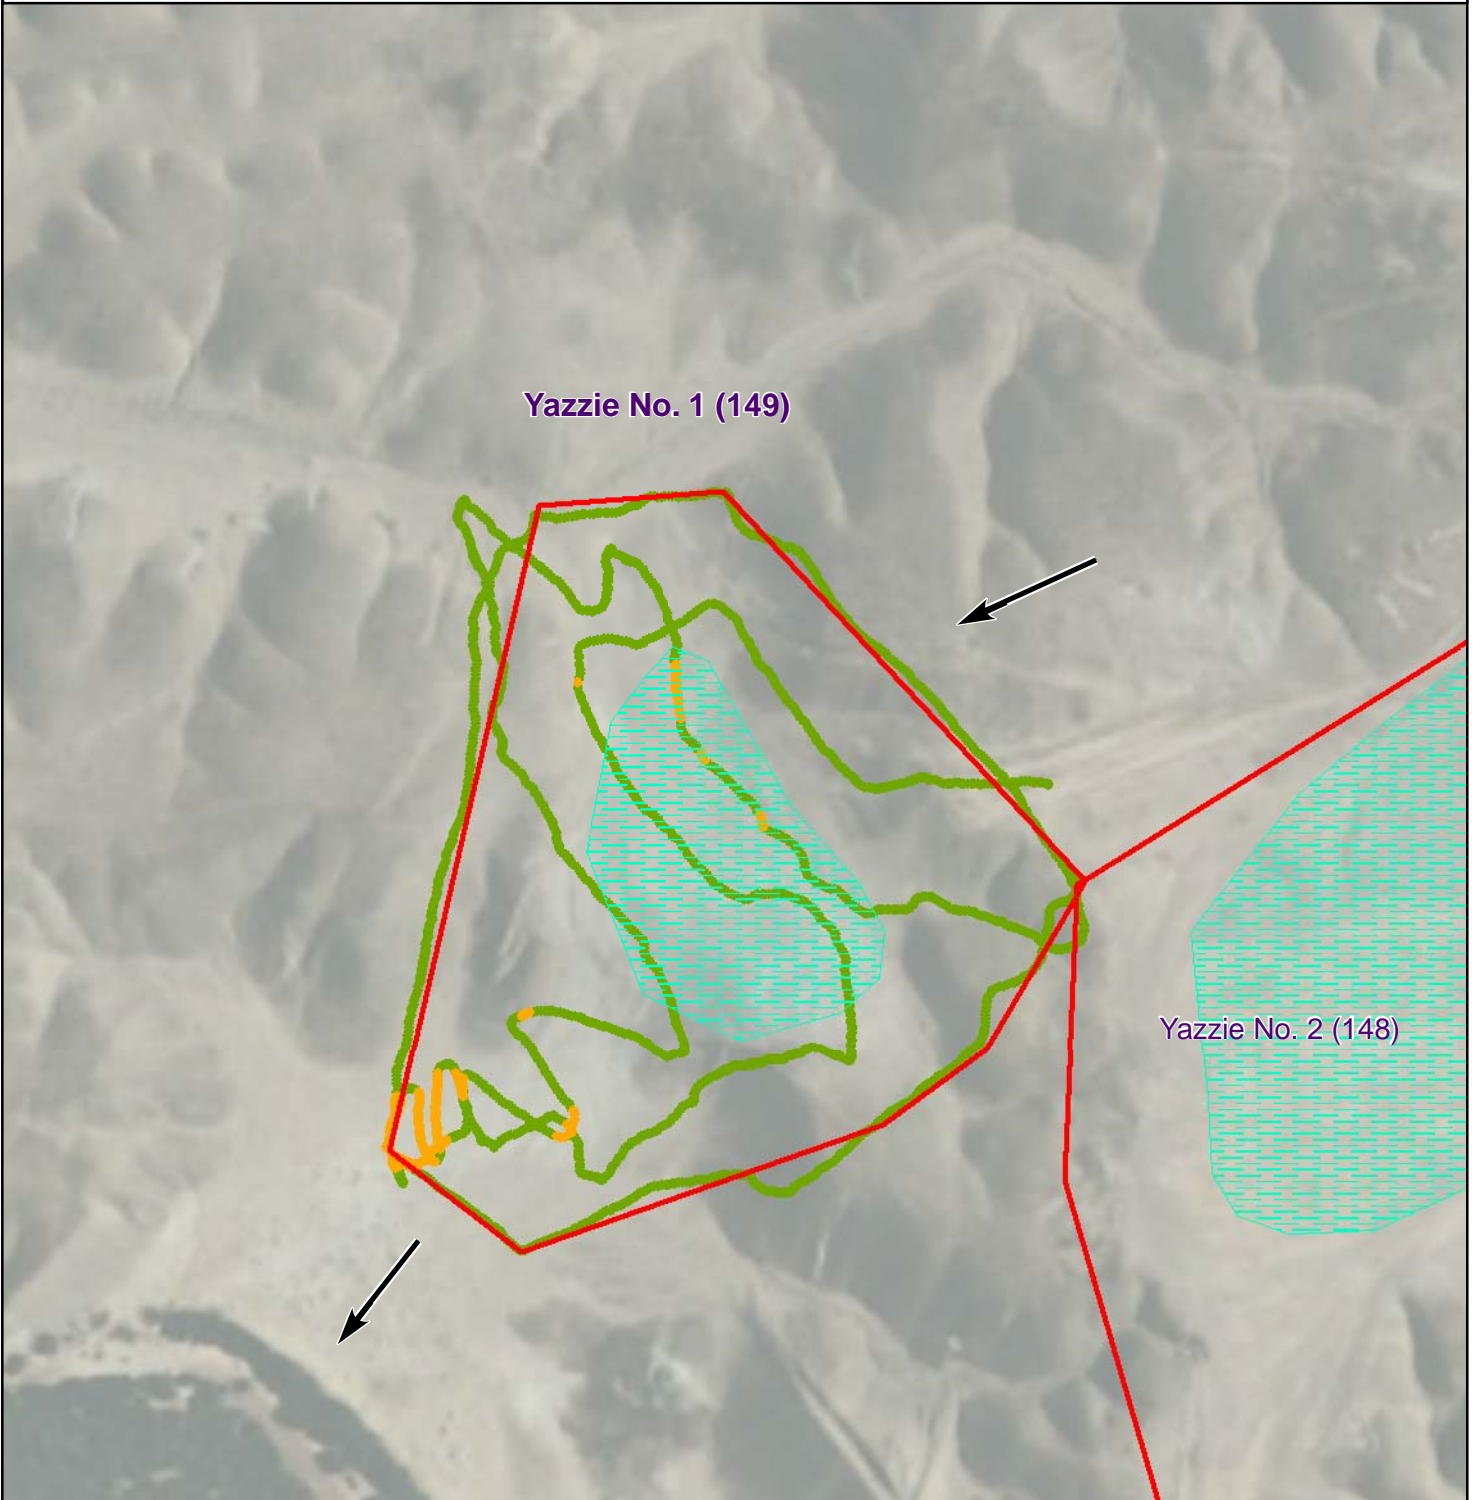
**Figure 1 - Gamma Radiation Measurements, Above Two Times Background
Yazzie No. 1 (149)
Coalmine Mesa Chapter, Navajo Nation**

A total of 2,452 gamma radiation measurements were collected from the mine site, ranging from 8,167 cpm to 63,576 cpm. The measurements collected at the reclamation cap were found at a maximum level of approximately 65,000 cpm. The measurements are represented in Figures 1 and 2.

Gamma survey conducted 11/2010
Measured as counts per minute (cpm)

Average background 10,512 cpm

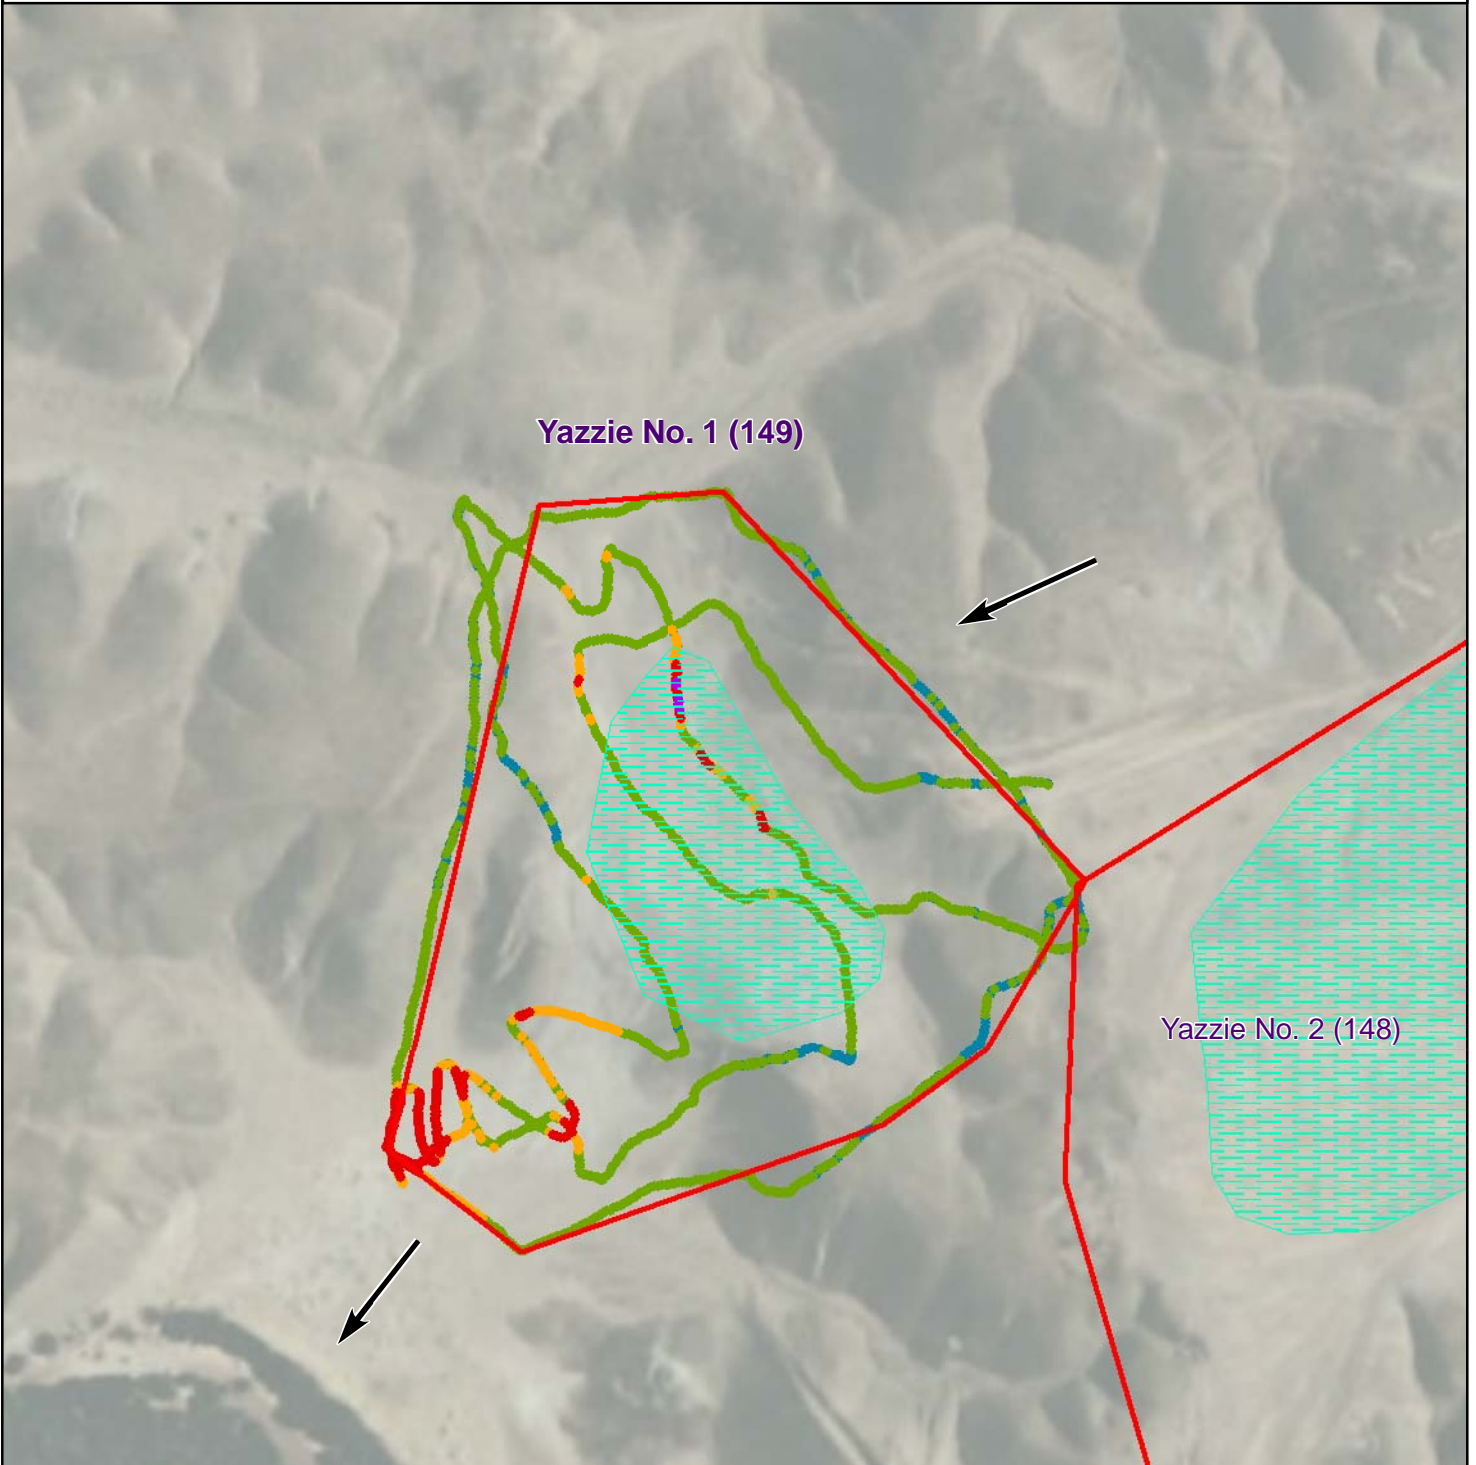
**Figure 2 - Gamma Radiation Measurements
Yazzie No. 1 (149)
Coalmine Mesa Chapter, Navajo Nation**

**Gamma survey conducted 11/2010
Measured as counts per minute (cpm)**

Average background 10,512 cpm
