Navajo Abandoned Uranium Mine

Site Screen Report

Elwood Thompson No. 1 AUM Site

Weston Solutions, Inc.

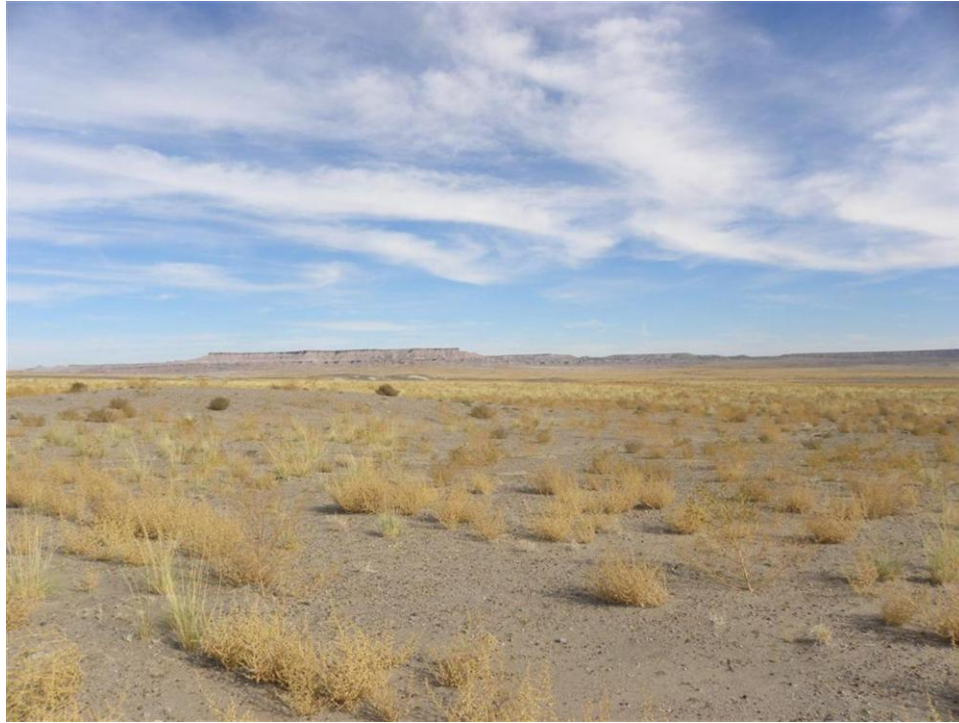
Photo 1. Elwood Thompson No. 1 mine site

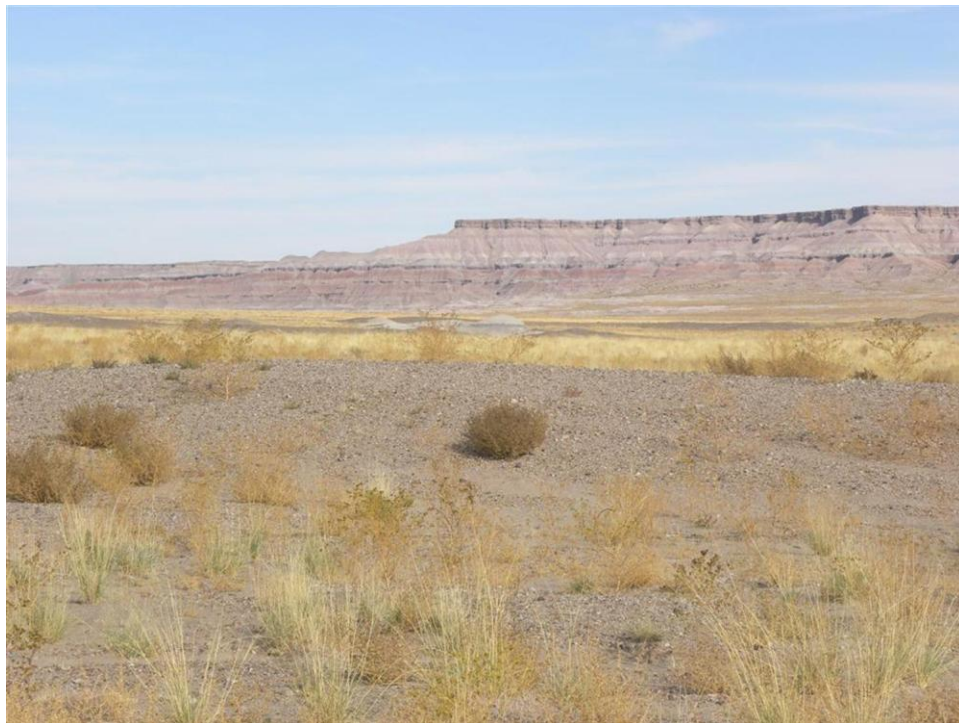
Possible small reclamation cap in center of site, grey material, 75' x 40'

Photo 2. Elwood Thompson No. 1 mine site, reclamation cap

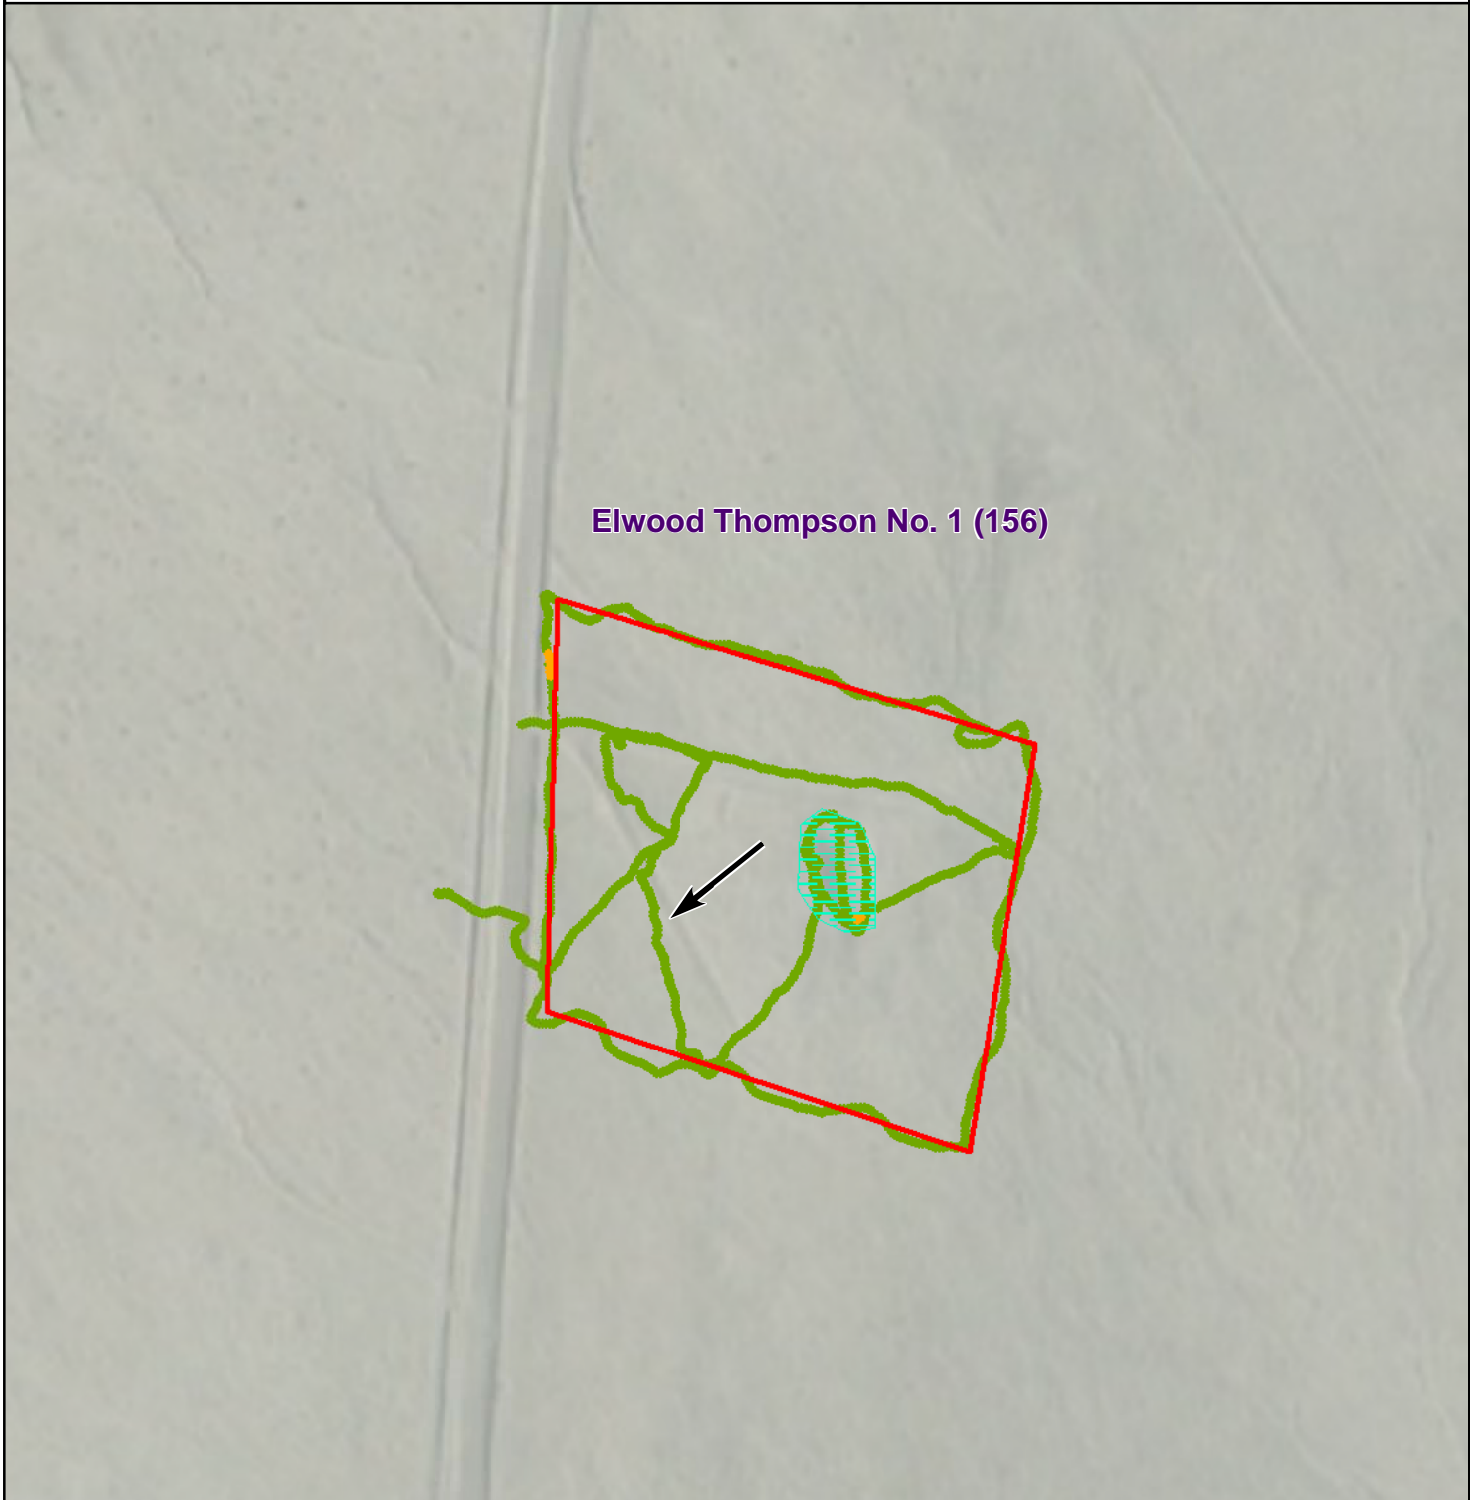
A total of 1,306 gamma radiation measurements were collected from the mine site, ranging from 9,058 cpm to 24,258 cpm. The measurements collected at the reclamation cap were found at a maximum level of approximately 25,000 cpm. The measurements are represented in Figures 1 and 2.

**Figure 1 - Gamma Radiation Measurements, Above Two Times Background
Elwood Thompson No. 1 (156)
Coalmine Mesa Chapter, Navajo Nation**

Gamma survey conducted 11/2010
Measured as counts per minute (cpm)

Average background 9,775 cpm

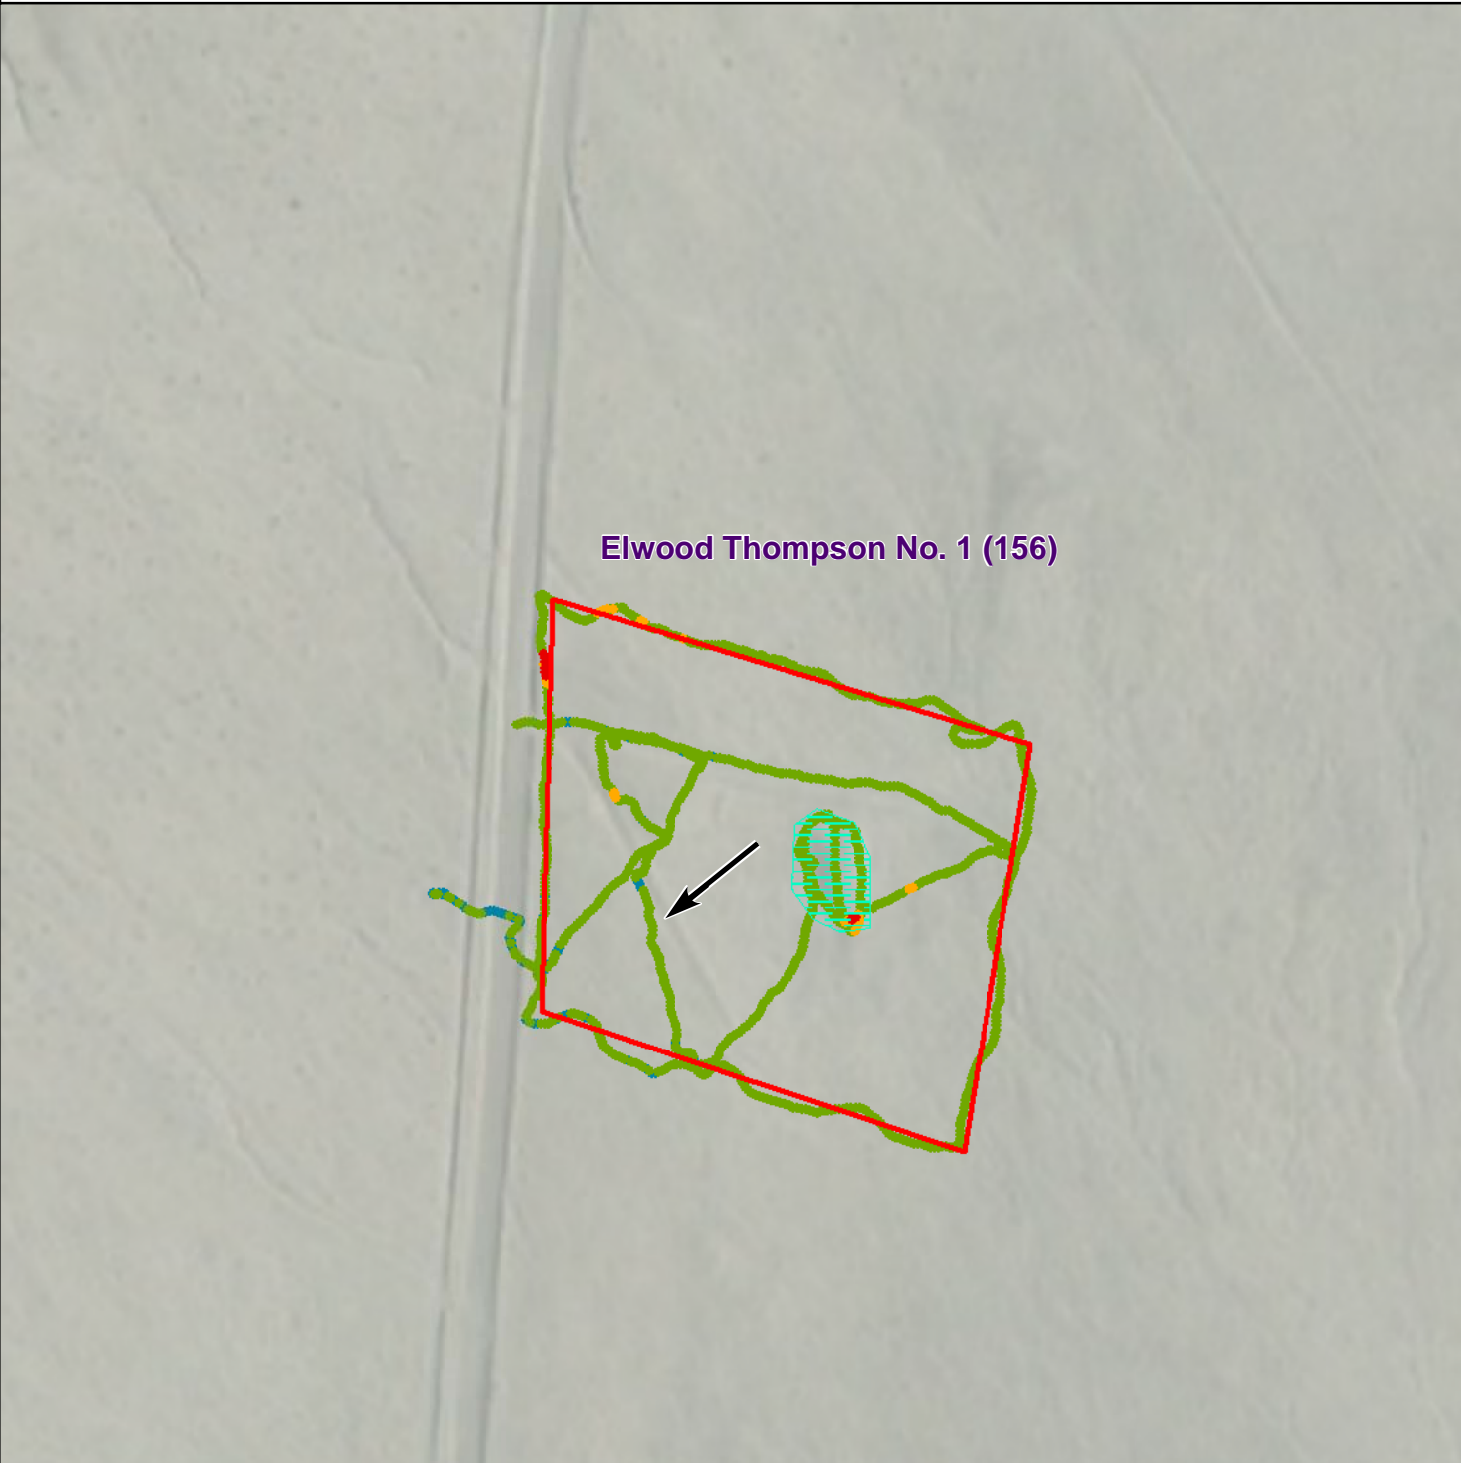
**Figure 2 - Gamma Radiation Measurements
Elwood Thompson No. 1 (156)
Coalmine Mesa Chapter, Navajo Nation**

**Gamma survey conducted 11/2010
Measured as counts per minute (cpm)**

Average background 9,775 cpm
