Navajo Abandoned Uranium Mine

Site Screen Report

Taylor Reid No. 2 AUM Site

Navajo AUM Western Region

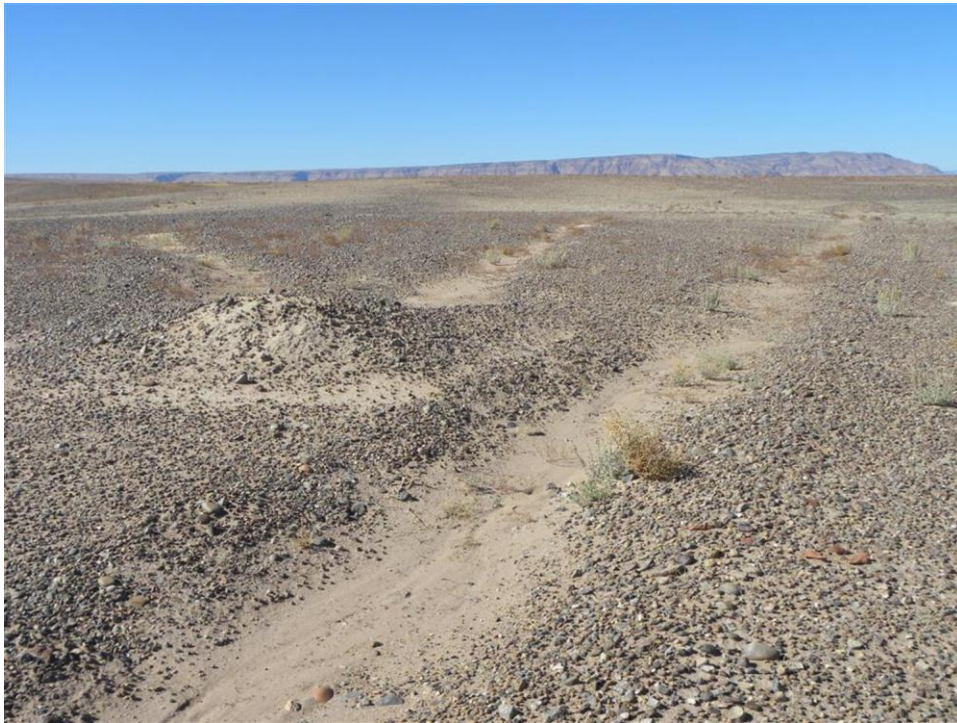
2 waste piles: 1 - 25' diameter x 3' h, within reclamation cap area; 2 - 50' diameter x 5' h

Photo 2. Taylor Reid No. 2 mine site, waste pile

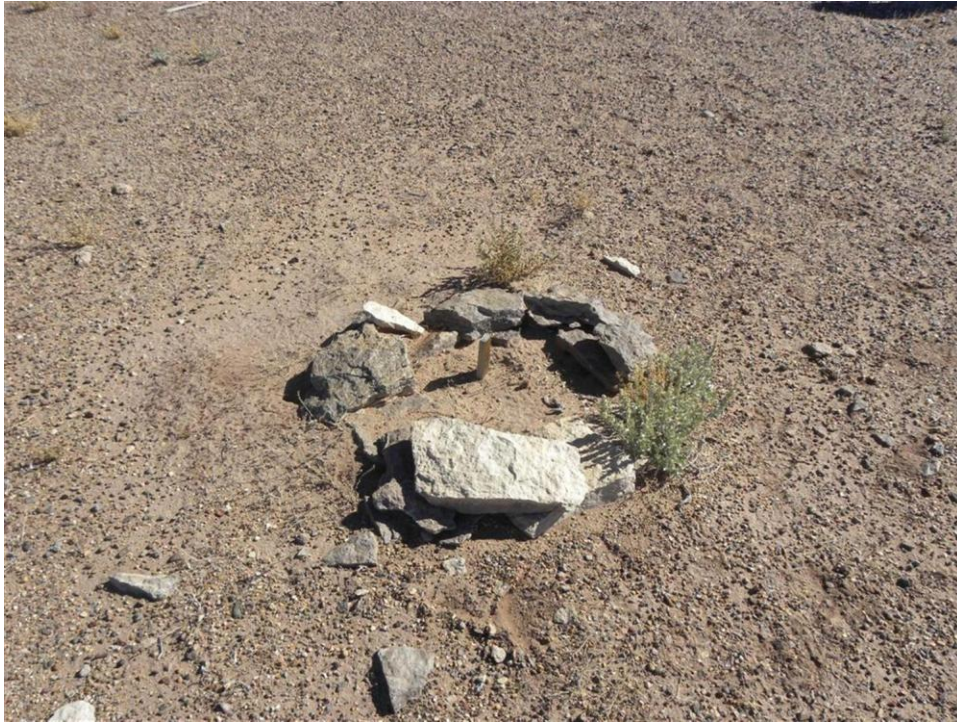
Photo 3. Taylor Reid No. 2 mine site, elevated gamma readings

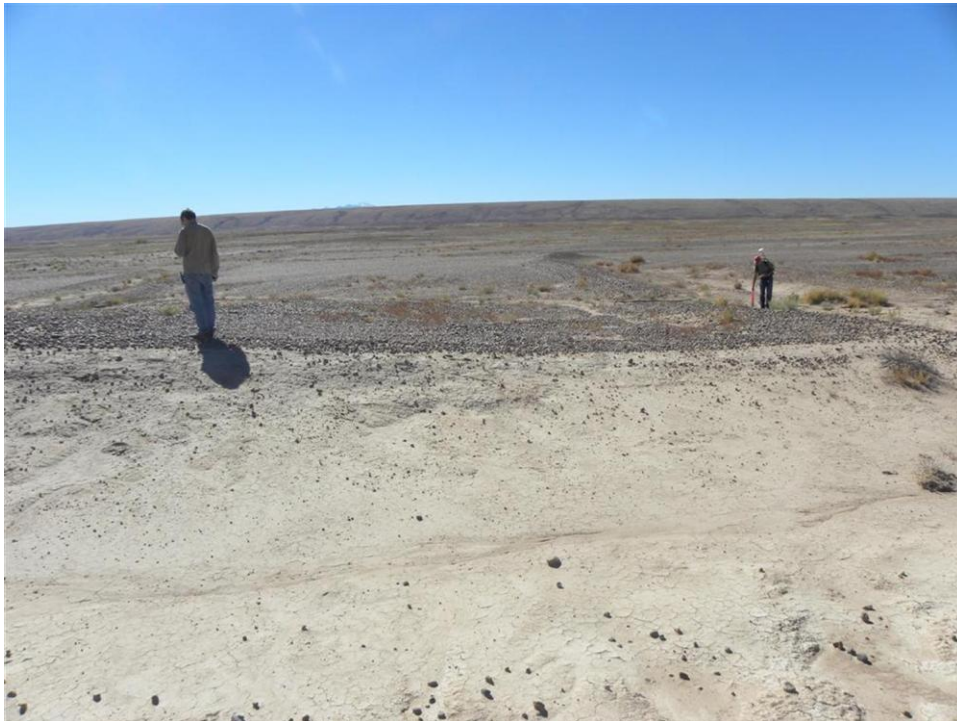
3 reclamation caps: cap 1 - large cap throughout S end of site, red-brown gravel with diversion channels; cap 2 - grey cap N of road with fine soil; cap 3 - small cap / pile with red-brown gravel S of road

Photo 4. Taylor Reid No. 2 mine site, reclamation area

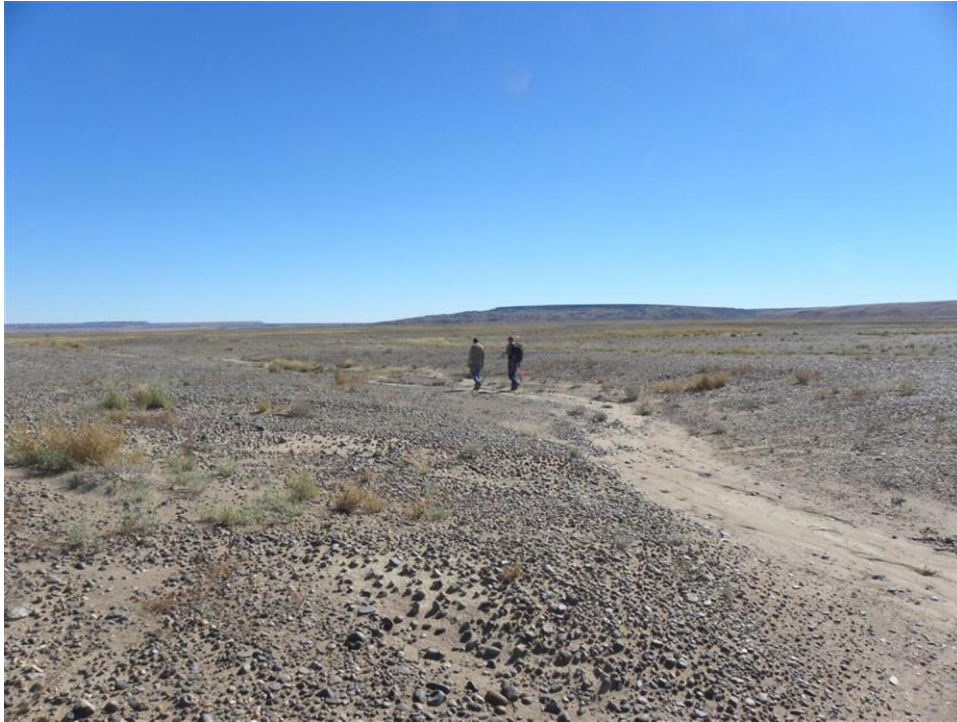
Photo 5. Taylor Reid No. 2 mine site, reclamation area drainage

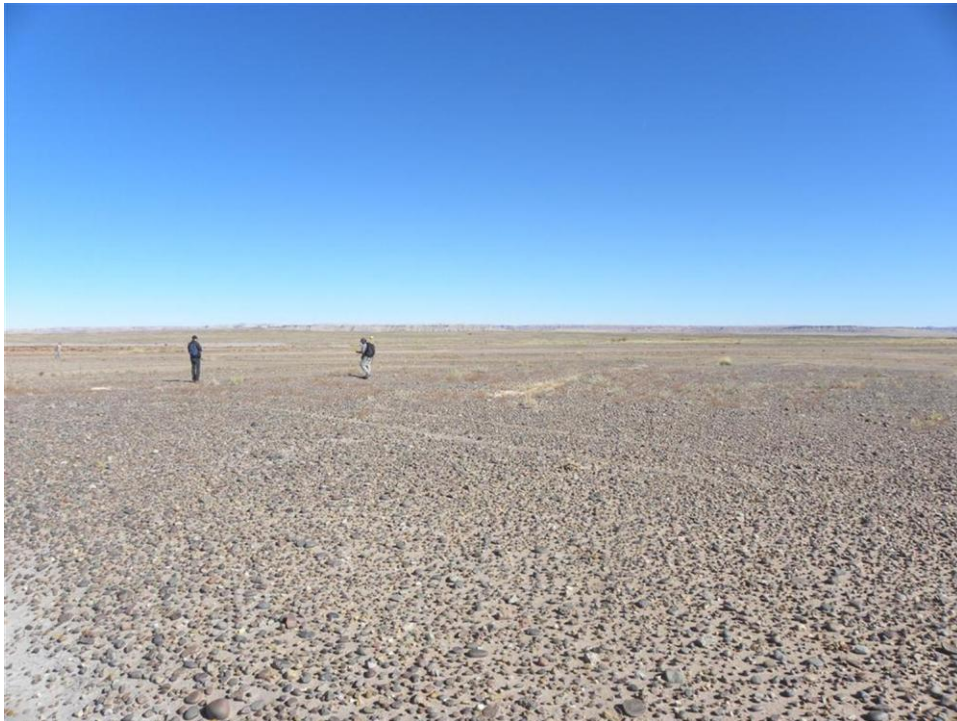
Photo 6. Taylor Reid No. 2 mine site, reclamation area
