# Navajo Abandoned Uranium Mine

## Site Screen Report

## Montezuma No. 1 AUM Site

**January 2011**

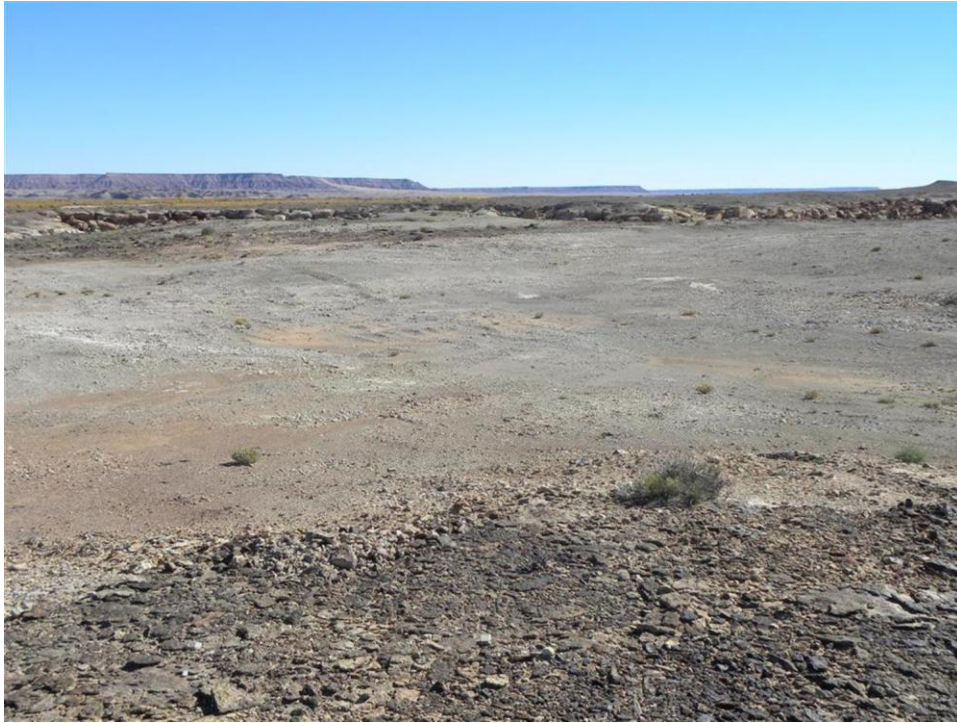
Photo 1. Montezuma No. 1 mine site

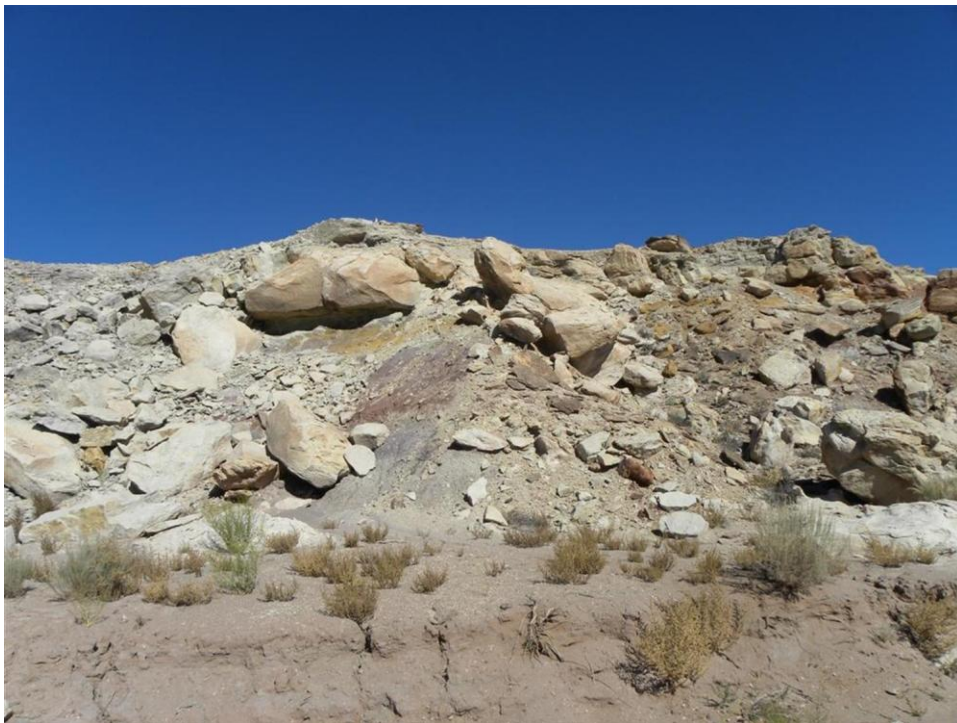
Photo 2. Montezuma No. 1 mine site

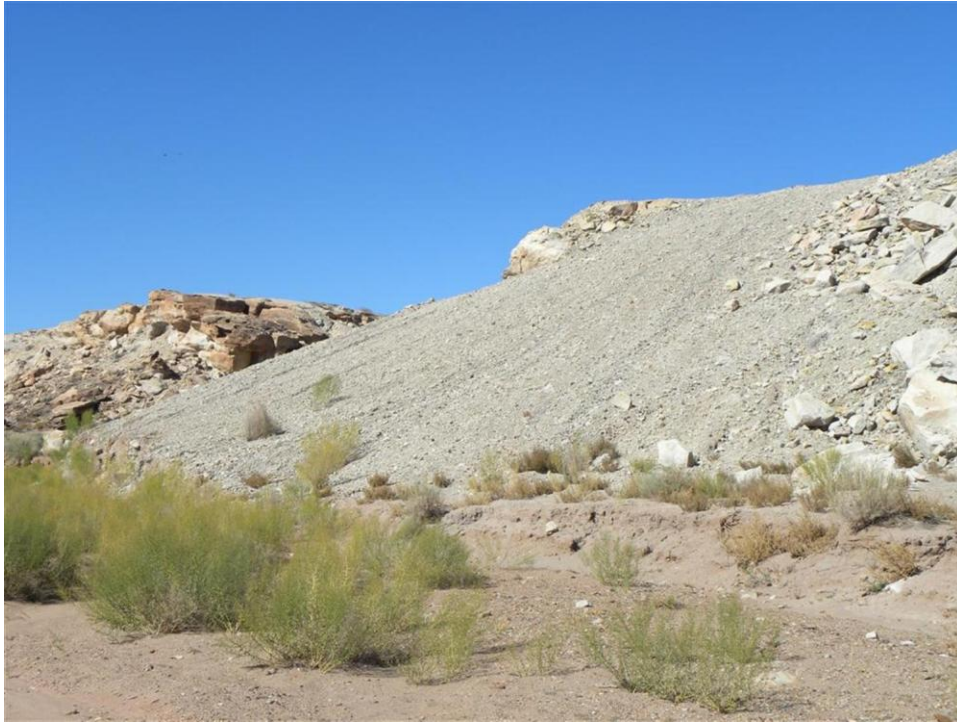
Large reclamation cap, grey stone pushed over small cliff, 120' x 100' x 30', above stream; apparent mining operations in nearby sidewall

Photo 3. Montezuma No. 1 mine site, reclamation cap

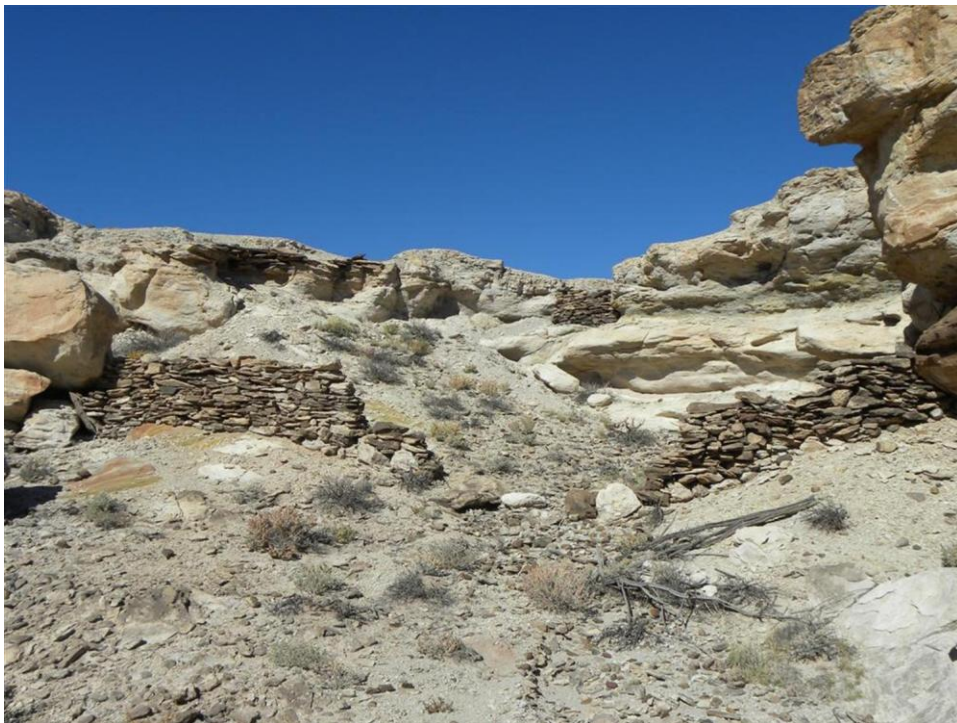
A total of 1,976 gamma radiation measurements were collected from the mine site, ranging from 8,217 cpm to 30,788 cpm. The measurements collected in the apparent camping area to the east of the site were found at a maximum level of approximately 20,000 cpm. The measurements are represented in Figures 1 and 2.

Photo 4. Montezuma No. 1 mine site, apparent camp area
