Navajo Abandoned Uranium Mine

Site Screen Report

Mine Name: Sunlight
Mine ID: 179

April 2012

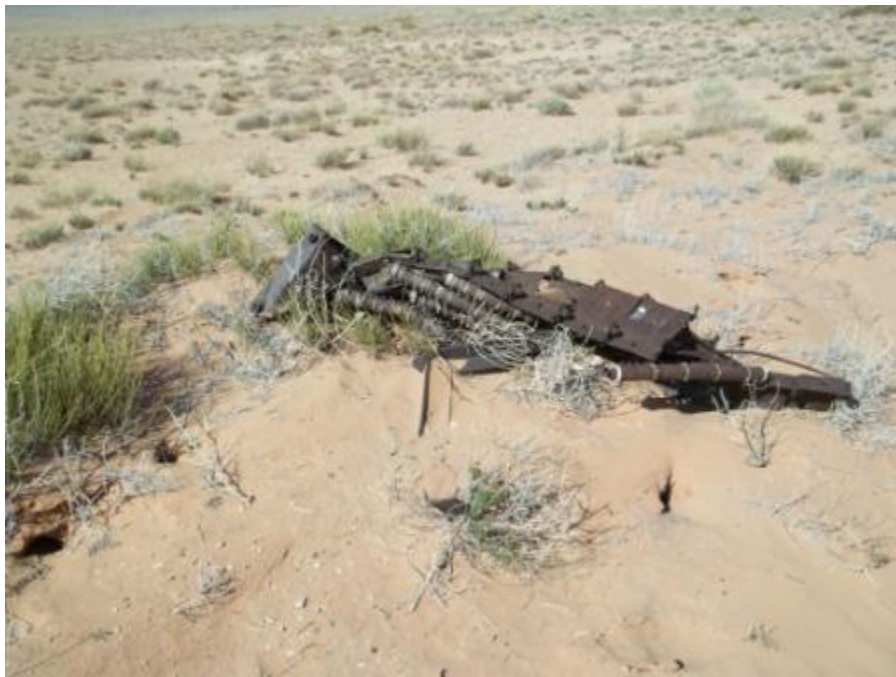
Photo 2

Mine Site #179 – Mining debris

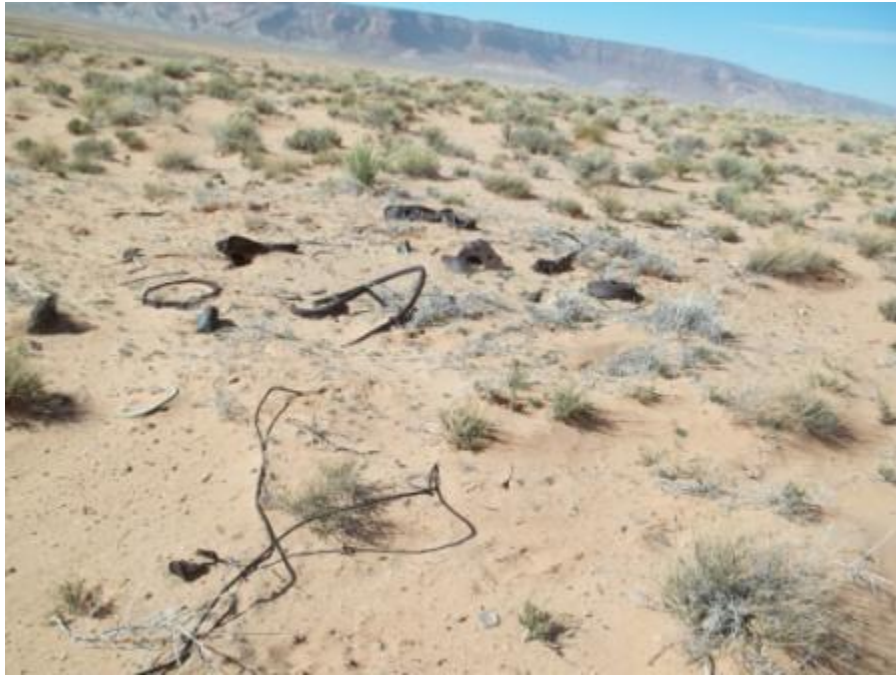
Photo 3

Mine Site #179 – Mining debris

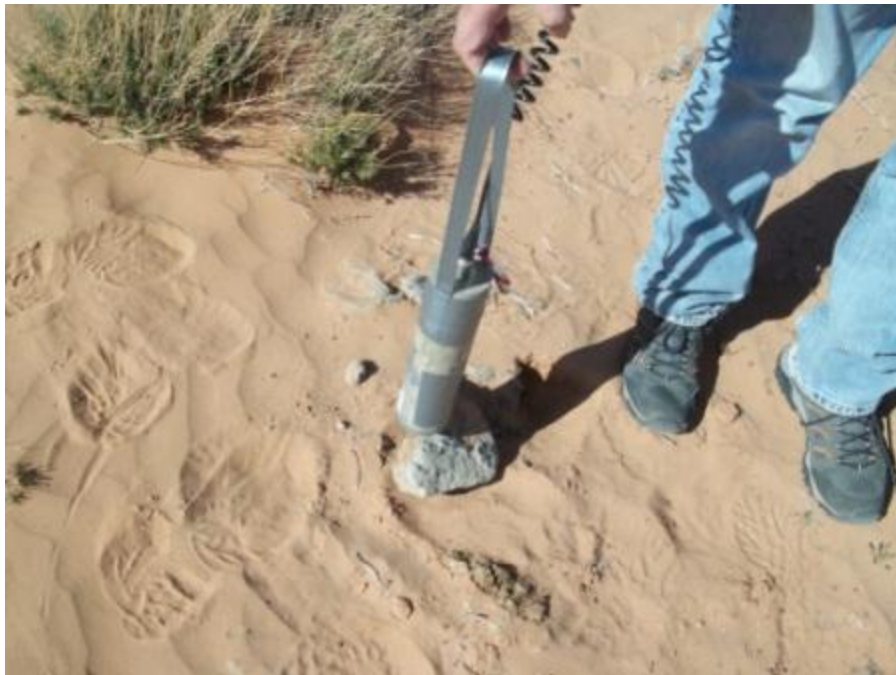
Photo 4

Some mining equipment and debris; tailings piles were noted on the Topo, alongside the road; some exposed ore was found in the southern part of the site

Mine Site #179 – Ore rock

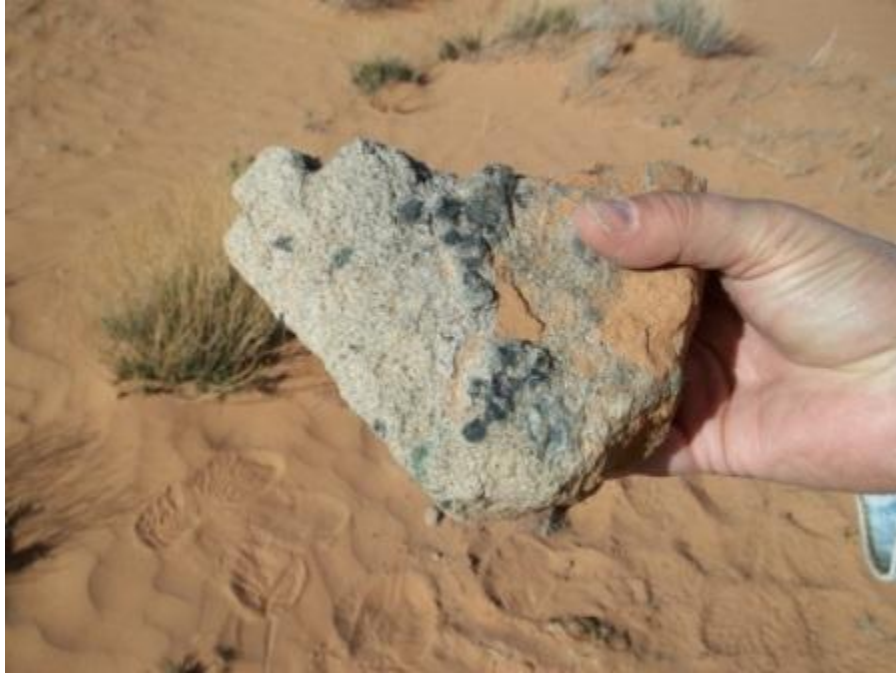
Photo 5

Mine Site #179 - Ore rock
