Navajo Abandoned Uranium Mine

Site Screen Report

Mine Name: Starlight East
Mine ID: 180

Weston Solutions, Inc.

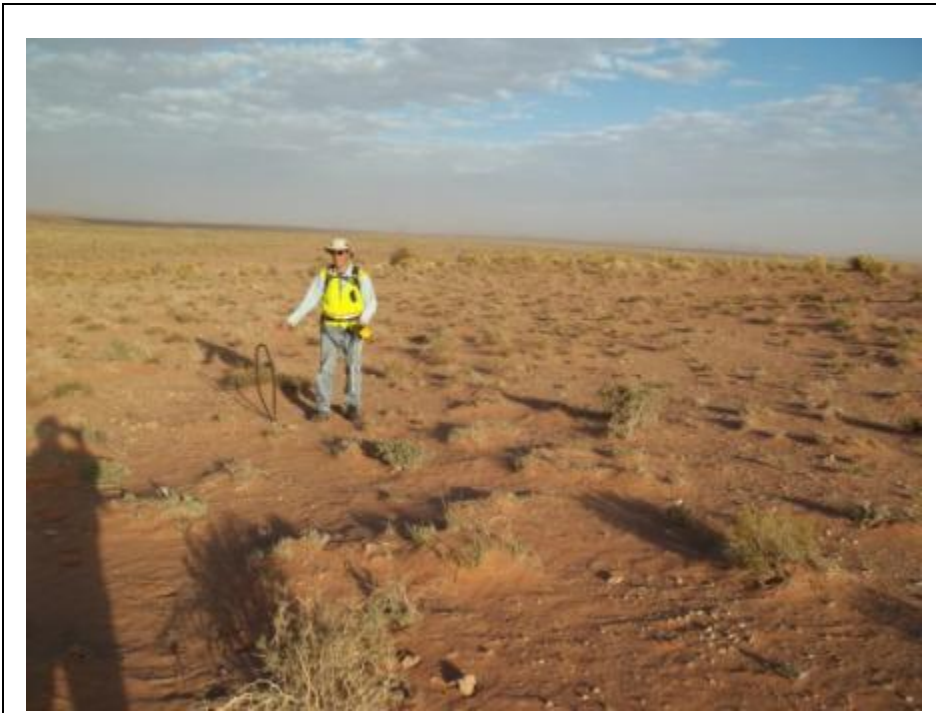
Photo 2	Mine Site #180 – Former shaft area
----------------	------------------------------------

Possible mine shaft, as shown on Topo, appeared to be backfilled or covered.

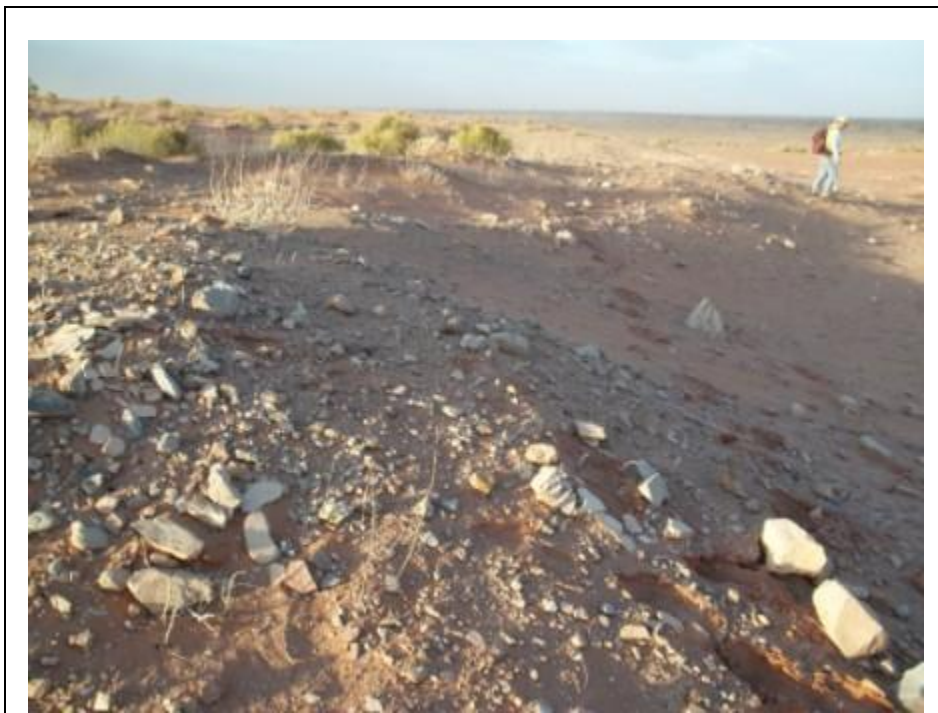
Photo 6

6 waste piles and scattered waste rock throughout the site

Mine Site #180 – Waste rock

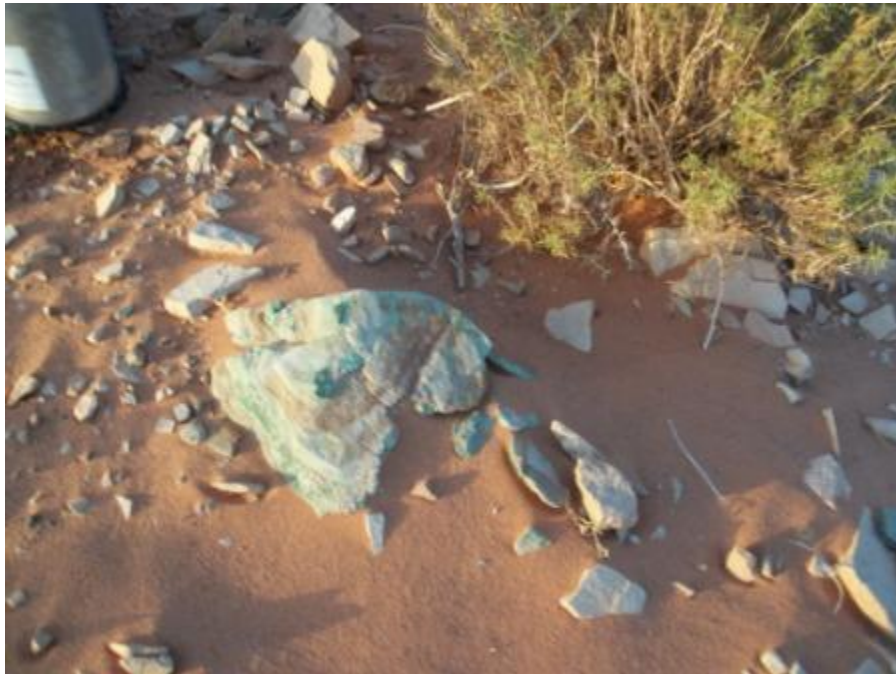
Photo 10

Mine Site #180 - Waste rock

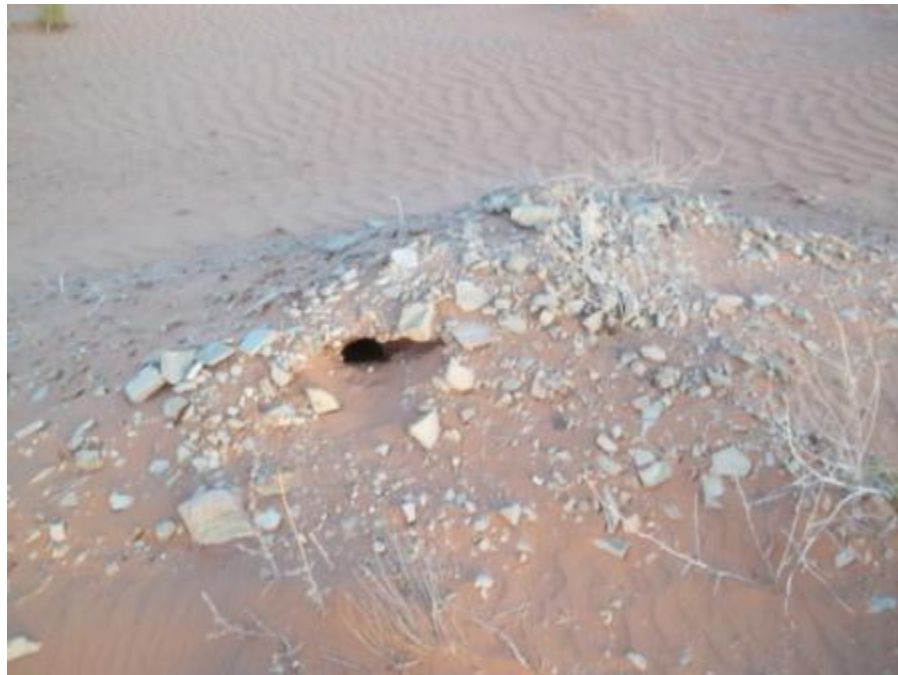
Photo 11

Mine Site #180 - Waste rock
