Navajo Abandoned Uranium Mine

Site Screen Report

Saytah Canyon AUM Site

August 2010

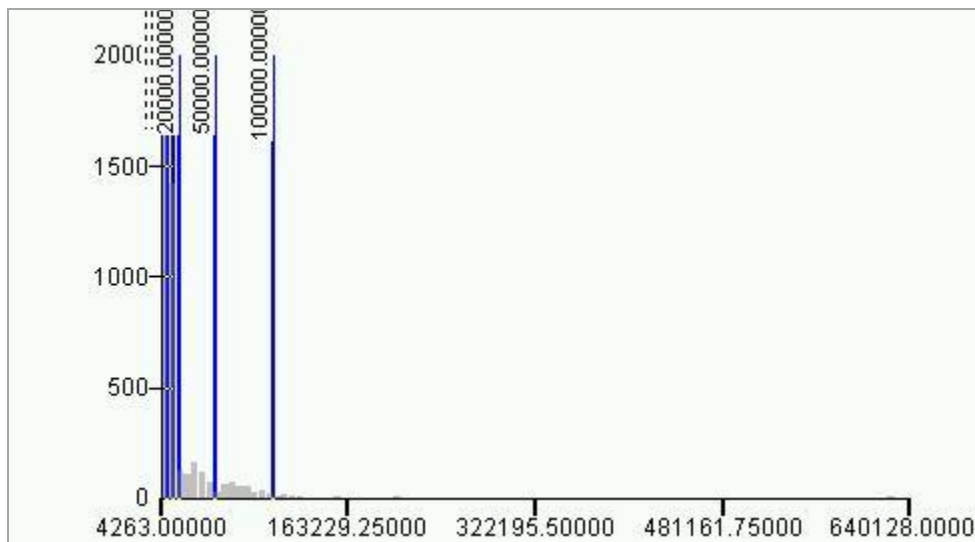
The following chart and statistics were generated by ESRI ArcGIS 9.3.1, and show the general distribution of the site gamma radiation measurements. The horizontal X axis represents the gamma radiation reading levels in cpm (lowest levels to the left). The vertical Y axis represents the frequency of each gamma radiation level.

Count:	4232
Minimum:	4263.00000
Maximum:	640128.00000
Sum:	103952303.00000
Mean:	24563.39863
Median:	11425.50000
Standard Deviation:	52542.91004

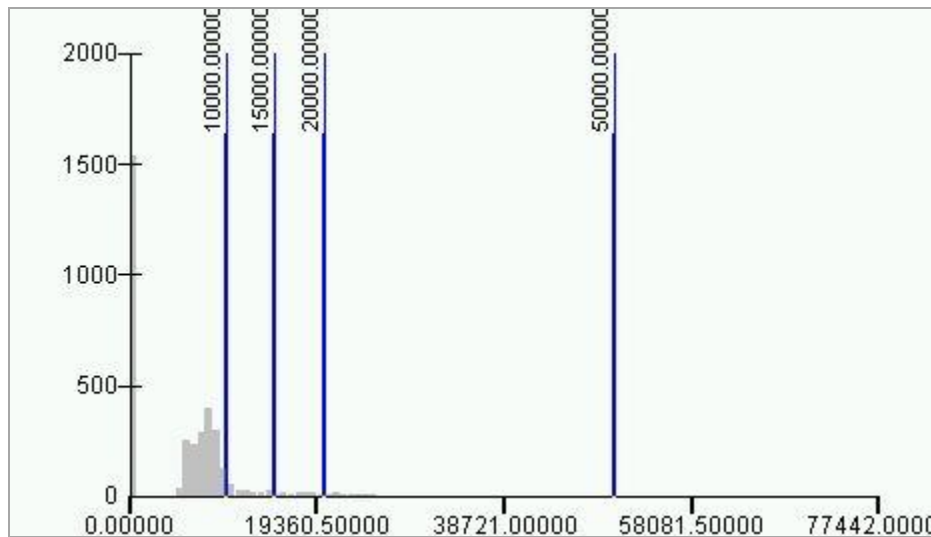
The following chart and statistics were generated by ESRI ArcGIS 9.3.1, and show the general distribution of the site gamma radiation measurements. The horizontal X axis represents the gamma radiation reading levels in cpm (lowest levels to the left). The vertical Y axis represents the frequency of each gamma radiation level.

Count:	3587
Minimum:	0.00000
Maximum:	77442.00000
Sum:	21275209.00000
Mean:	5931.19849
Median:	6129.00000
Standard Deviation:	8422.86712

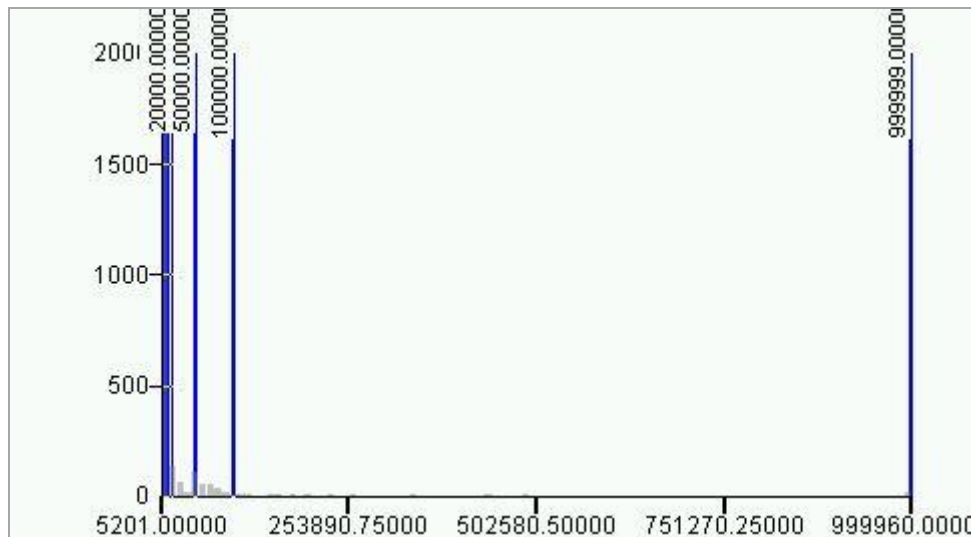
The following chart and statistics were generated by ESRI ArcGIS 9.3.1, and show the general distribution of the site gamma radiation measurements. The horizontal X axis represents the gamma radiation reading levels in cpm (lowest levels to the left). The vertical Y axis represents the frequency of each gamma radiation level.

Count:	2639
Minimum:	5201.00000
Maximum:	999960.00000
Sum:	100615481.00000
Mean:	38126.36643
Median:	9423.00000
Standard Deviation:	113452.34130

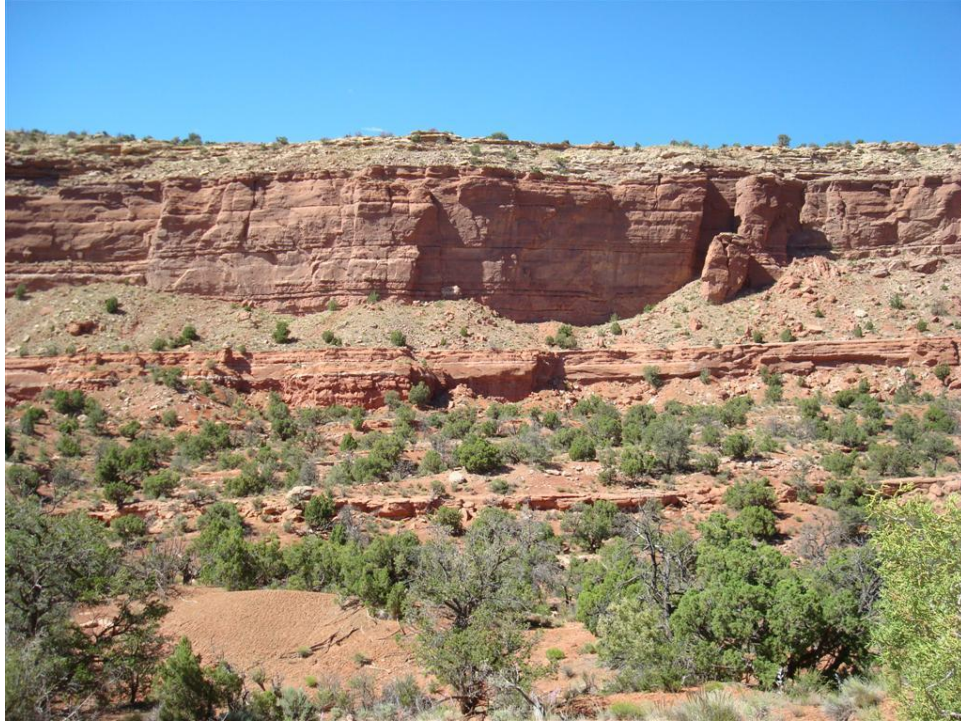
Photo 1. Plot 16 site #186

#186 - Scattered waste rock in bench area

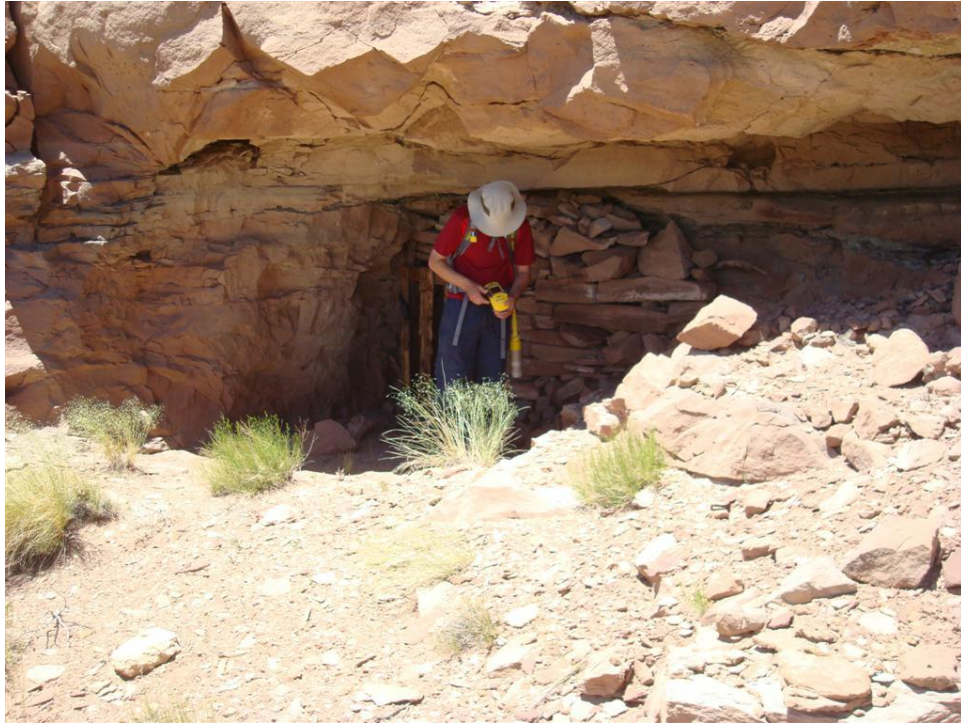
#186 - 1 sealed adit; 1 collapsed adit

Photo 5. Plot 16 site #186, adit

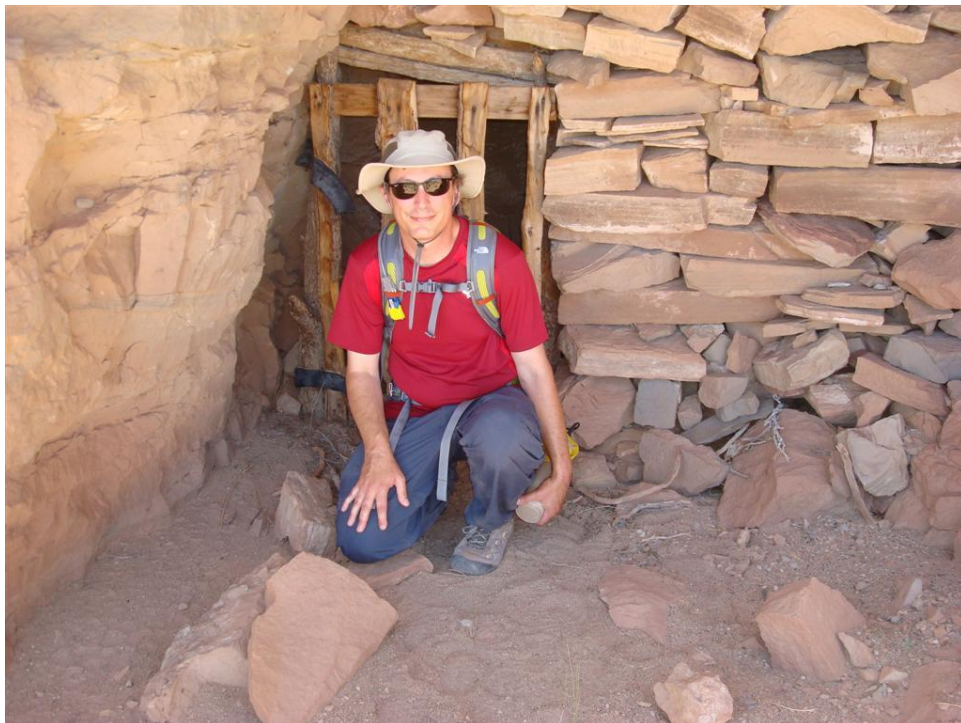
Photo 6. Plot 16 site #186, adit entrance

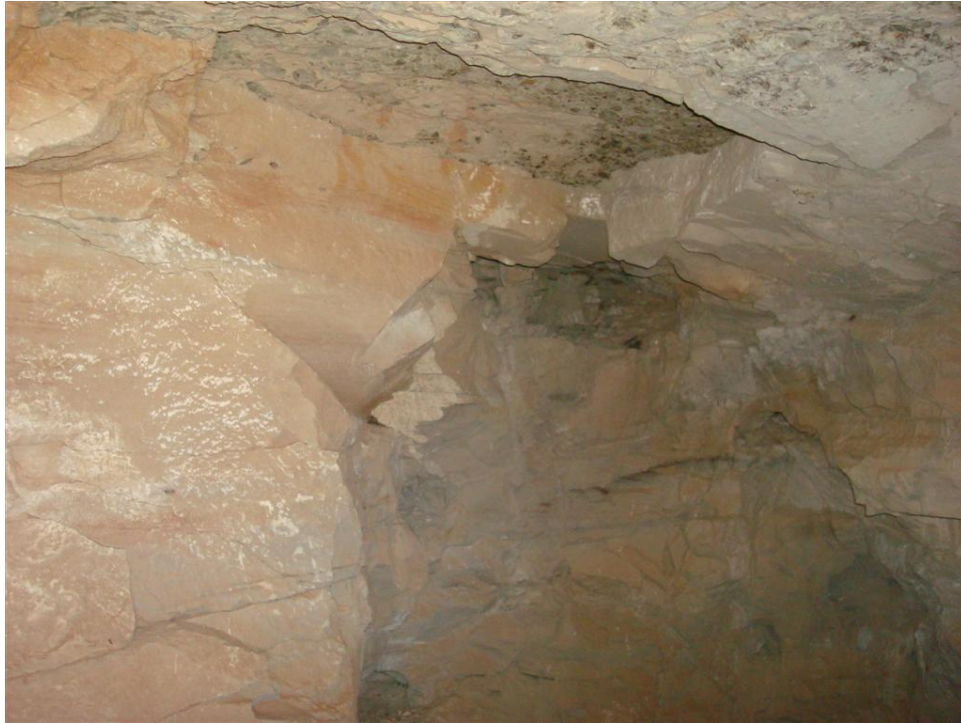
Photo 5. Plot 16 site #186, adit internal

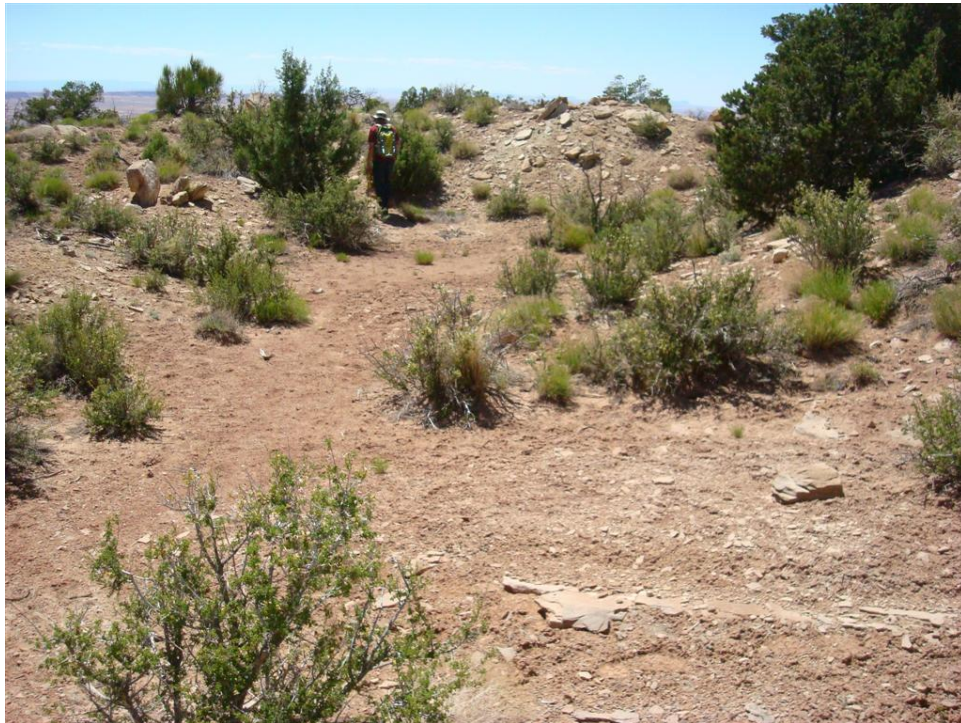
#619 - 1 circular waste pile approximately 400 yd³; smaller pile near pit approx 40 yd³

Photo 6. Plot 15 site #619

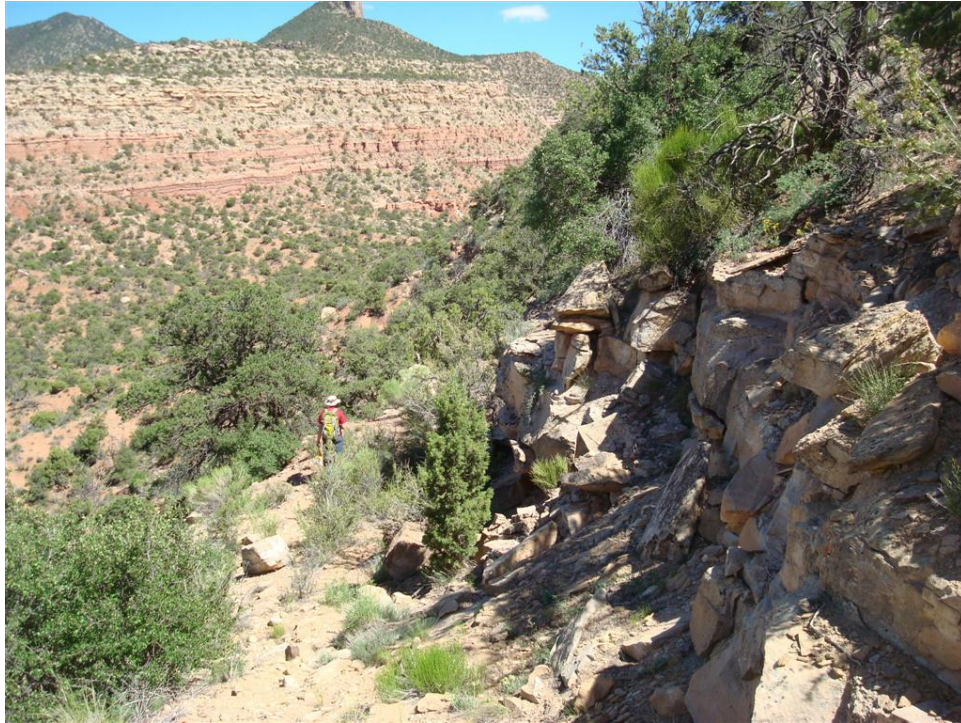
#620 - Waste rock below adits 150'x100'x5'

Photo 9. Plot 14 site #620

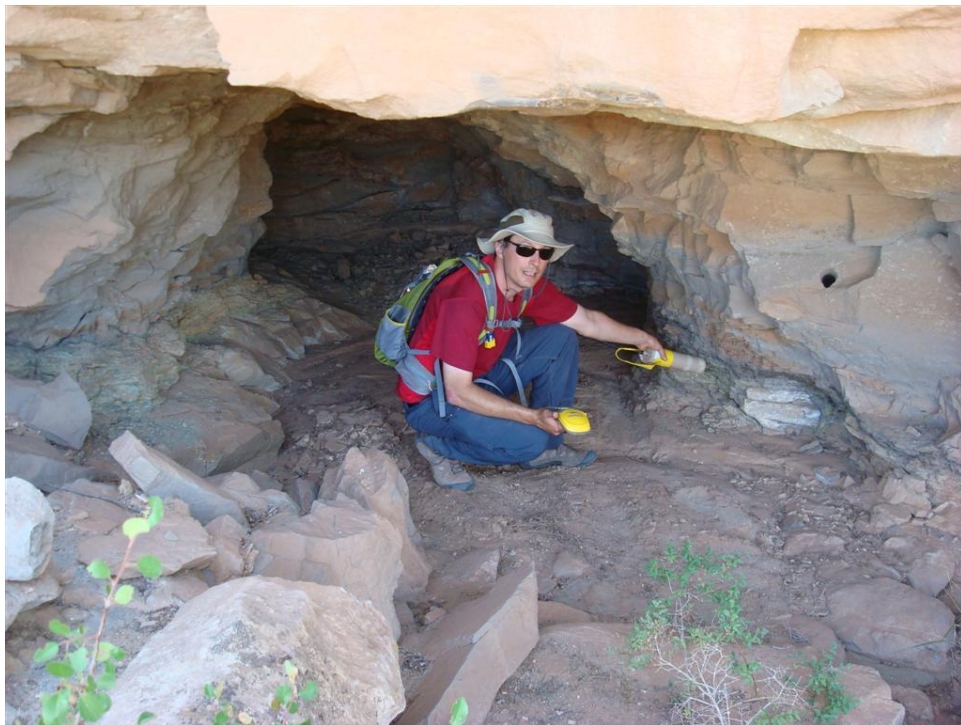
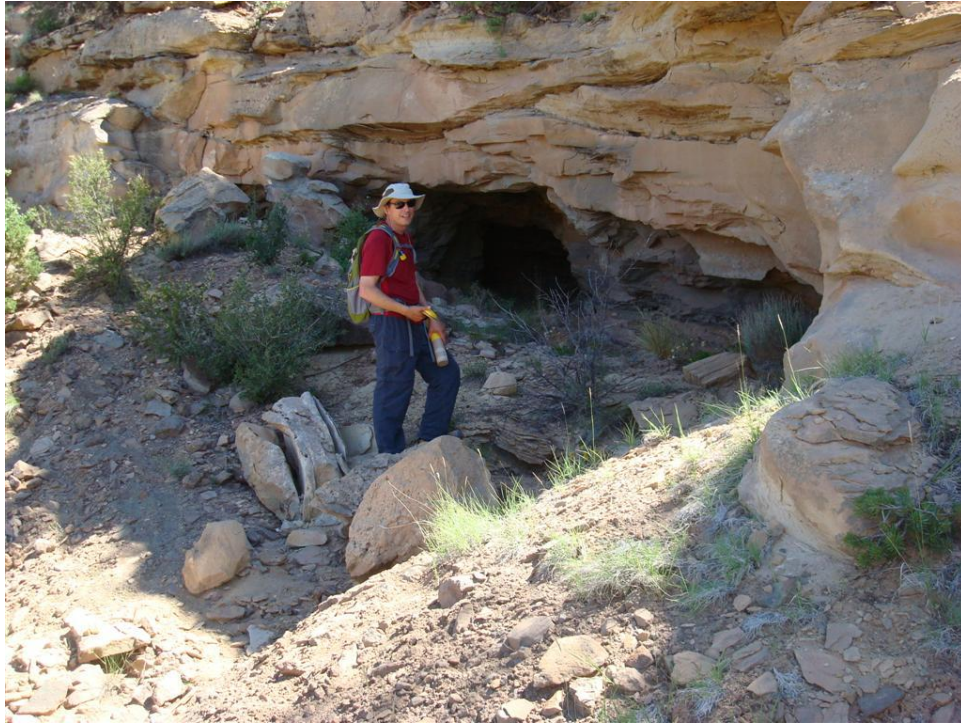
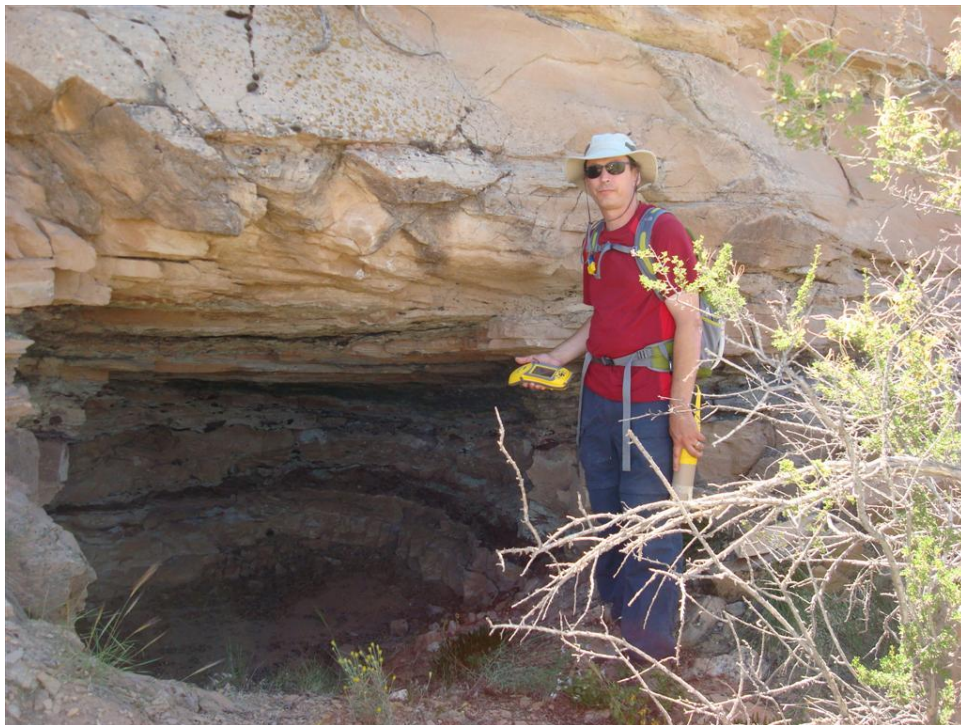
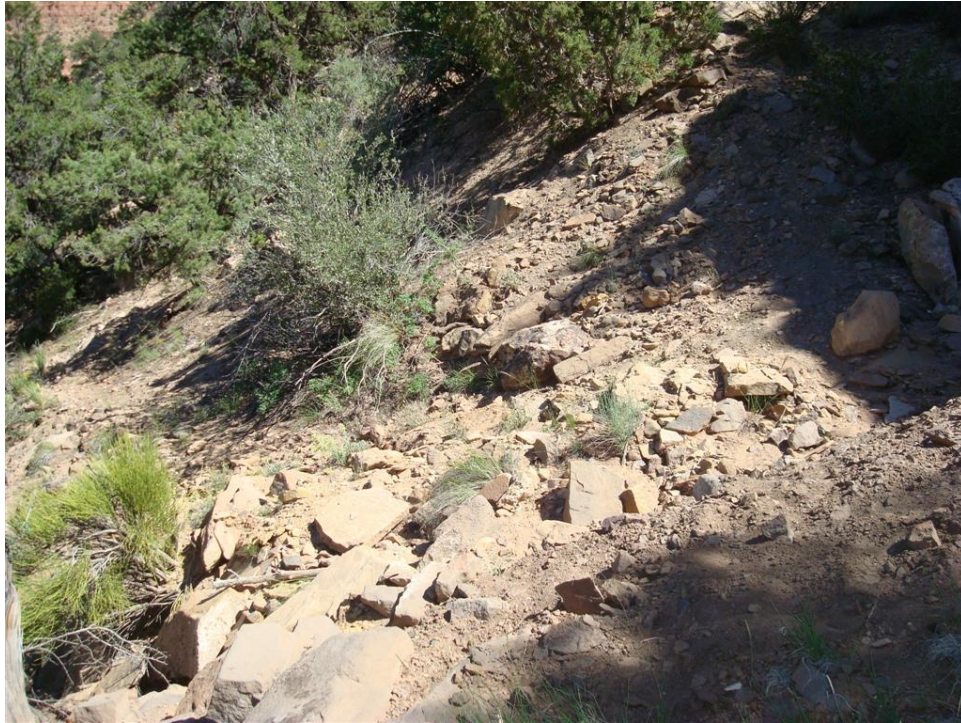
A total of 2,639 gamma radiation measurements were collected from the mine site, ranging from 5,201 cpm to 999,960 cpm. Measurements collected in the vicinity of the waste debris near the adit were found at levels up to approximately 1,000,000 cpm (the maximum gamma radiation level the equipment can detect). The measurements are represented in Figures 1 and 2.

#620 - 2 adits on hillside, one open

Photo 10. Plot 14 site #620, adit

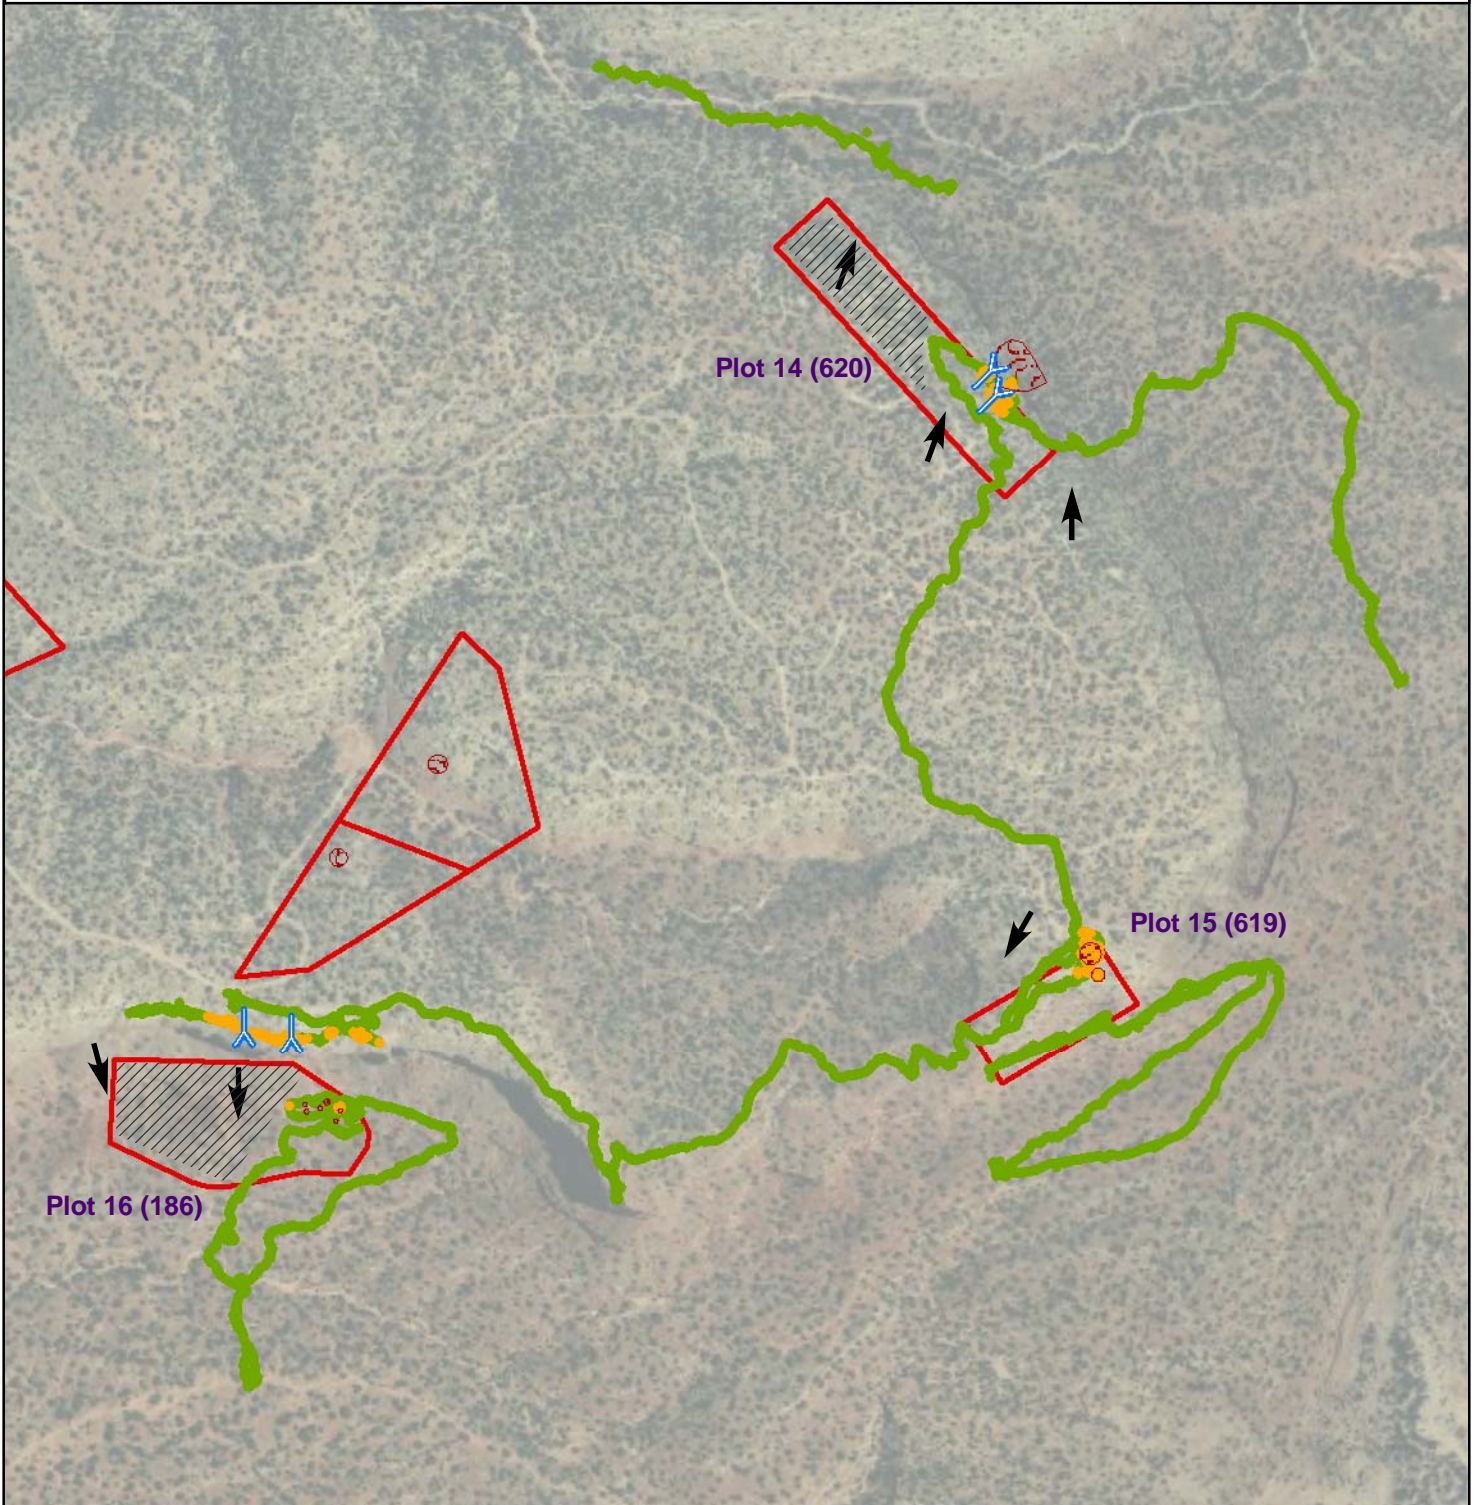
**Figure 1 - Gamma Radiation Measurements, Above Two Times Background
 Plot 16 (186), Plot 15 (619), Plot 14 (620)
 Sweetwater Chapter, Navajo Nation**

Gamma survey conducted 06/2010
 Measured as counts per minute (cpm)

Average background = 9,121 cpm

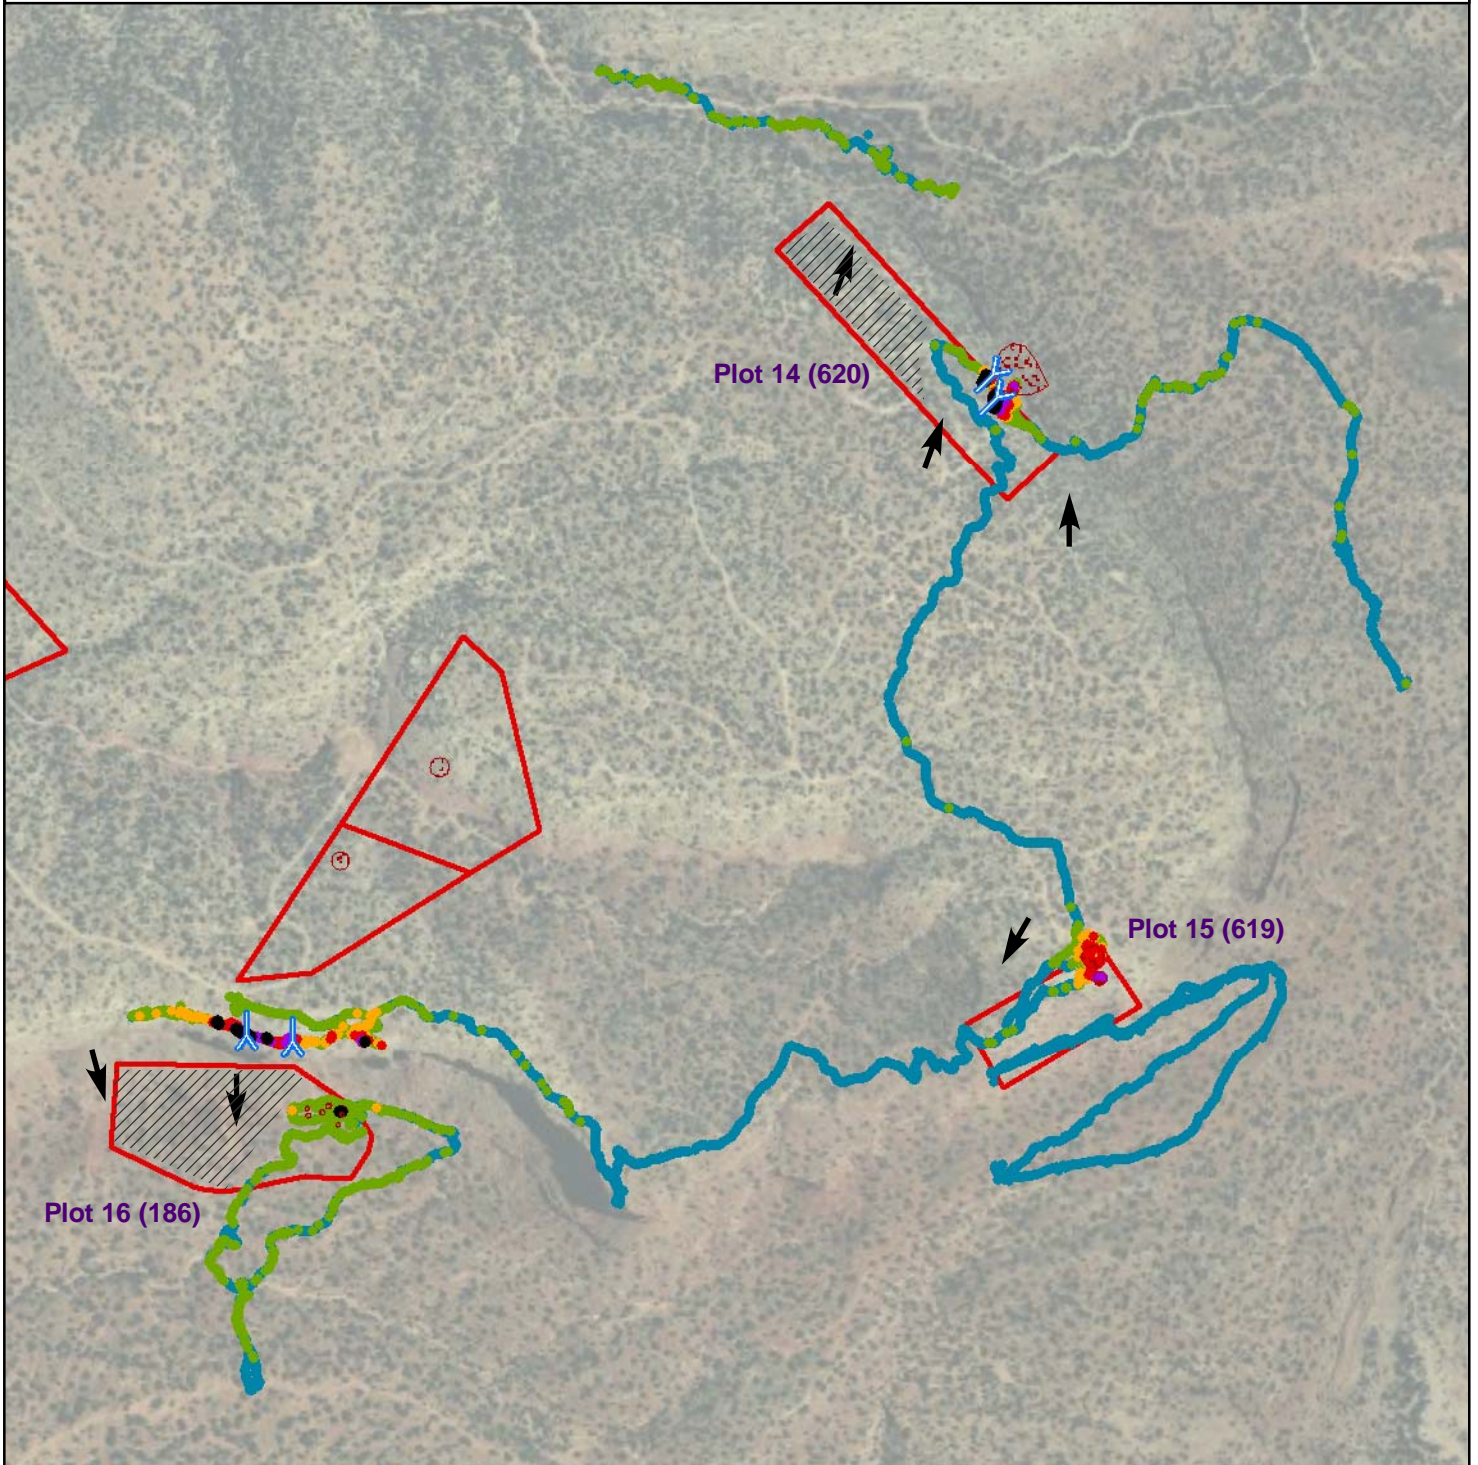
A total of 4,232 gamma radiation measurements were collected from the mine site, ranging from 4,263 cpm to 640,128 cpm. Measurements collected in the vicinity of the waste debris were found at levels up to approximately 600,000 cpm. The measurements are represented in Figures 1 and 2.

A total of 3,587 gamma radiation measurements were collected from the mine site, ranging from 5,899 cpm to 77,442 cpm. Measurements collected in the vicinity of the waste debris were found at levels up to approximately 70,000 cpm. The measurements are represented in Figures 1 and 2.

**Figure 2 - Gamma Radiation Measurements
Plot 16 (186), Plot 15 (619), Plot 14 (620)
Sweetwater Chapter, Navajo Nation**

Gamma survey conducted 06/2010
Measured as counts per minute (cpm)
