Navajo Abandoned Uranium Mine

Site Screen Report

Black No. 2 Mine (West) AUM Site

Weston Solutions, Inc.

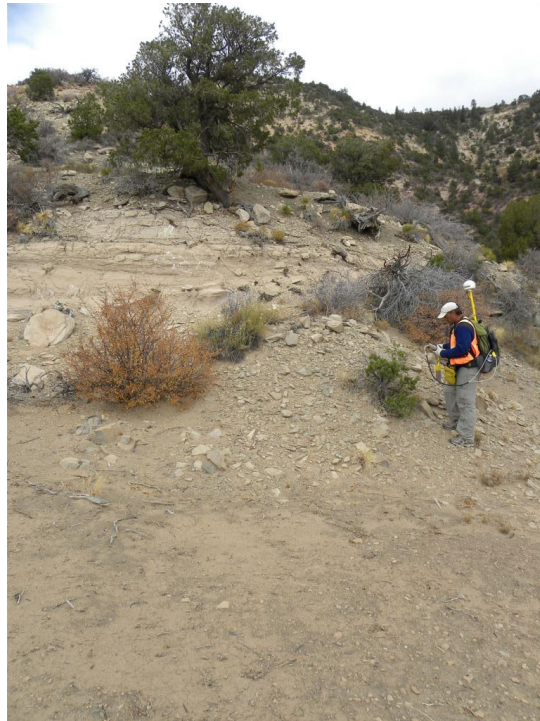
Photo 4. Waste pile

Small waste pile at southeast, approximately 6' x 6', with a total estimated volume of 7 yd³

Unreclaimed waste pile
