# Navajo Abandoned Uranium Mine

## Site Screen Report

### CBW-MC AUM Site

**August 2010**

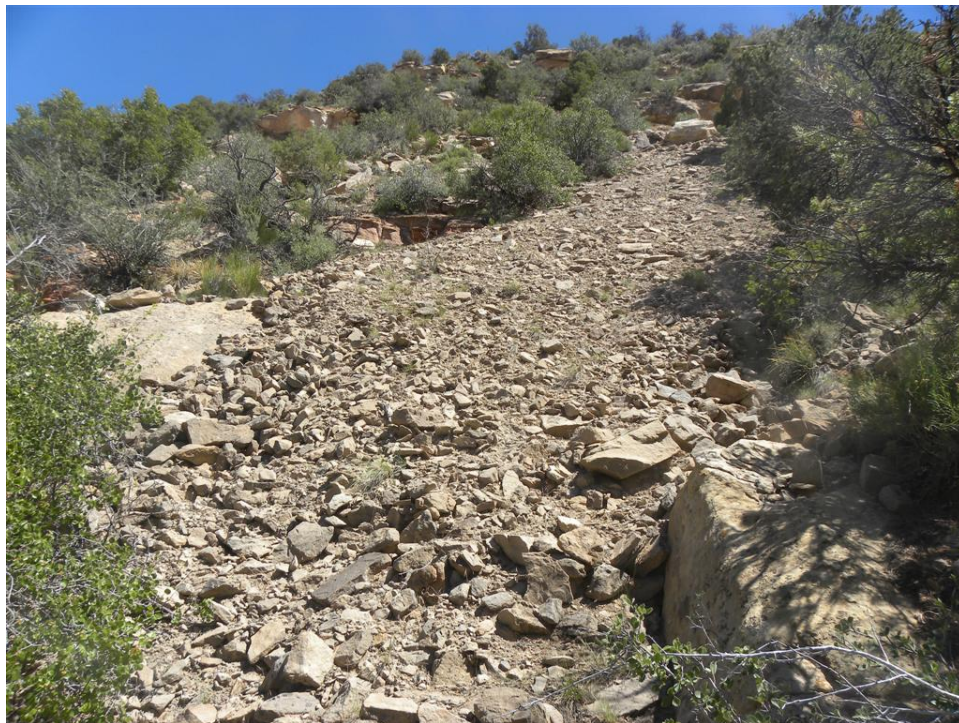
Waste debris extending to drainages from adits, 100' x 80' x 1.5'

Photo 2. CBW-MC site, waste rock

2 sealed adits; unreclaimed waste rock

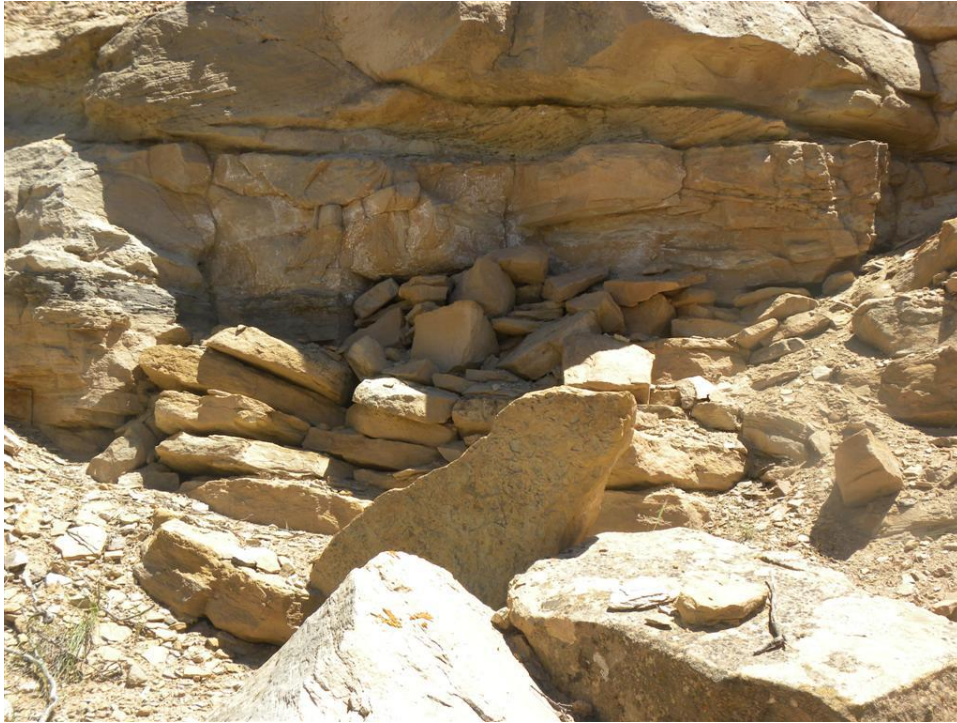
2 stone sealed adits: adit 1 12' x 6', adit 2 10' x 5'

Photo 3. CBW-MC site, sealed adit 1

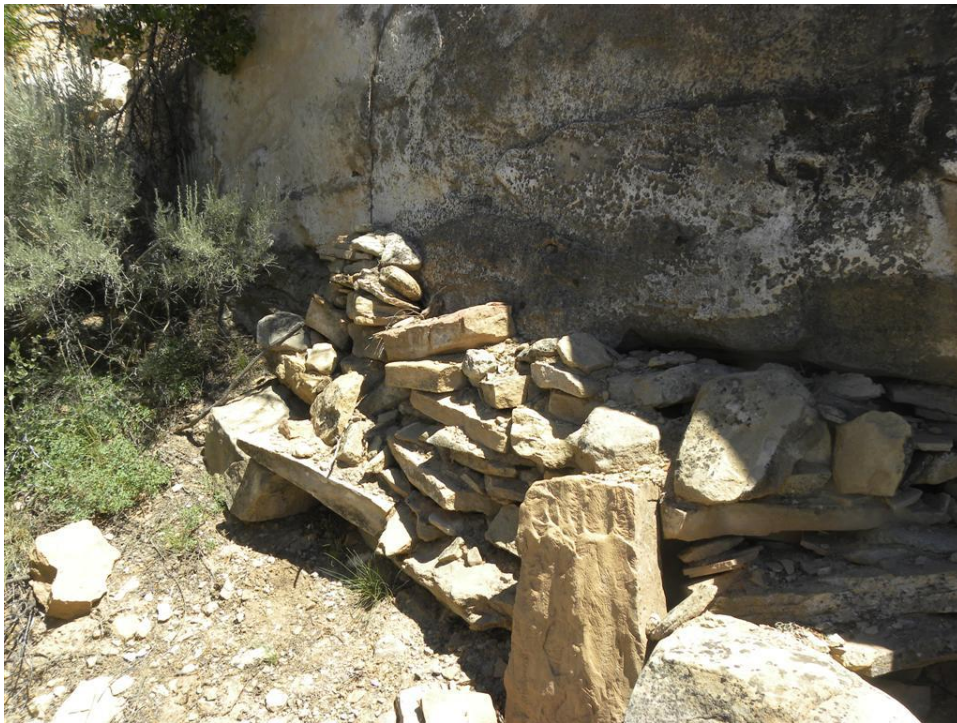
Photo 4. CBW-MC site, sealed adit 2
