Navajo Abandoned Uranium Mine

Site Screen Report

Barton 3 AUM Site

August 2010

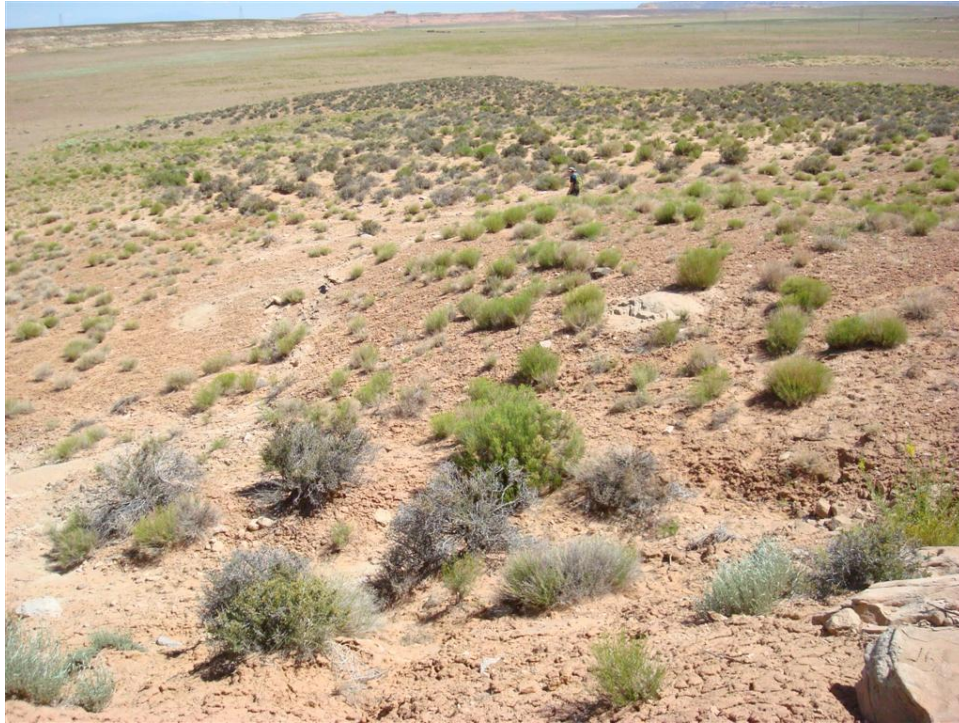
Photo 1. Barton 3 site

Potentially capped waste pile

Small pits along stratigraphic level

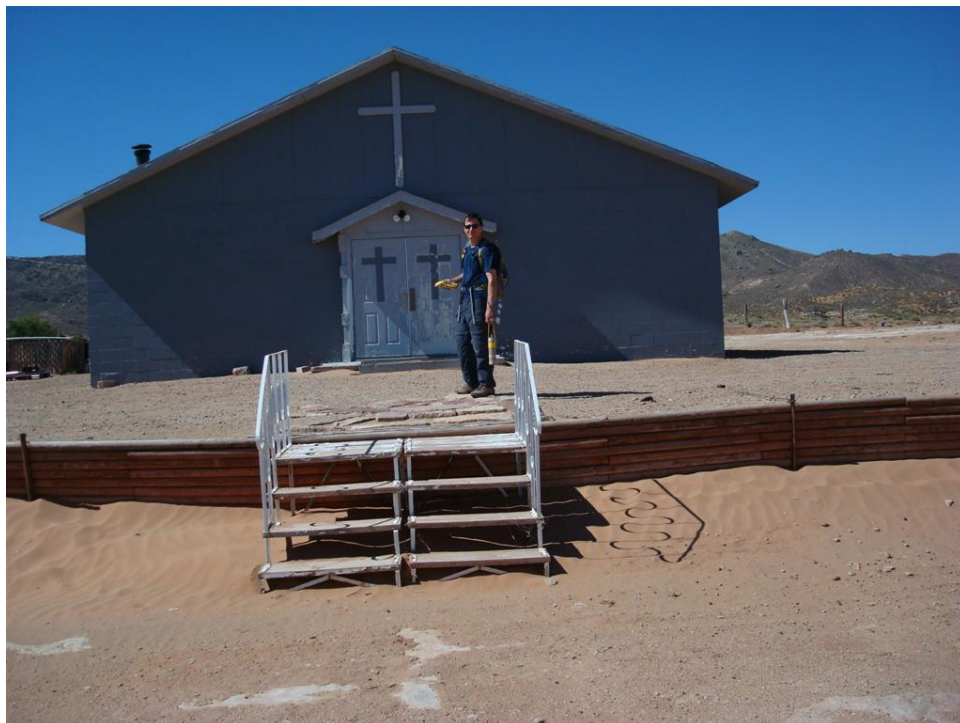
Rocks used as building materials at and around the houses and church approximately 0.2 miles northeast of the site were found to have gamma radiation levels of greater than 100,000 cpm.

Photo 16. Barton 3 site, church 0.2 mi NE of site, with elevated gamma readings. There is additional assessment work that is on-going.

Elevated gamma readings found in rocks near the church and housing compound, approximately 0.2 mi NE of site
