Navajo Abandoned Uranium Mine

Site Screen Report

Manuel Denetsone No. 2 AUM Site

Navajo AUM Western Region

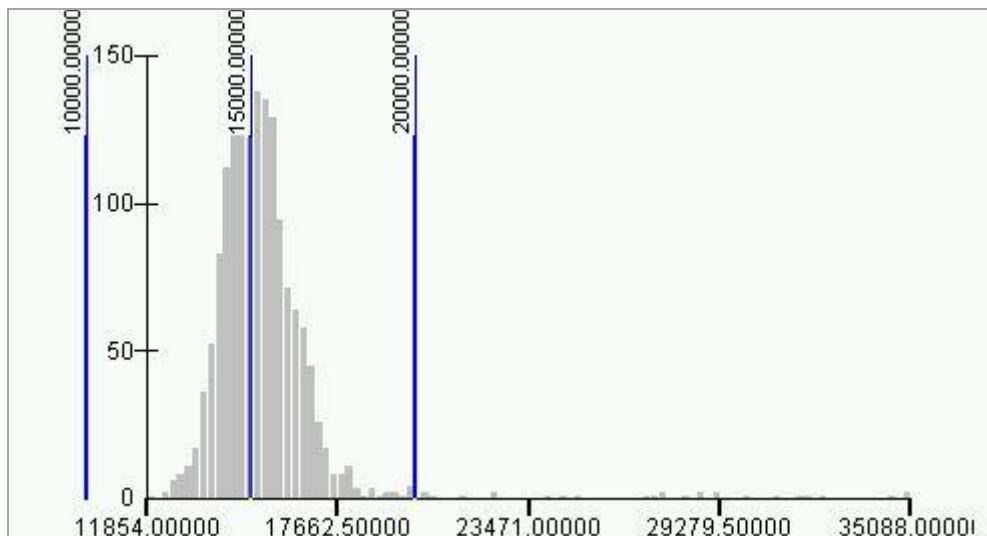
The following chart and statistics were generated by ESRI ArcGIS 9.3.1, and show the general distribution of the site gamma radiation measurements. The horizontal X axis represents the gamma radiation reading levels in cpm (lowest levels to the left). The vertical Y axis represents the frequency of each gamma radiation level.

Count:	1564
Minimum:	11854.00000
Maximum:	35088.00000
Sum:	24188932.00000
Mean:	15466.06905
Median:	15228.00000
Standard Deviation:	1983.72058

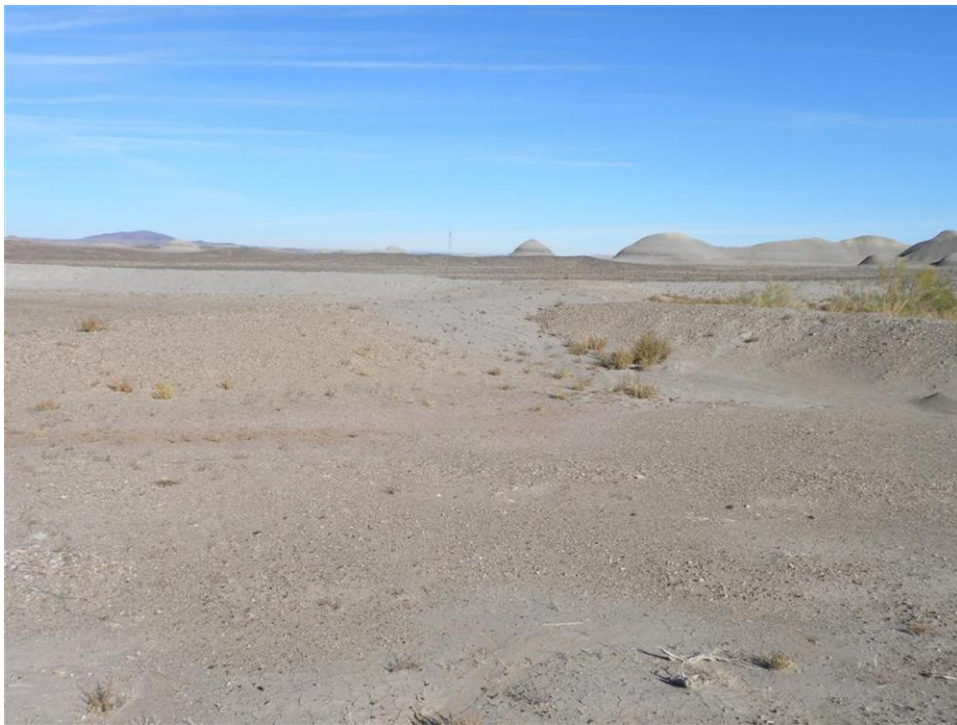
Photo 2. Manuel Denetsone No. 2 mine site, reclamation area

Reclamation cap, in good condition, few erosion cuts, berms for erosion control

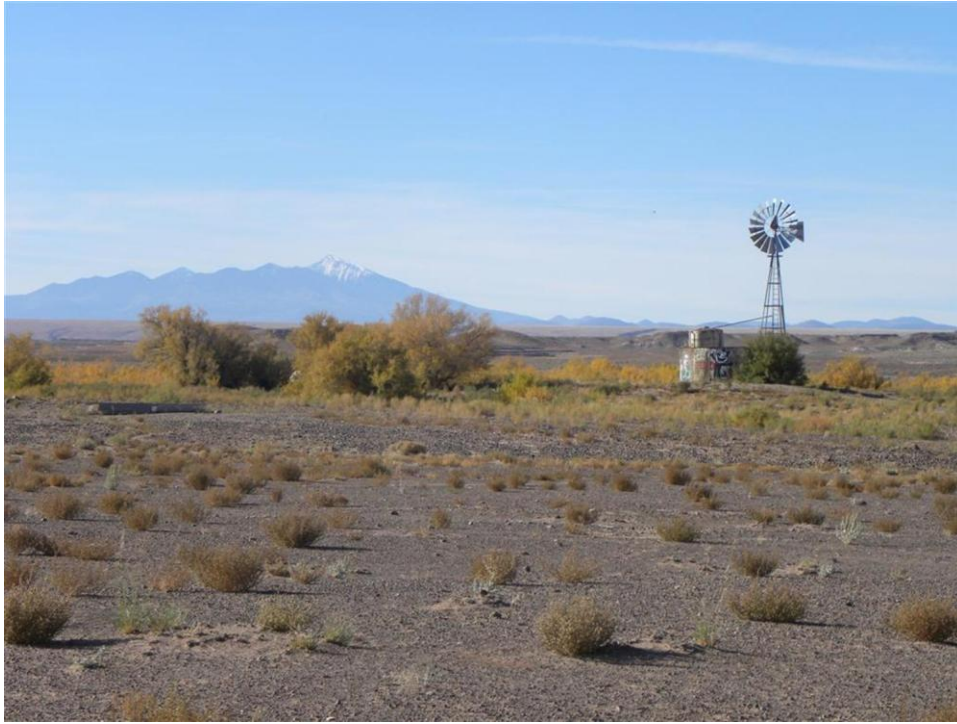
Photo 3. Manuel Denetsone No. 2 mine site, well approximately 0.25 mi southwest of site

0 to 0.25 miles: Windmill Well with tank and nearby pond approximately 0.25 mi SW of the site; 2 livestock troughs; Little Colorado River Basin approximately 0.25 mi W of the site

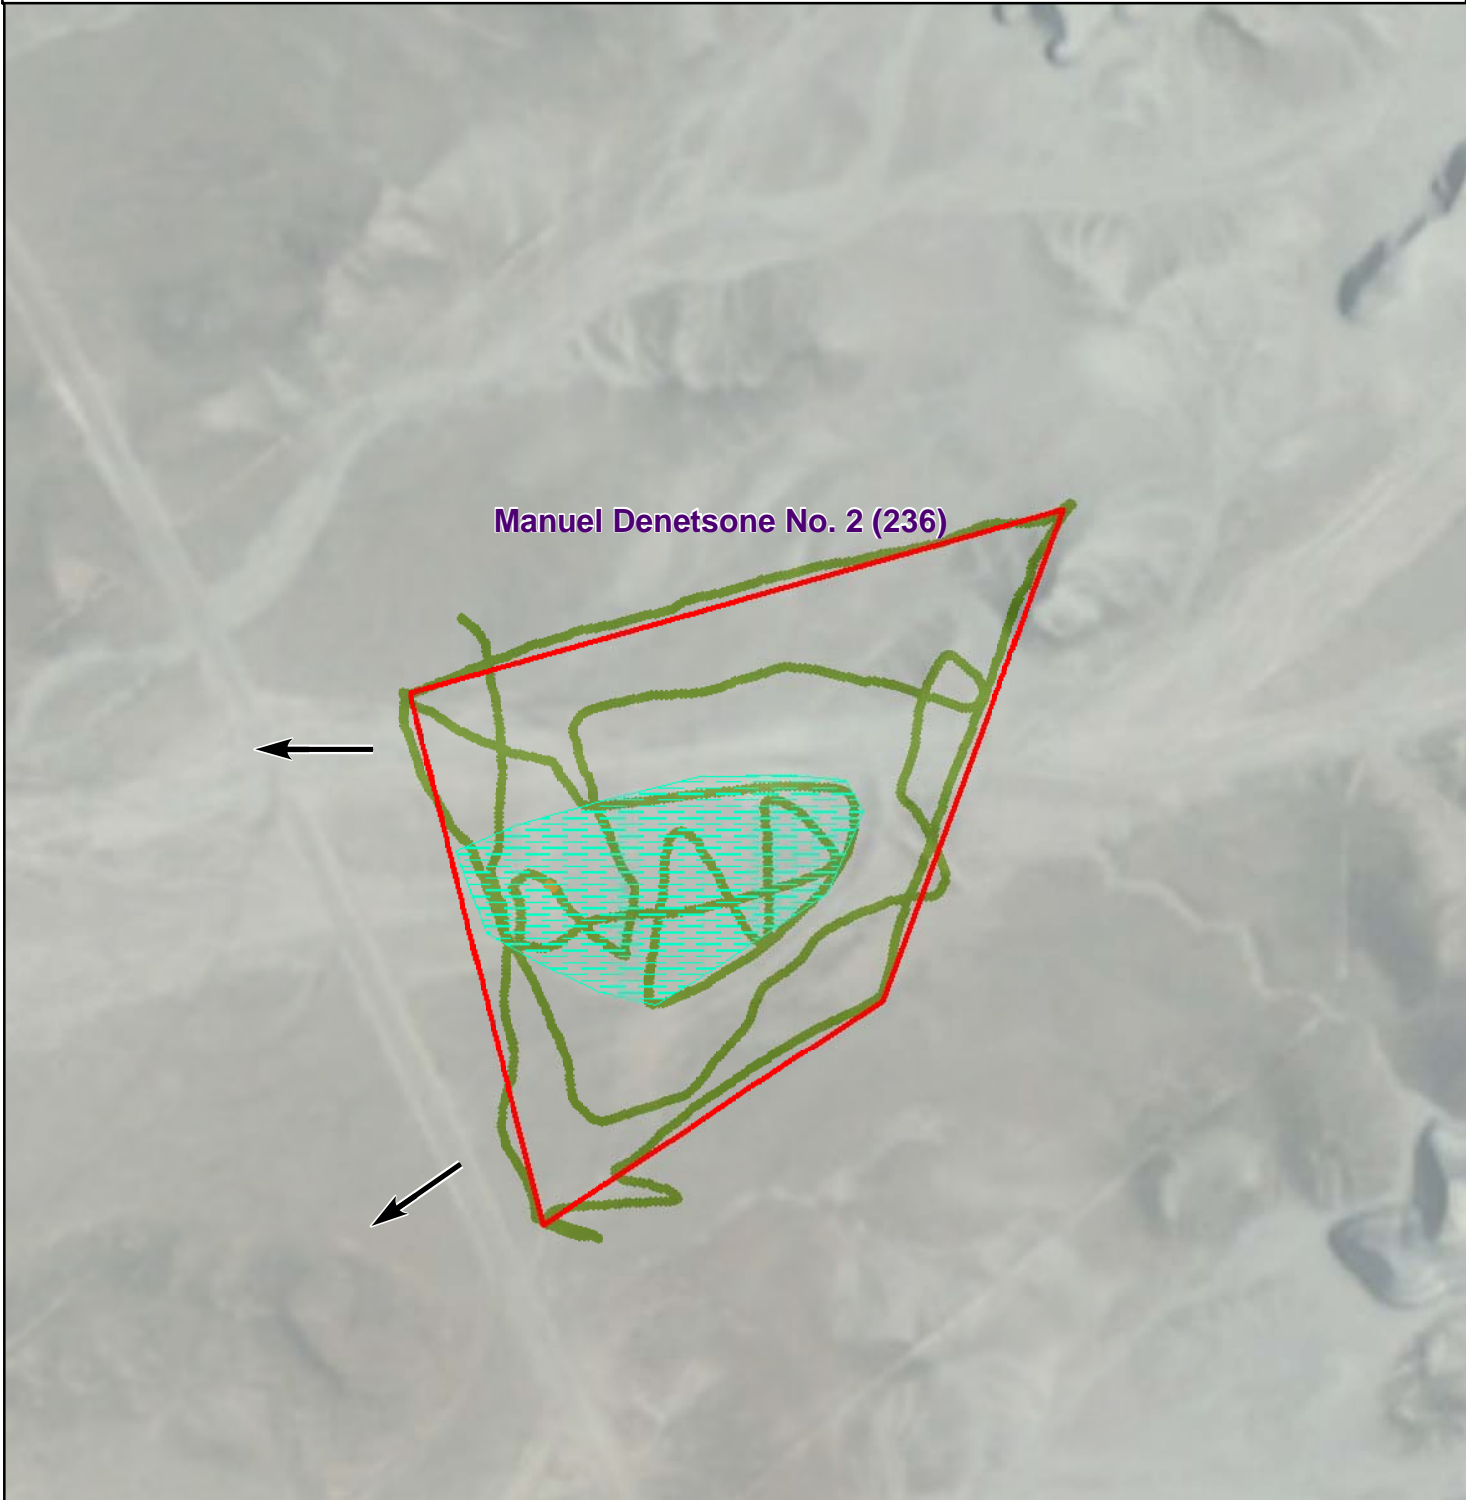
**Figure 1 - Gamma Radiation Measurements, Above Two Times
Manuel Denetsone No. 2 (236)
Coalmine Mesa Chapter, Navajo Nation**

A total of 1,564 gamma radiation measurements were collected from the mine site, ranging from 11,854 cpm to 35,088 cpm. The measurements collected at the reclamation cap were found at background levels. The measurements are represented in Figures 1 and 2.

Gamma survey conducted 11/2010
Measured as counts per minute (cpm)

Average background 14,054 cpm

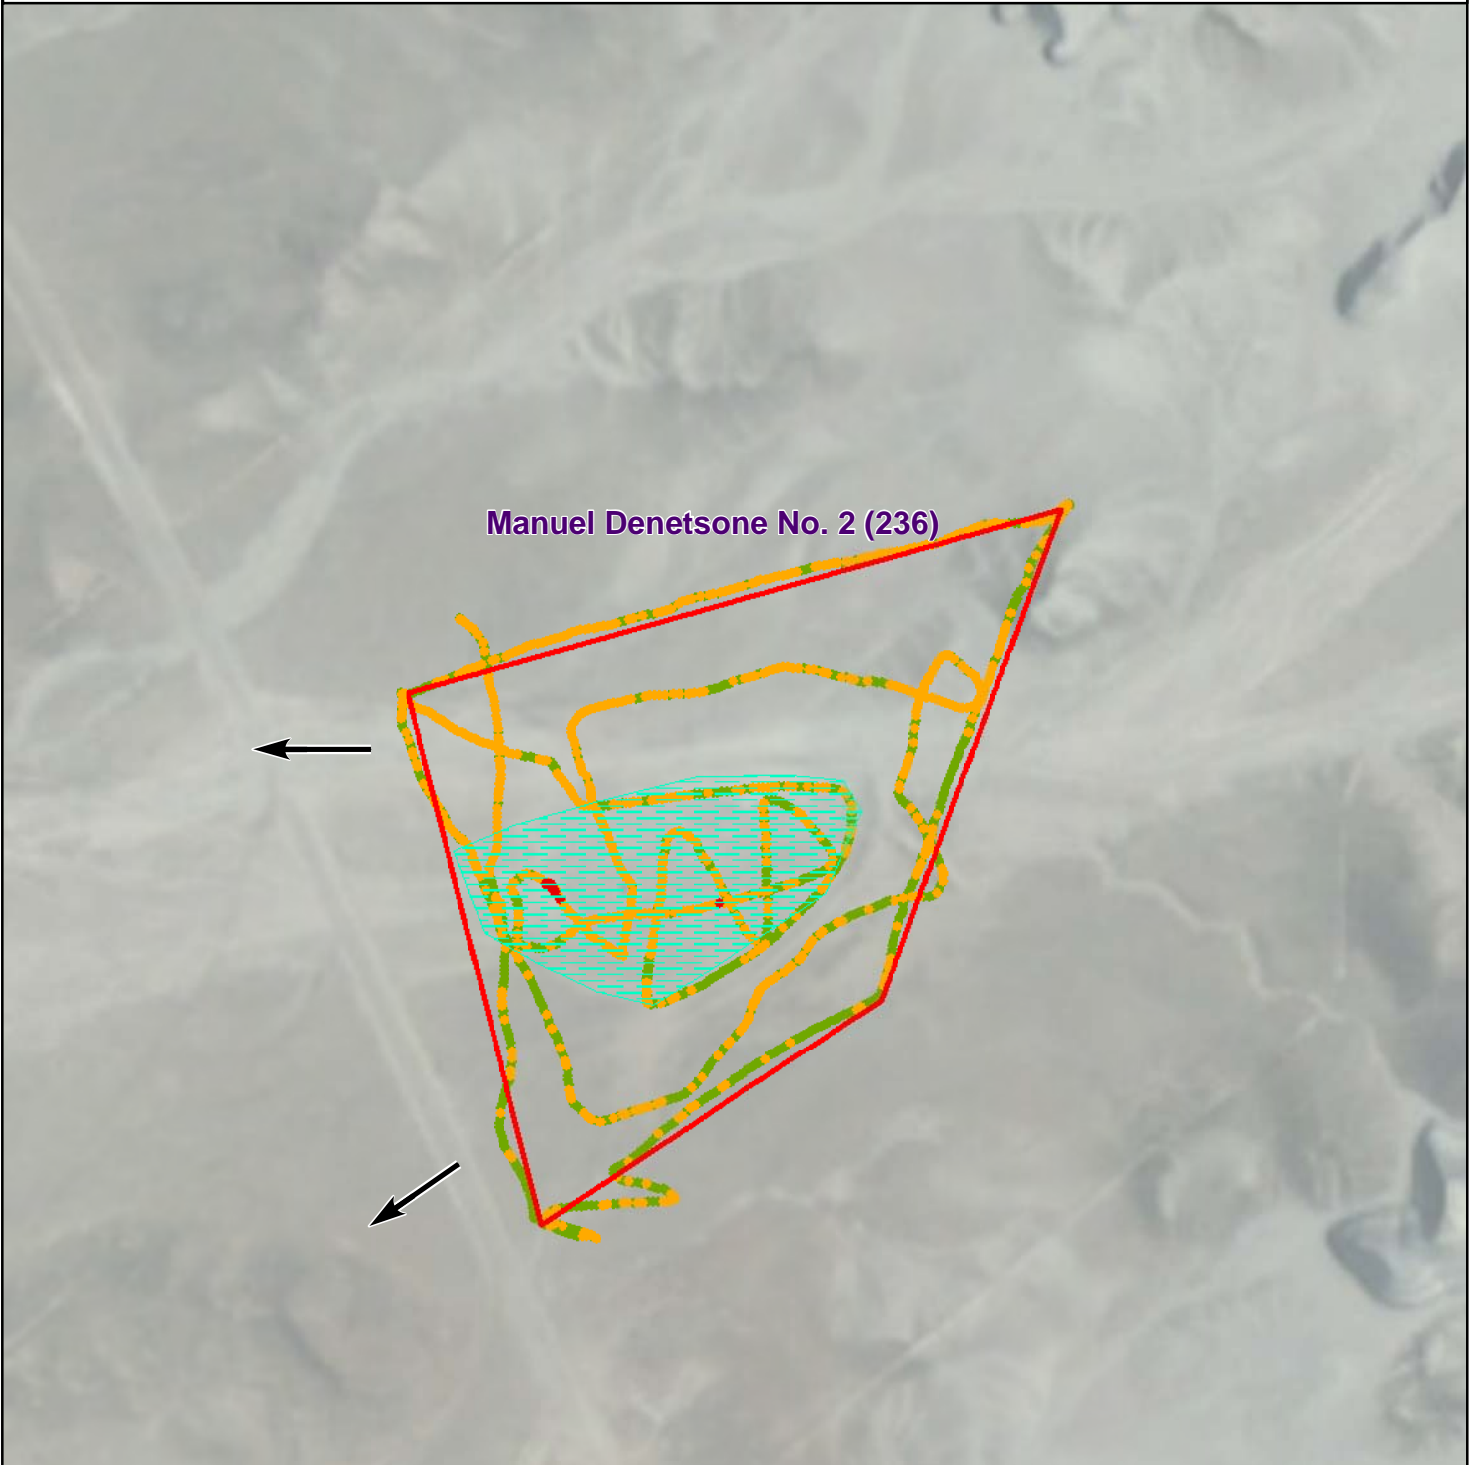
**Figure 2 - Gamma Radiation Measurements
Manuel Denetsone No. 2 (236)
Coalmine Mesa Chapter, Navajo Nation**

**Gamma survey conducted 11/2010
Measured as counts per minute (cpm)**

Average background 14,054 cpm
