Navajo Abandoned Uranium Mine

Site Screen Report

Mine Name: **Harvey Blackwater Claim (South)**Mine ID: **238**

April 2012

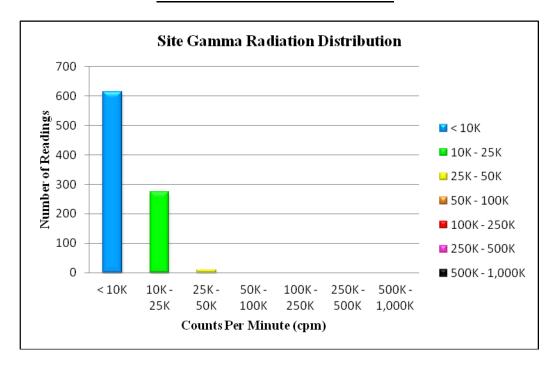
Distribution Chart and Statistics:

A total of 898 gamma radiation measurements were collected from the mine site, ranging from 5,221 cpm to 32,647 cpm. The measurements are represented in Figures 1 and 2.

Site Gamma Radiation Statistics				
Number of Readings	898			
Minimum (cpm)	5,221			
Maximum (cpm)	32,647			
Mean (cpm)	9,258			
Median (cpm)	8,819			
Standard Deviation	3,466

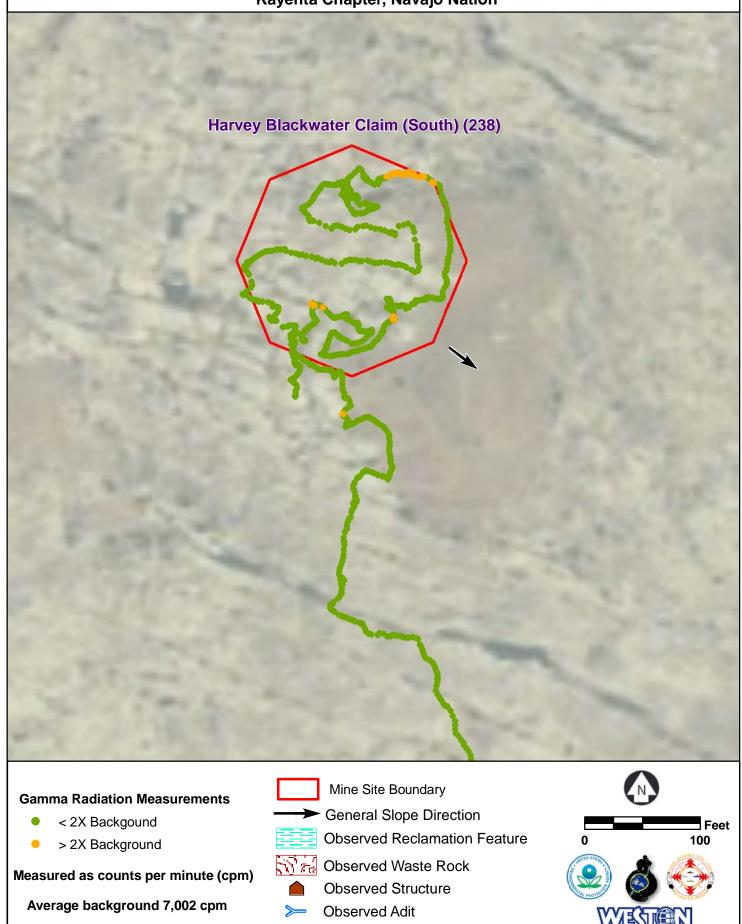
Figure 1 - Gamma Radiation Measurements, Above Two Times Background Harvey Blackwater Claim (South) (238) Kayenta Chapter, Navajo Nation

Highest gamma radiation measurement: 32,647 counts per minute (cpm)

Background Average: 7,002 cpm **Two Times Background:** 14,004 cpm

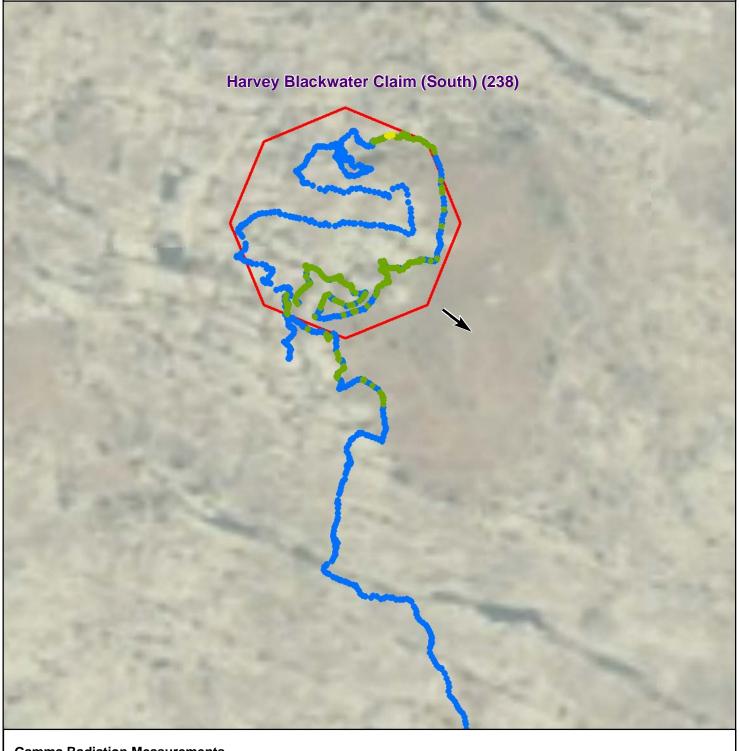
Figure 2 - Gamma Radiation Measurements Harvey Blackwater Claim (South) (238) Kayenta Chapter, Navajo Nation

Measured as counts per minute (cpm)

Average background 7,002 cpm
