# Navajo Abandoned Uranium Mine

## Site Screen Report

**Mine Name: Harvey Blackwater No. 3**  
**Mine ID: 239**

**April 2012**

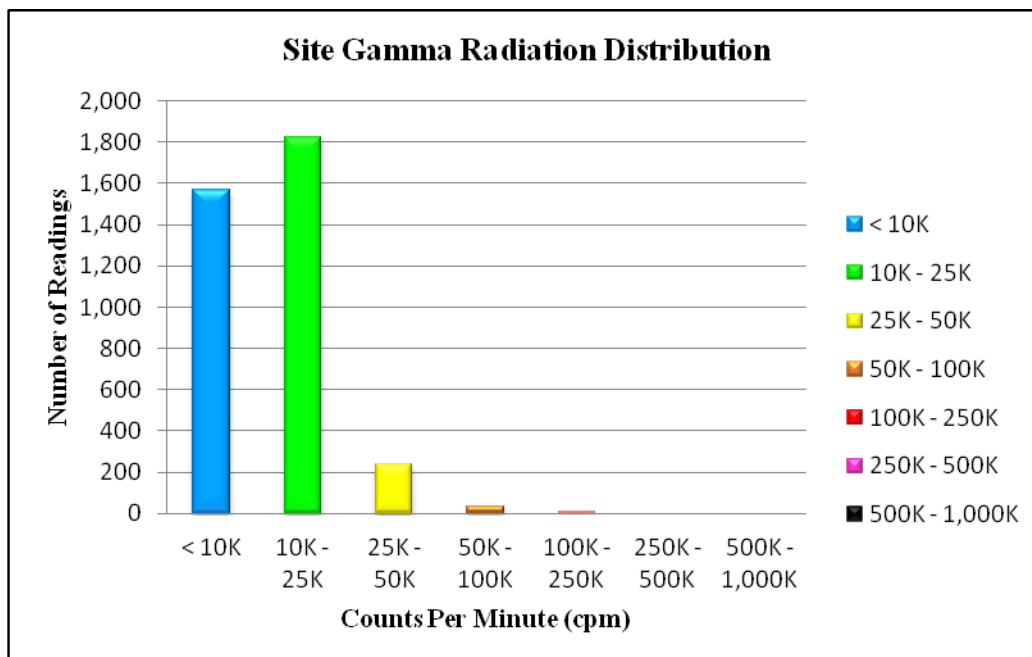
### Distribution Chart and Statistics:

A total of 3,664 gamma radiation measurements were collected from the mine site, ranging from 5,812 cpm to 124,286 cpm. The measurements are represented in Figures 1 and 2.

<b>Site Gamma Radiation Statistics</b>	
Number of Readings	3,664
Minimum (cpm)	5,812
Maximum (cpm)	124,286
Mean (cpm)	13,428
Median (cpm)	10,558
Standard Deviation	8,674

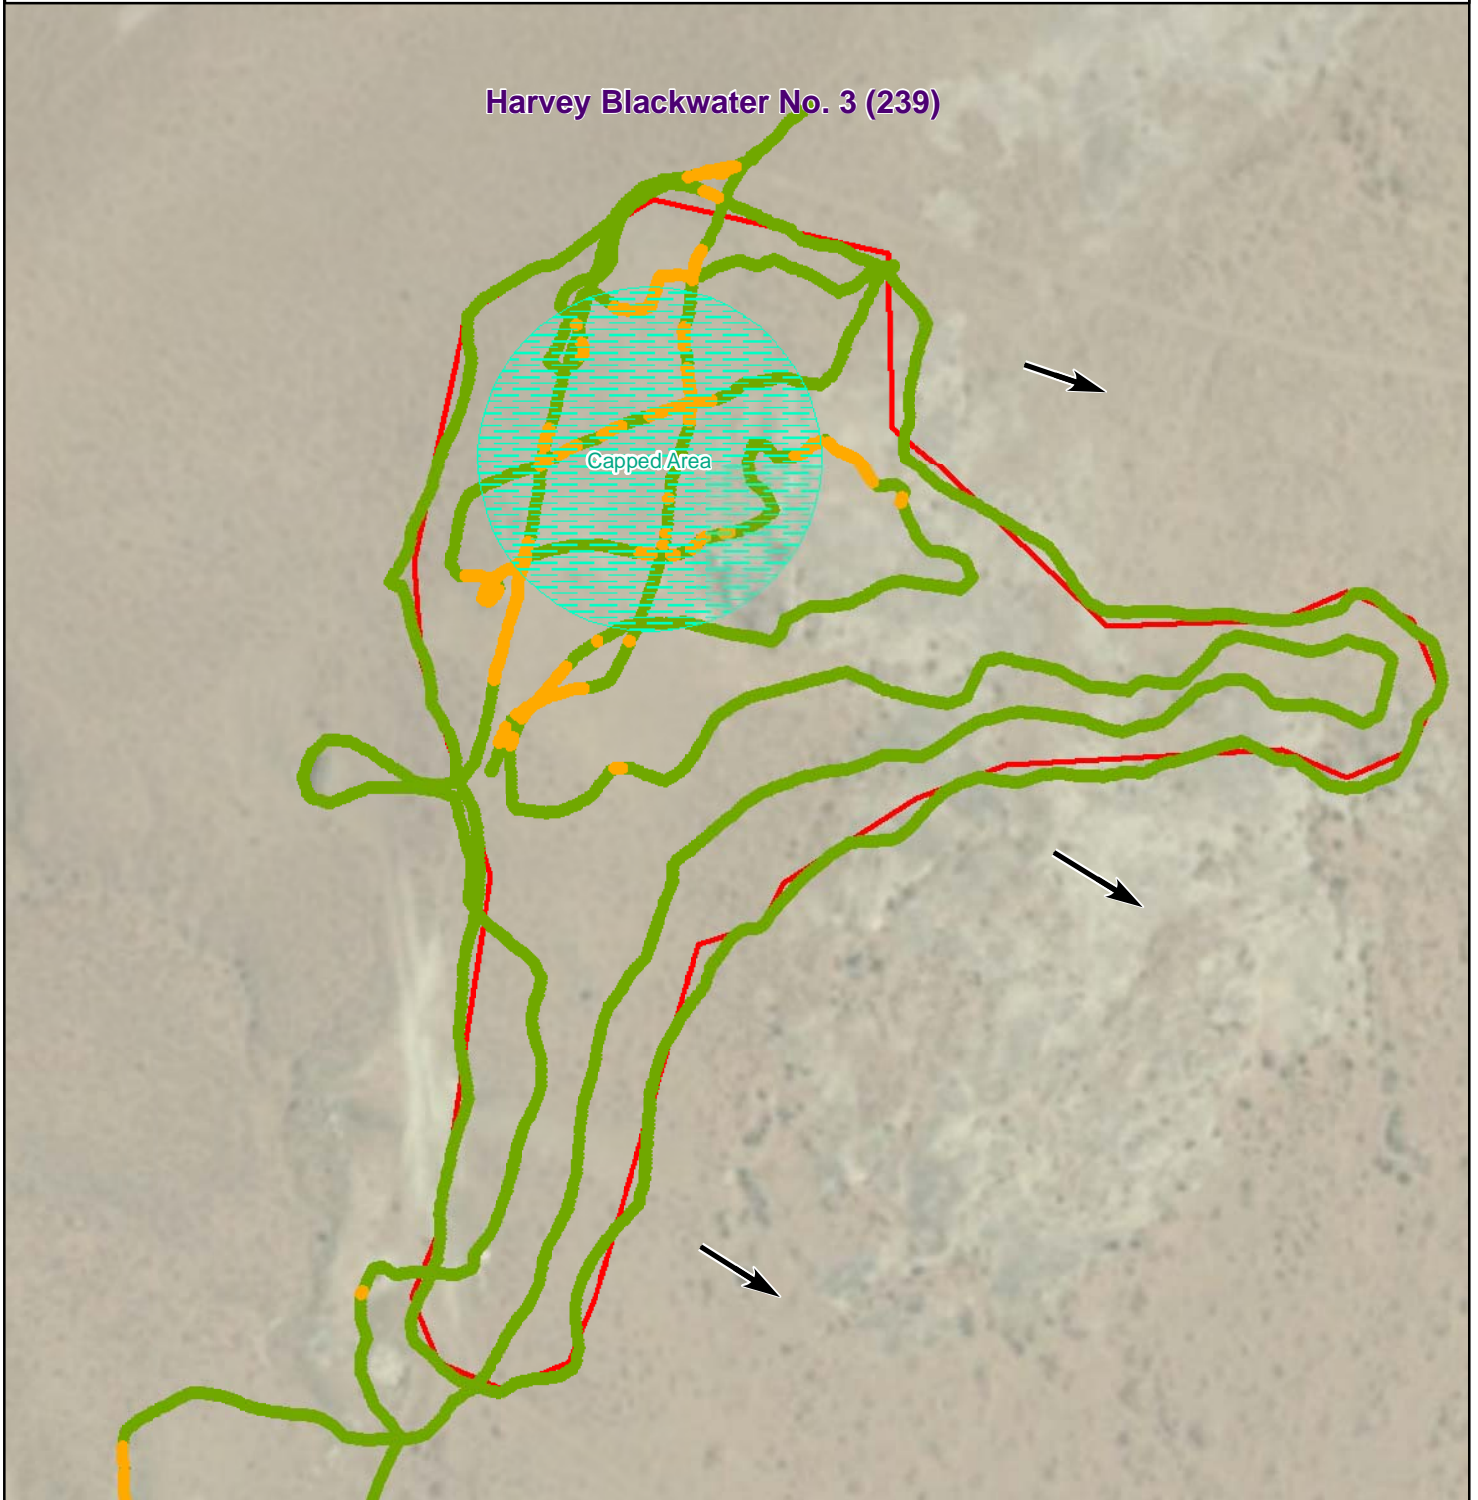
**Figure 1 - Gamma Radiation Measurements, Above Two Times Background  
Harvey Blackwater No. 3 (239)  
Kayenta Chapter, Navajo Nation**

Average background 10,577 cpm

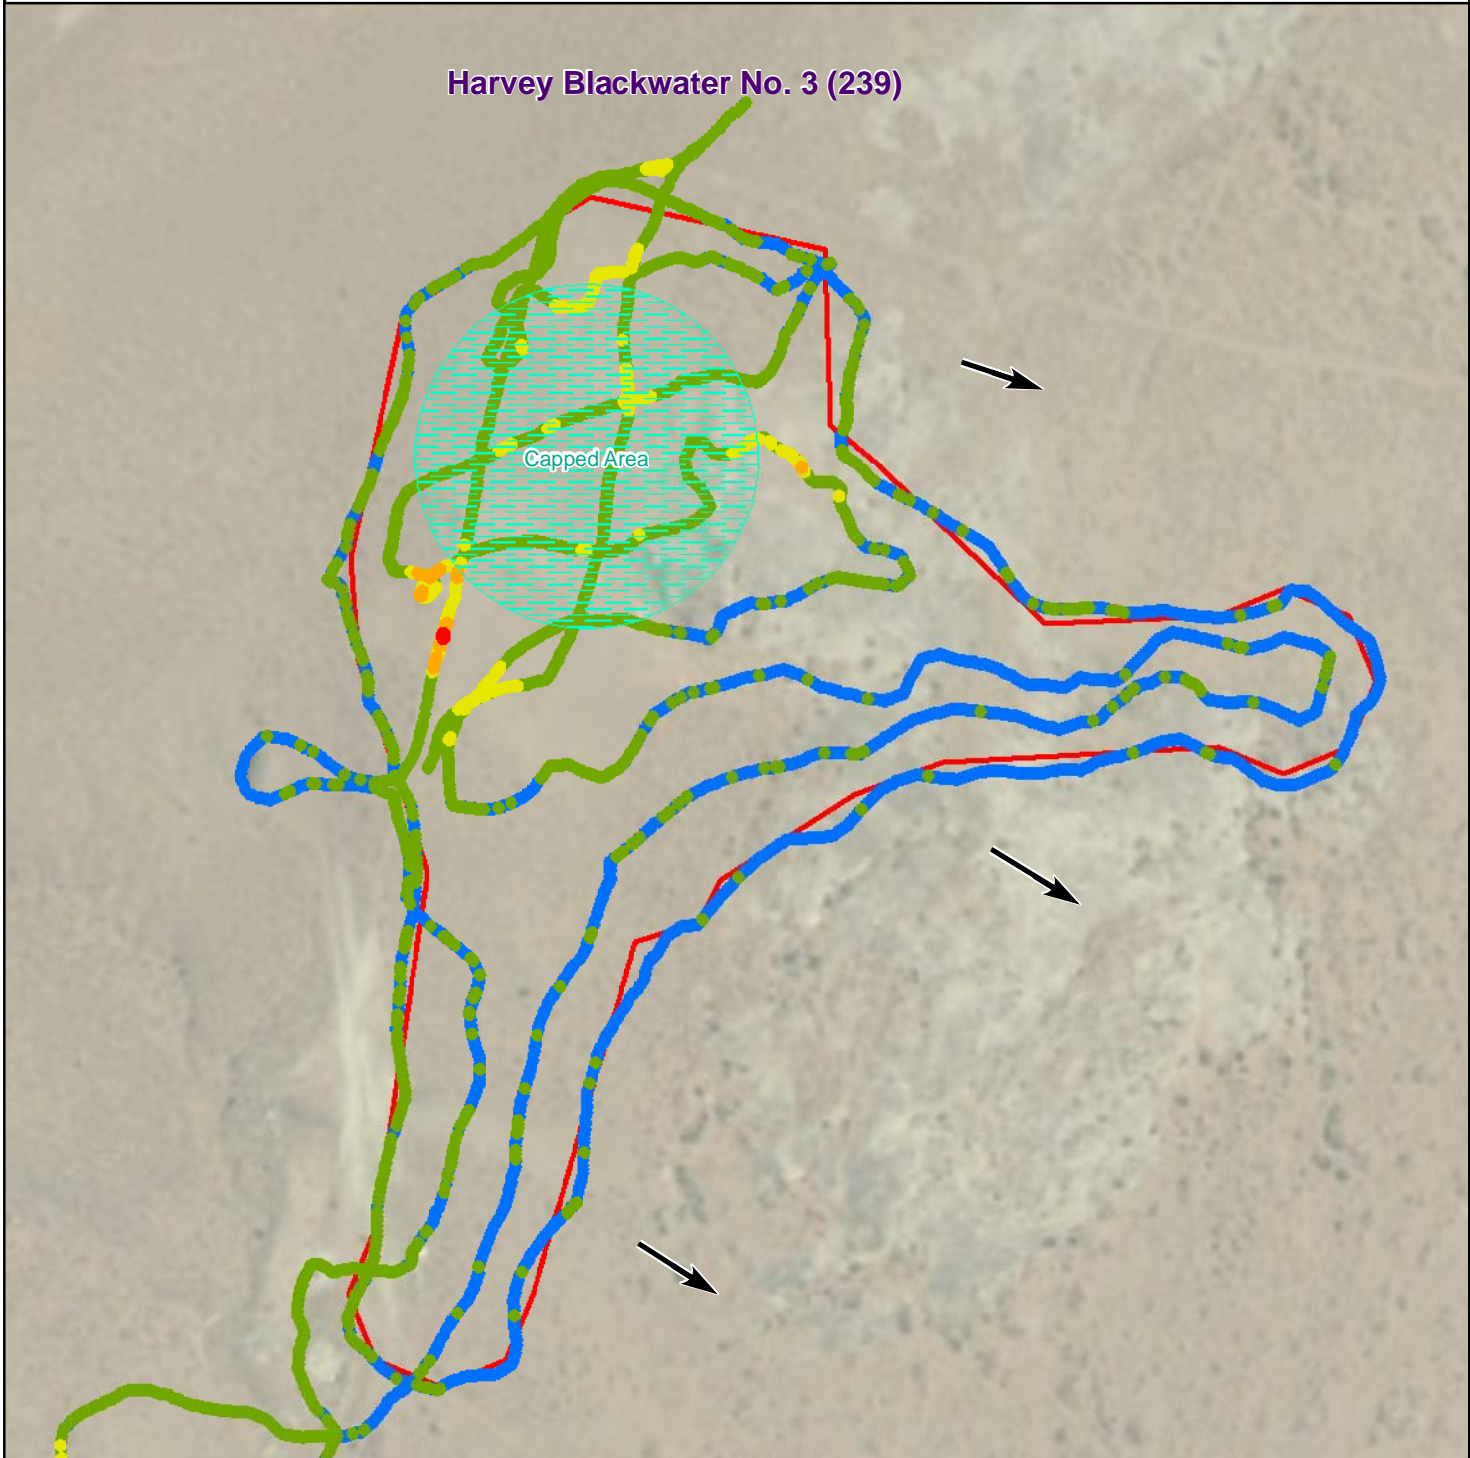
**Figure 2 - Gamma Radiation Measurements  
Harvey Blackwater No. 3 (239)  
Kayenta Chapter, Navajo Nation**

Average background 10,577 cpm
