Navajo Abandoned Uranium Mine

Site Screen Report

Mine Name: Harvey Blackwater No. 4
Mine ID: 240

April 2012

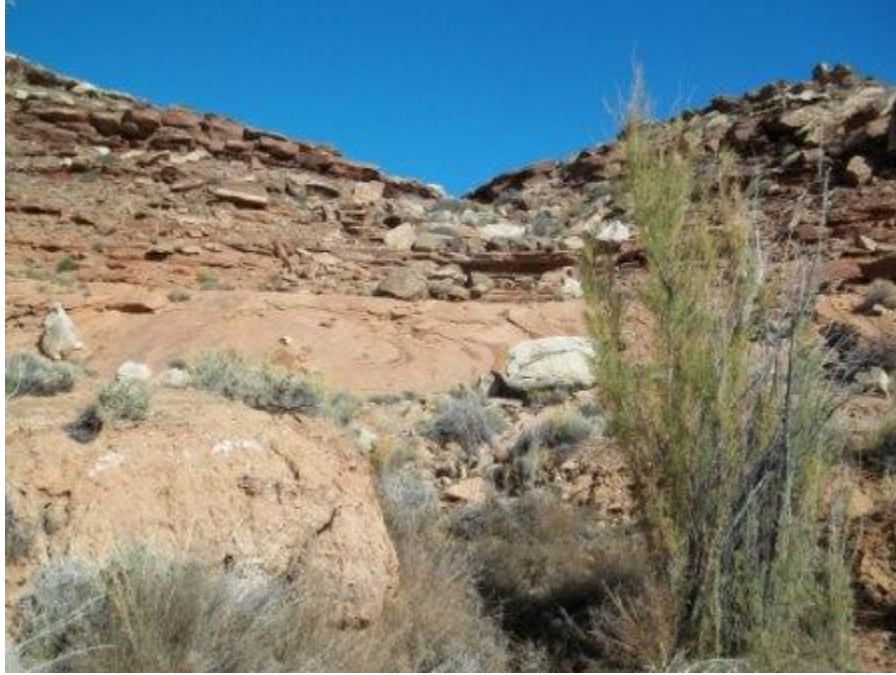
Photo 1

Mine Site #240

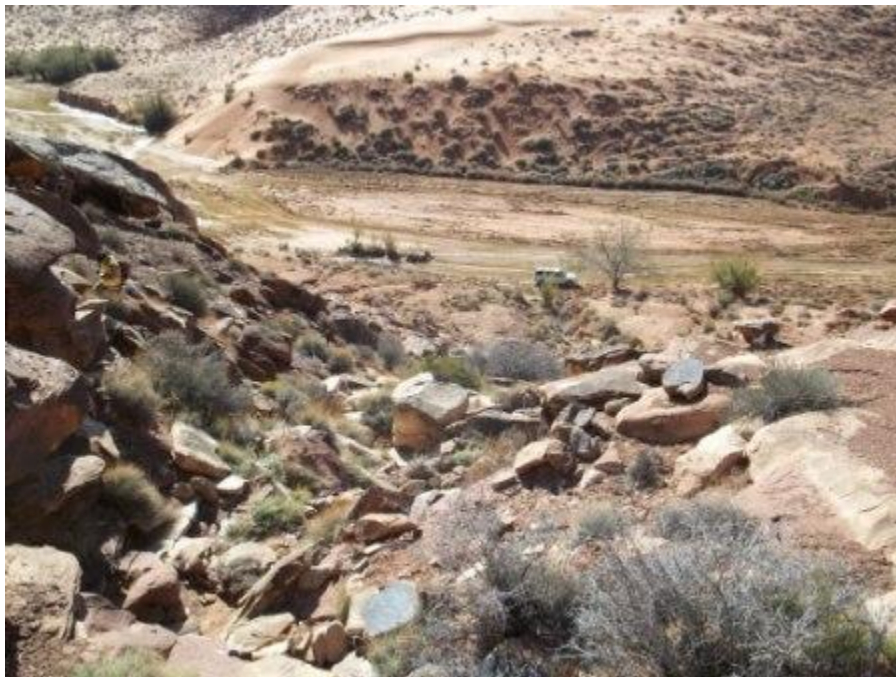
Photo 2

Mine Site #240

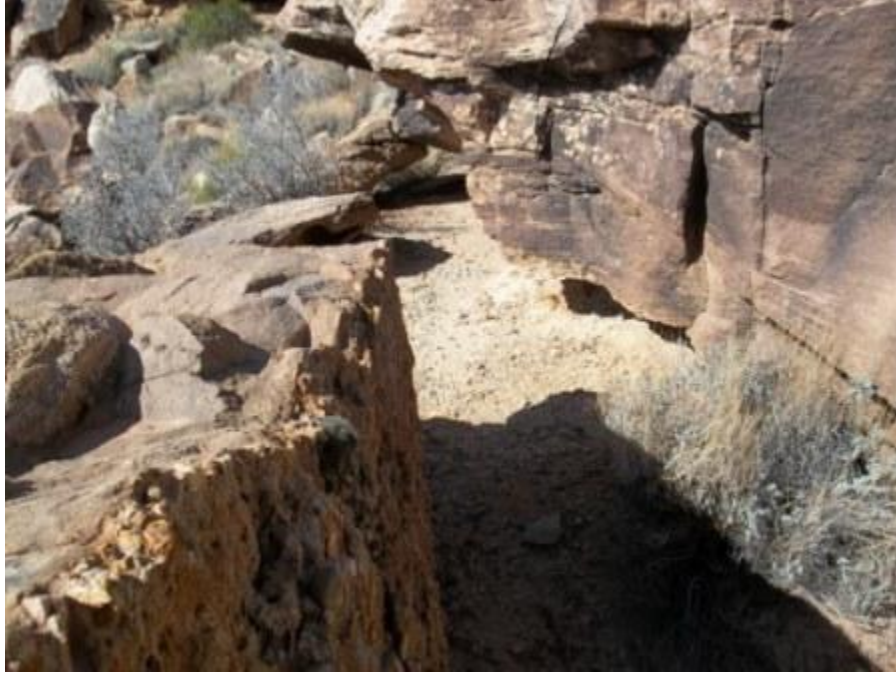
Photo 3

Mine Site #240

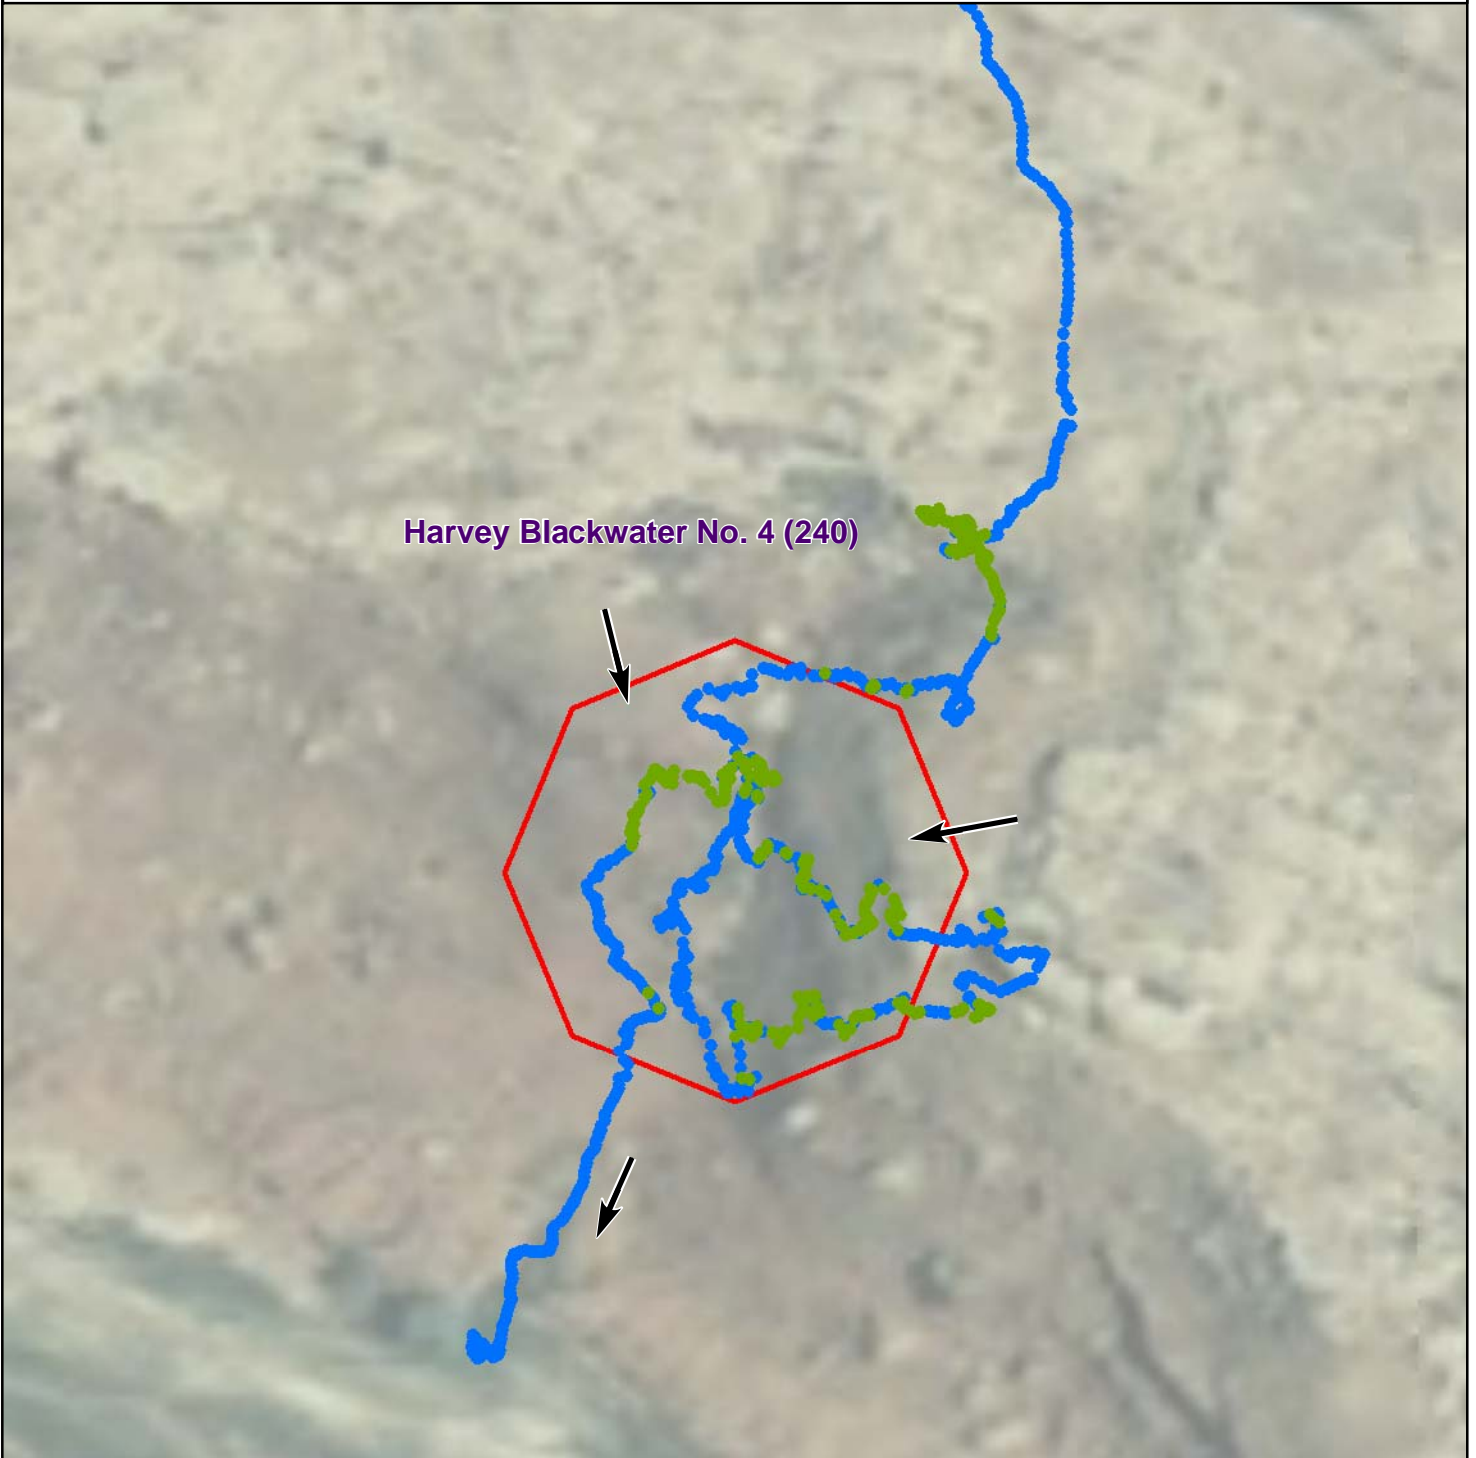
**Figure 2 - Gamma Radiation Measurements
Harvey Blackwater No. 4 (240)
Kayenta Chapter, Navajo Nation**

A total of 1,472 gamma radiation measurements were collected from the mine site, ranging from 4,083 cpm to 23,604 cpm. The measurements are represented in Figures 1 and 2.

Gamma Radiation Measurements

- 0 - 10,000 cpm
- 10,000 - 25,000 cpm
- 25,000 - 50,000 cpm
- 50,000 - 100,000 cpm
- 100,000 - 250,000 cpm
- 250,000 - 500,000 cpm
- 500,000 - 1,000,000 cpm

Average background 7,002 cpm

Measured as counts per minute (cpm)
