Navajo Abandoned Uranium Mine

Site Screen Report

Mine Name: Monument No. 1 North
Mine ID: 247

Weston Solutions, Inc.

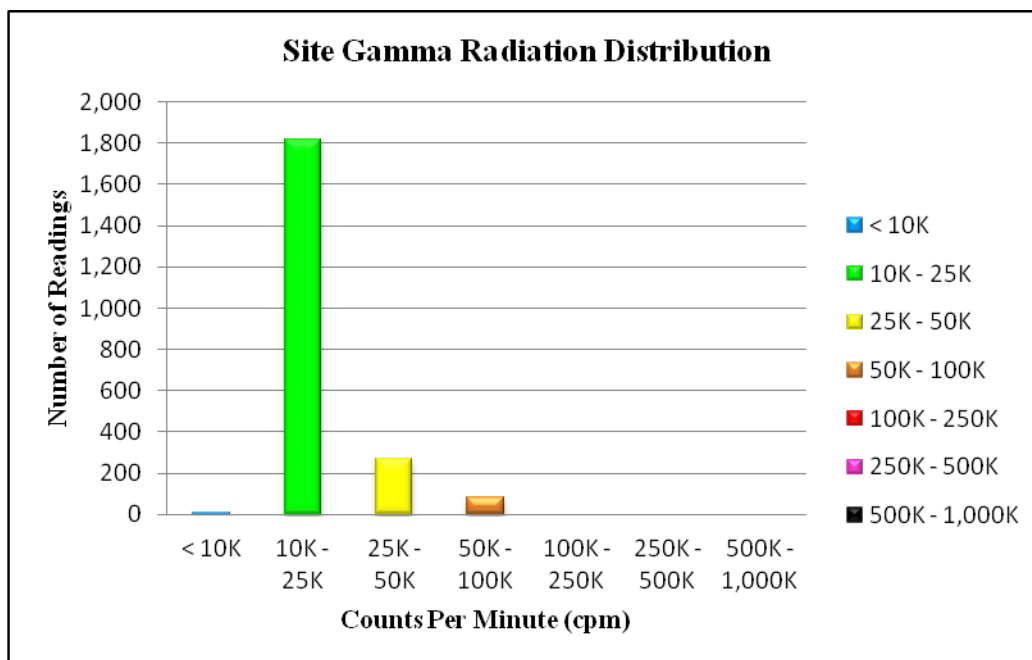
Distribution Chart and Statistics:

Site Gamma Radiation Statistics	
Number of Readings	2,182
Minimum (cpm)	8,403
Maximum (cpm)	82,597
Mean (cpm)	19,762
Median (cpm)	16,146
Standard Deviation	11,190

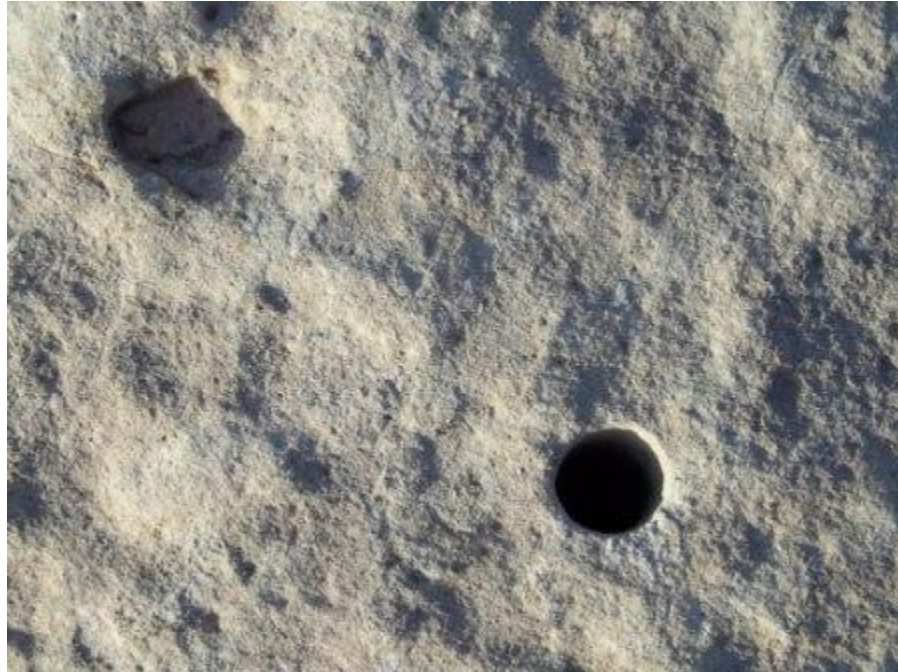
Photo 3

Mine Site #247 - Borehole

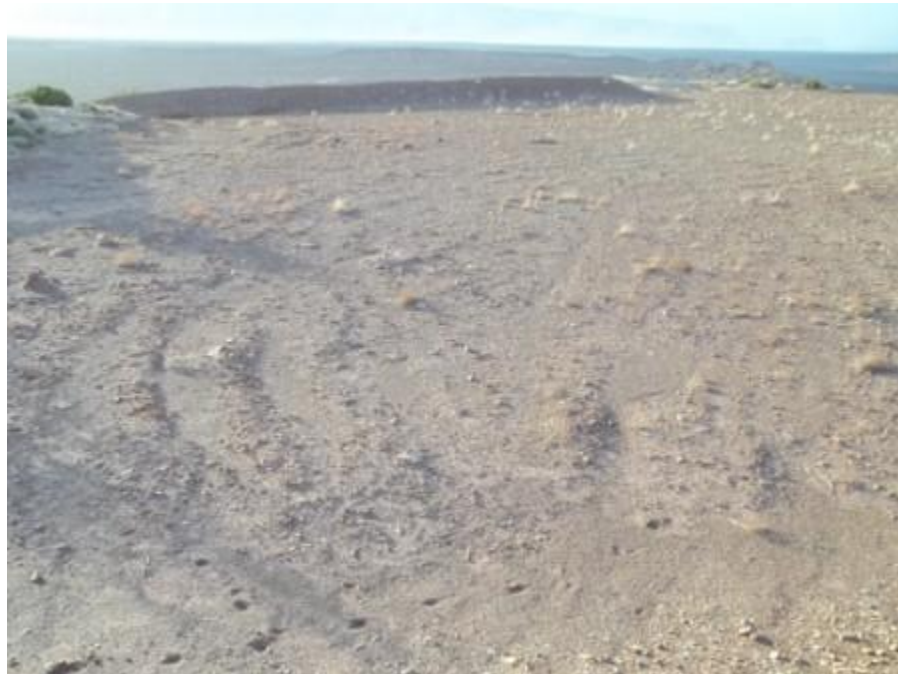
Photo 4

Mine Site #247
