Navajo Abandoned Uranium Mine

Site Screen Report

Mine Name: Black Rock
Mine ID: 249

April 2012

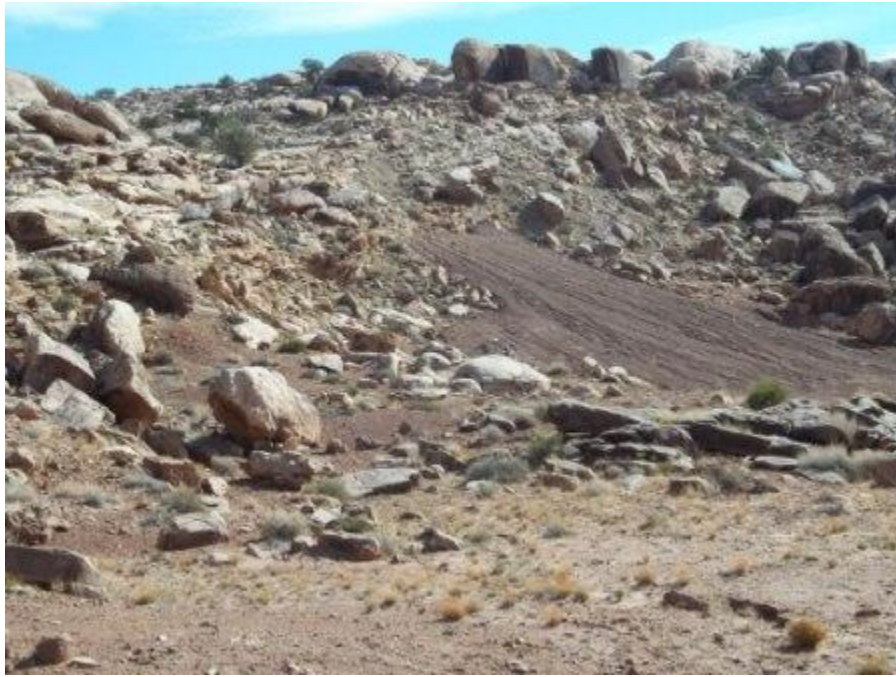
Photo 1

Mine Site #249

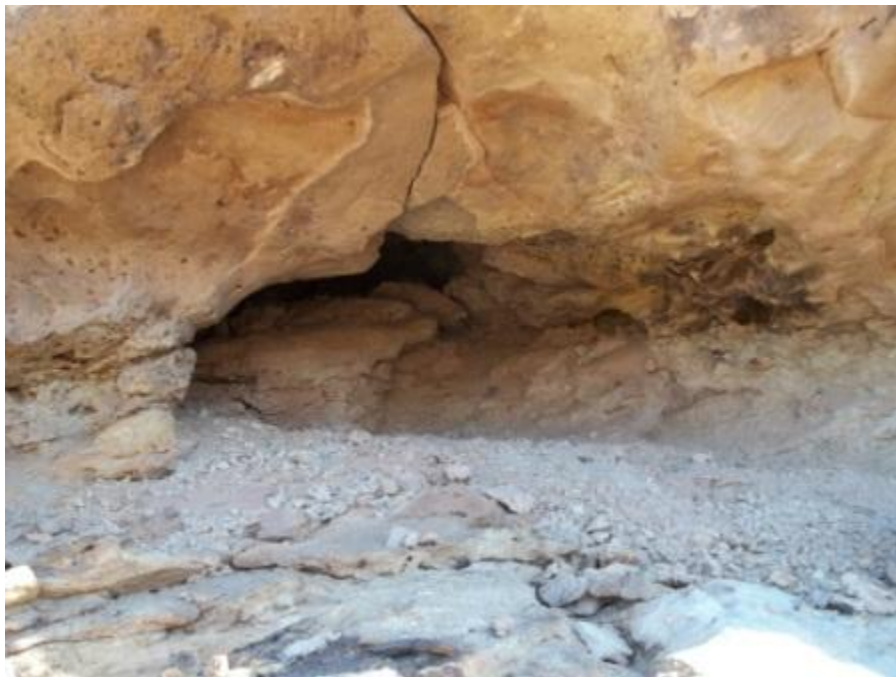
Photo 2

1 adit, red stone sealed, approximately 6' wide x 3' high

Mine Site #249 - Adit

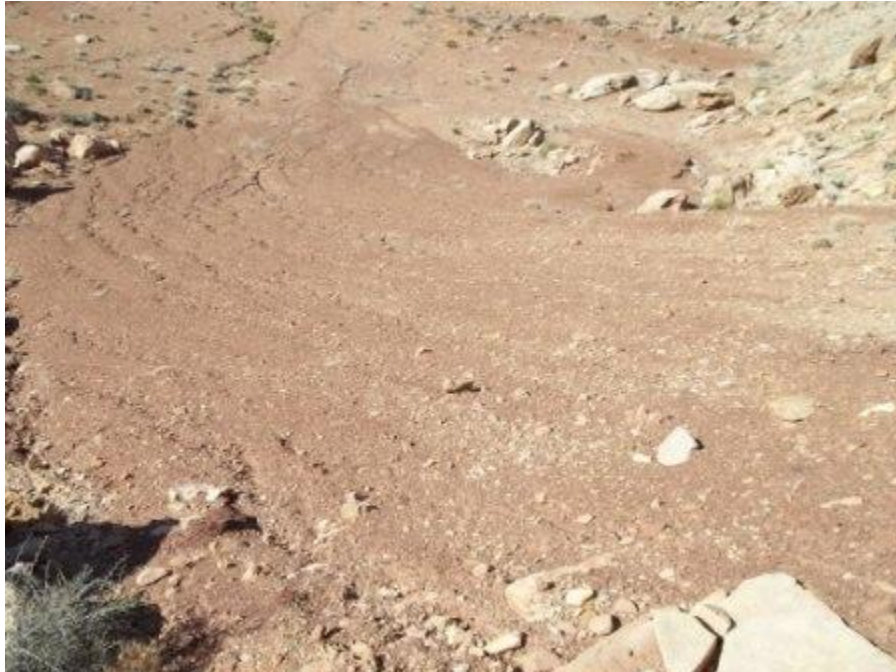
Photo 3

Reclamation cap / tailings area, red clay, with drainage west toward Route 163, 50' wide x 100' long

Mine Site #249 - Cap

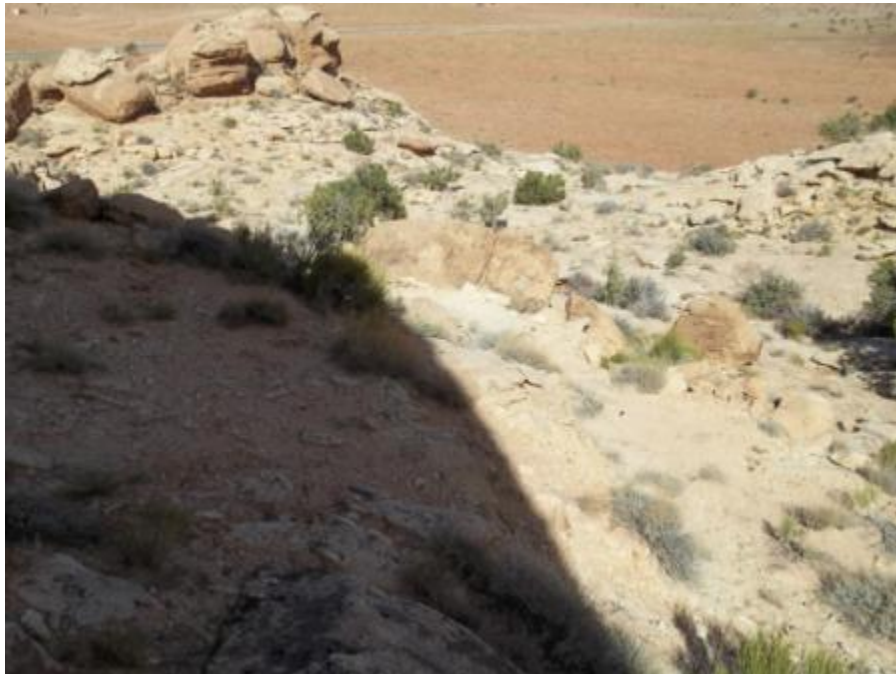
Photo 4

Mine Site #249
