Navajo Abandoned Uranium Mine

Site Screen Report

Mine Name: **Big Chief**Mine ID: **251**

April 2012

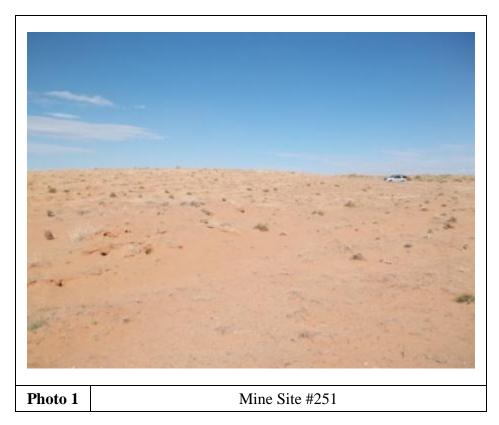
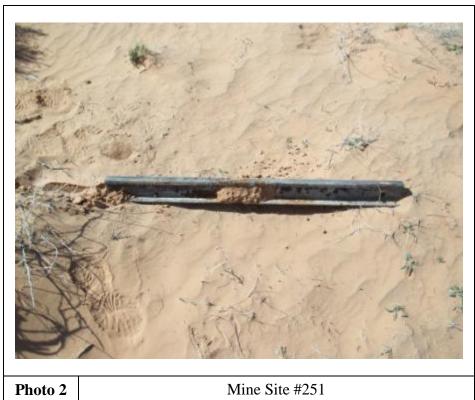
Part VI Photos

Reclamation cap over former shaft location
