Navajo Abandoned Uranium Mine

Site Screen Report

John John 1 AUM Site

Weston Solutions, Inc.

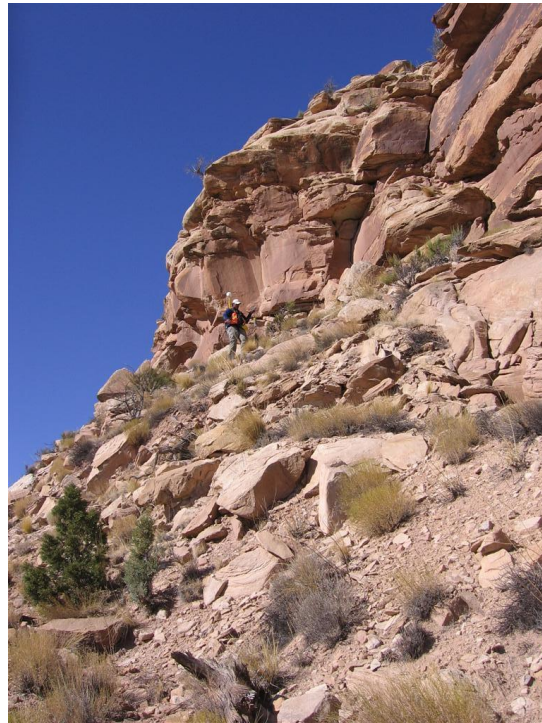
Debris in paths with elevated radiation, 100' x 50', with a total estimated volume of 926 yd³

Photo 1. Mine site #270 waste debris

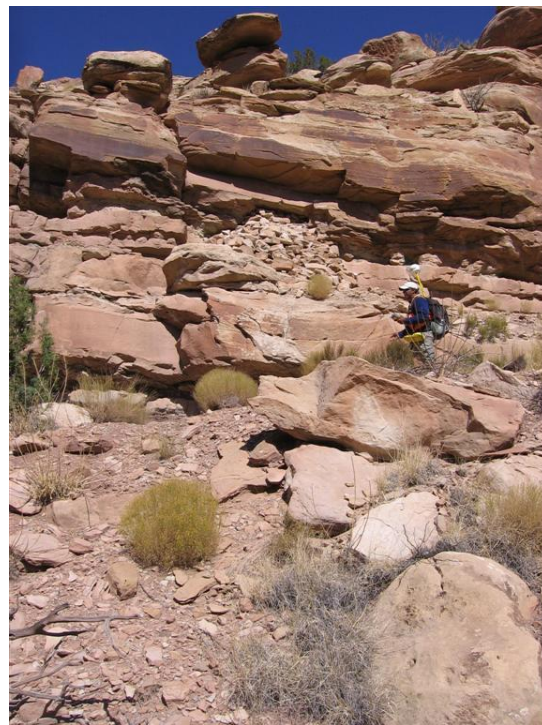
Sealed adit in cliff wall, approximately 8-ft wide by 6-ft high

Waste pile near adit, assorted smaller waste rock, 75' x 75', with a total estimated volume of 1,042 yd³

Photo 2. Mine site #271 sealed adit and waste debris

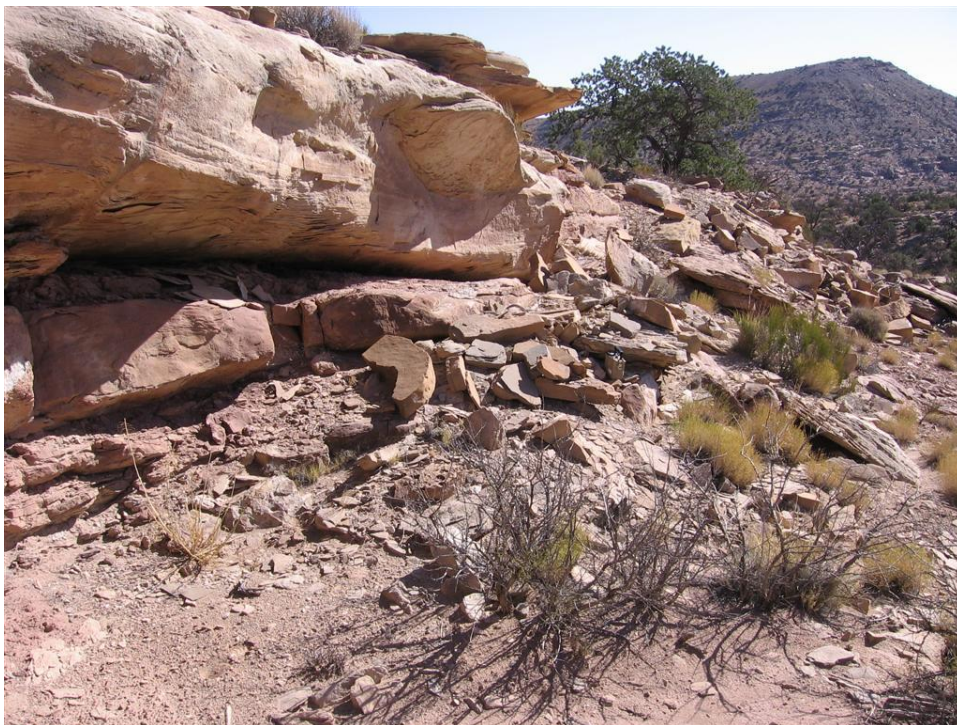
Waste piles wash down into drainage, typically small, 15' x 15' (x5), with a total estimated volume of 208 yd³

Photo 6. Photo 4. Mine site #442 waste debris

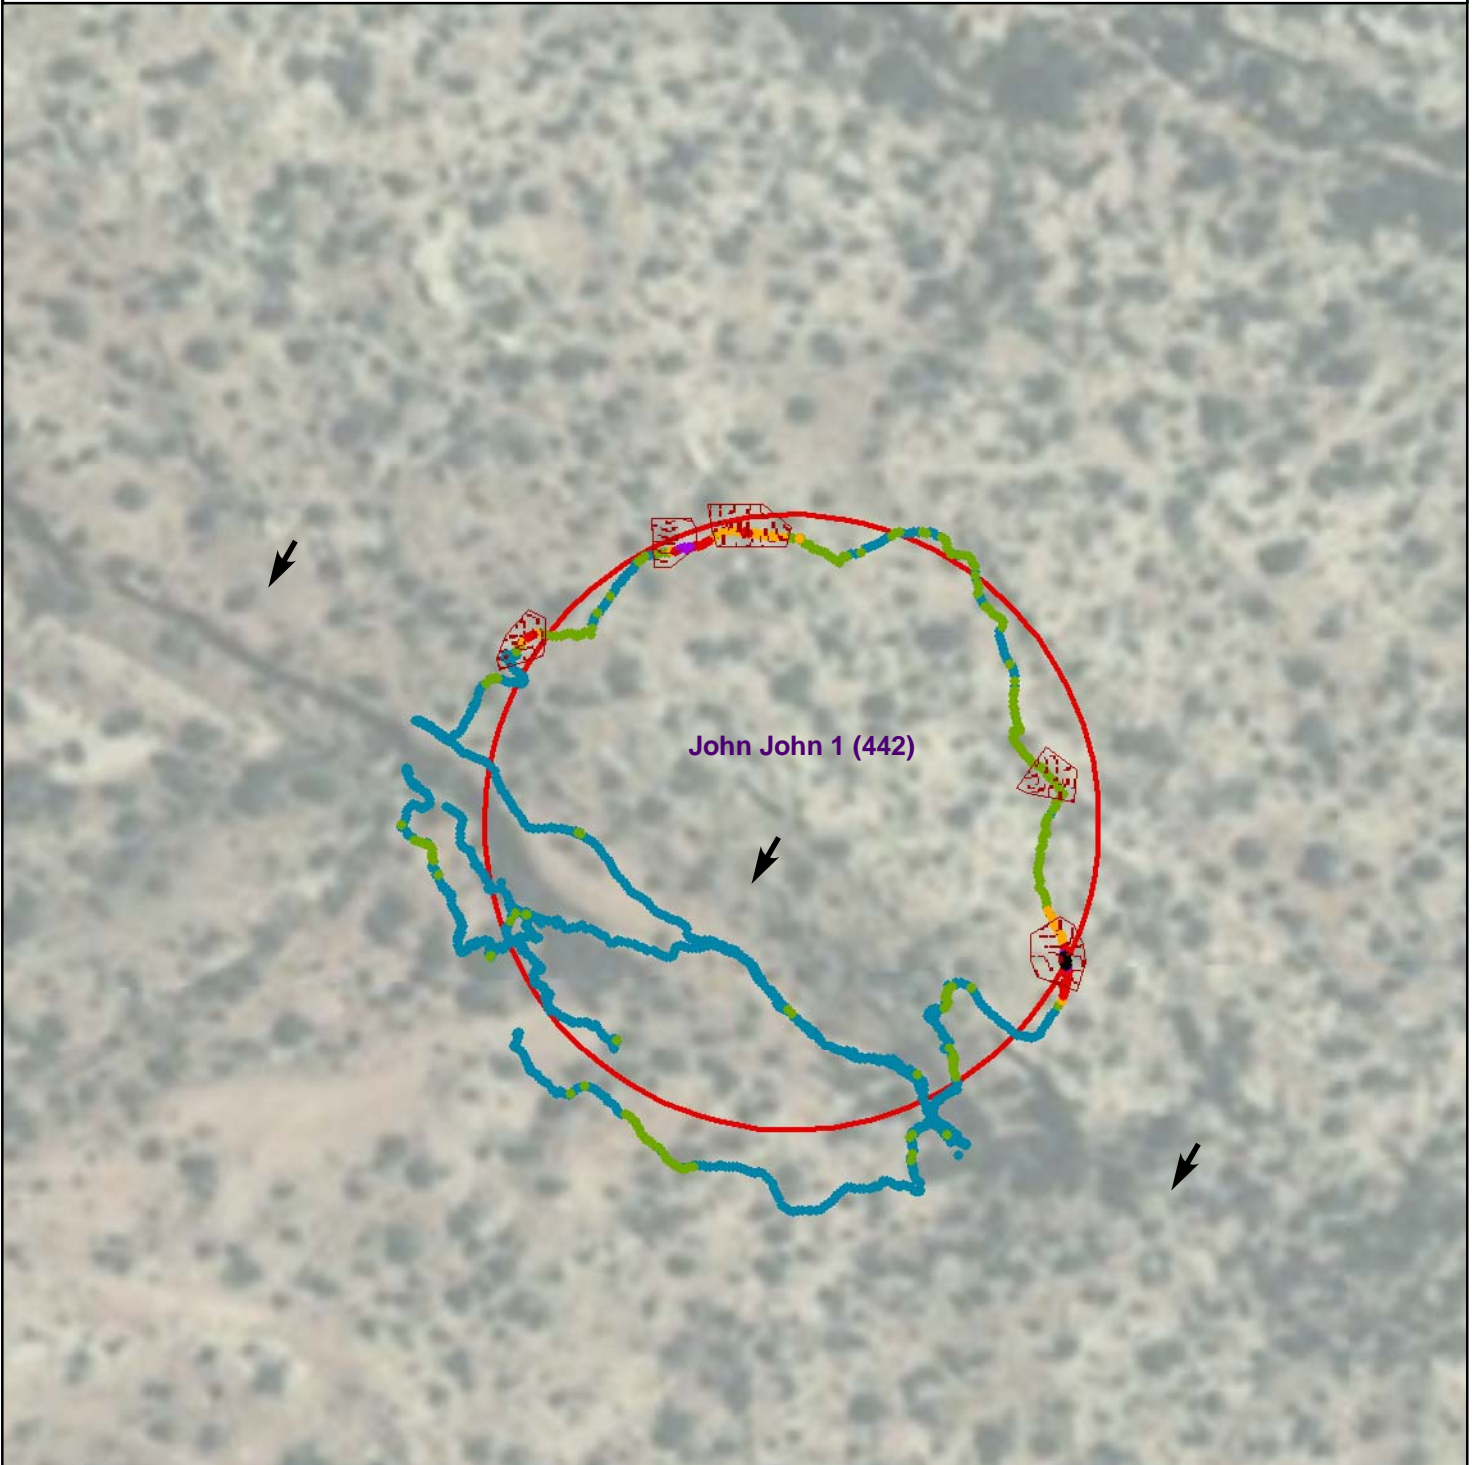
A total of 1,642 gamma radiation measurements were collected from the mine site, ranging from 5,388 cpm to 153,631 cpm. Measurements collected at the waste piles ranged from approximately 35,000 cpm to 150,000 cpm. The measurements are represented in Figures 6 and 7.

**Figure 7 - Gamma Radiation Measurements
John John 1 (442)
Beclabito Chapter, Navajo Nation, Arizona**
