Navajo Abandoned Uranium Mine

Site Screen Report

NA-0420 AUM Site

Navajo AUM Northern Region

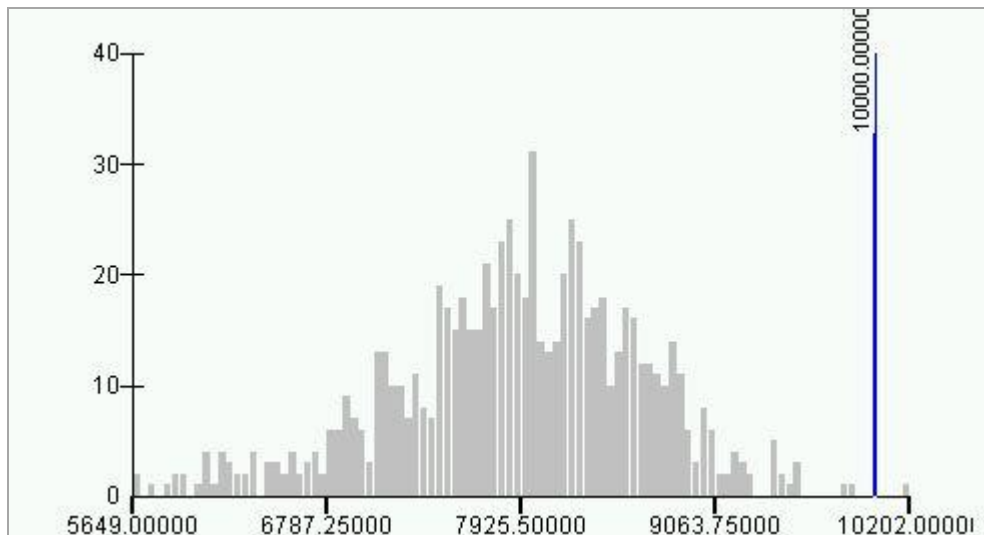
The following chart and statistics were generated by ESRI ArcGIS 9.3.1, and show the general distribution of the site gamma radiation measurements. The horizontal X axis represents the gamma radiation reading levels in cpm (lowest levels to the left). The vertical Y axis represents the frequency of each gamma radiation level.

Count:	758
Minimum:	5649.00000
Maximum:	10202.00000
Sum:	5989683.00000
Mean:	7901.95646
Median:	7939.50000
Standard Deviation:	726.22936

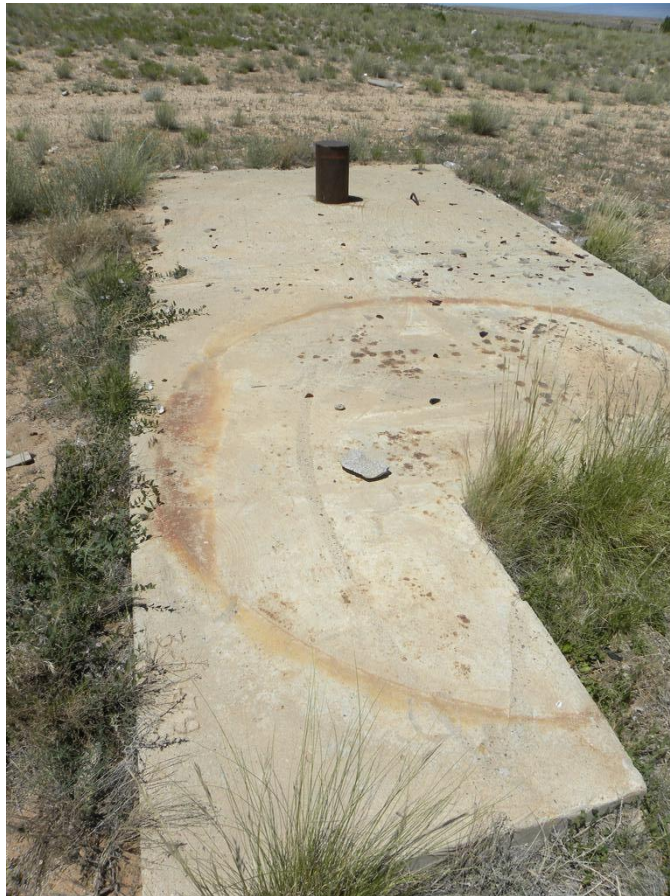
There is the possibility that the site has been reclaimed with a soil and/or gravel cap; concrete pad was located immediately S of site.

Photo 4. NA-0420 site, concrete pad, labeled 3-29-71

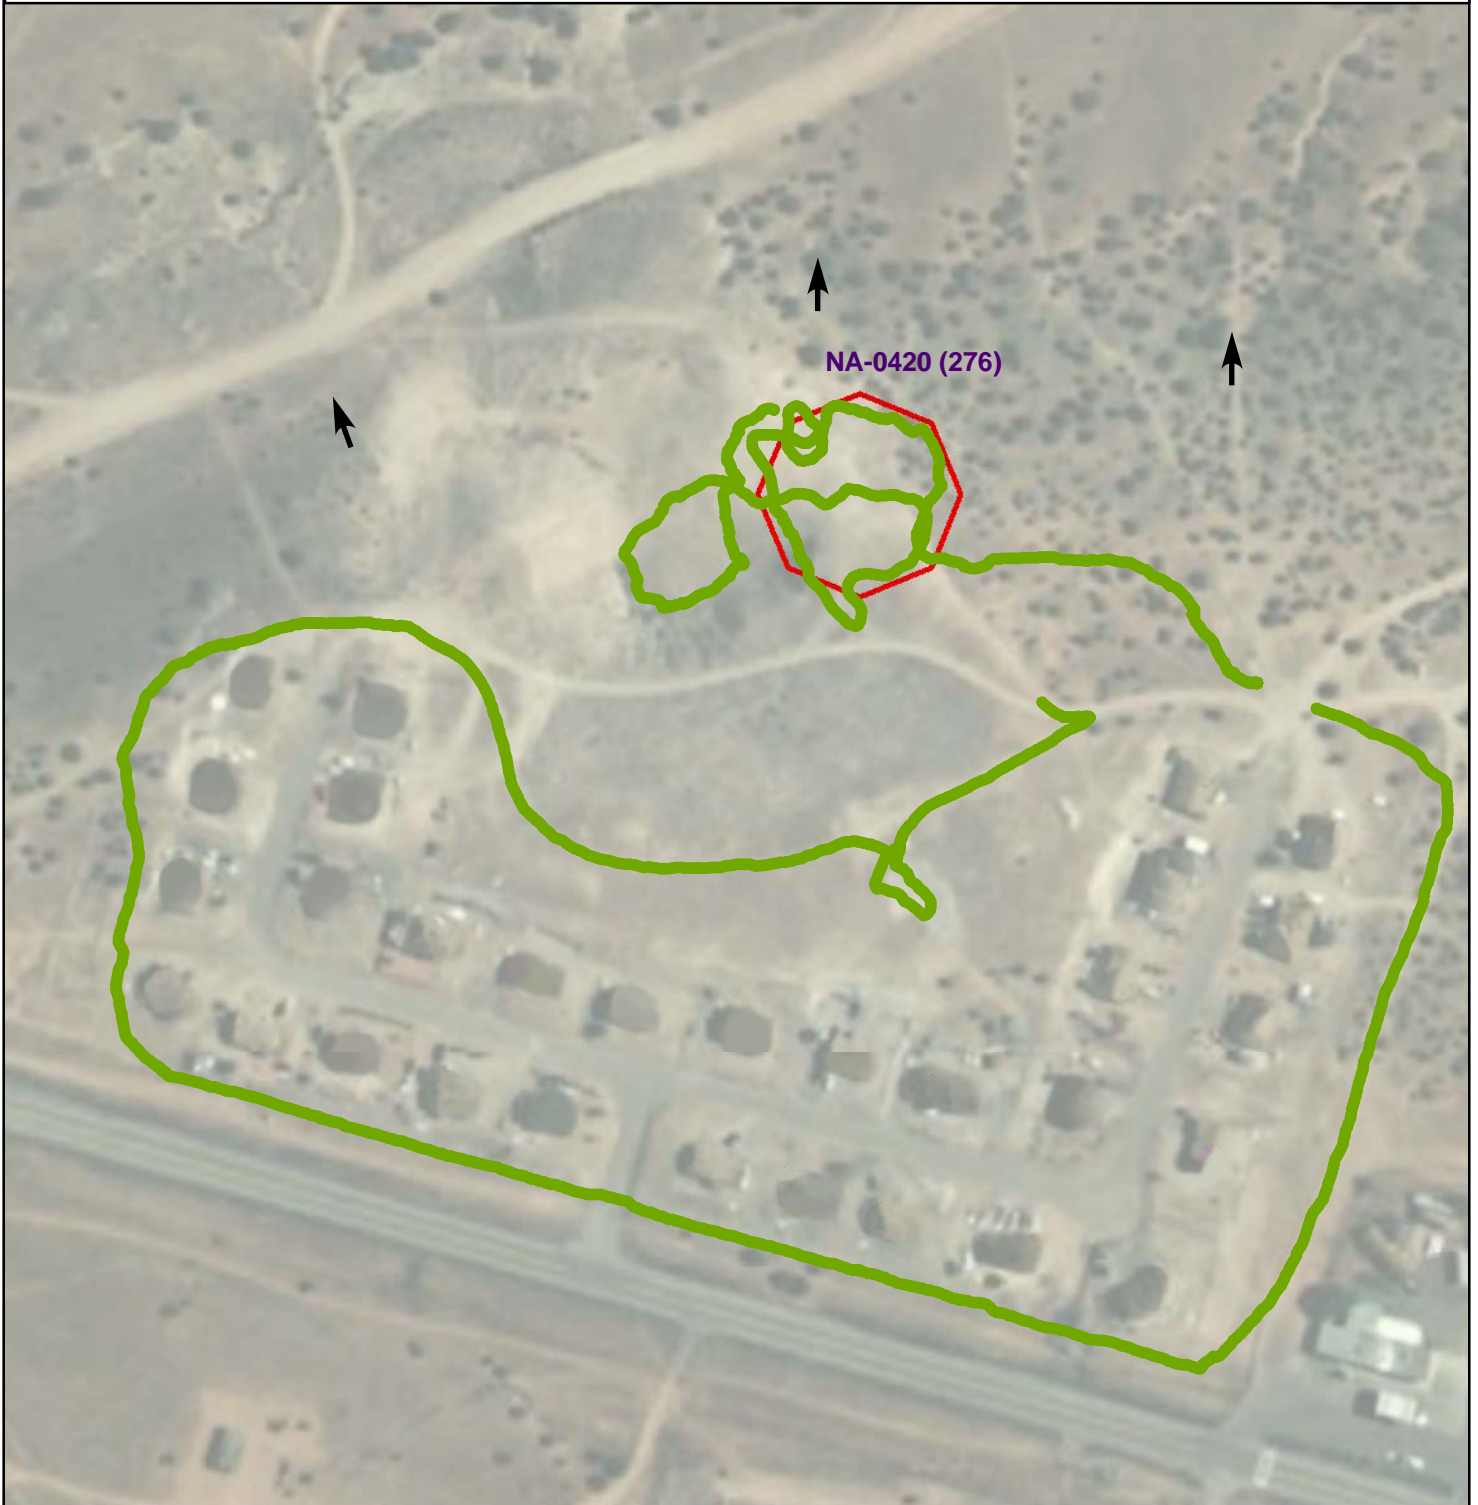
**Figure 1 - Gamma Radiation Measurements, Above Two Times Background
NA-0420 (276)
Beclabito Chapter, Navajo Nation**

A total of 758 gamma radiation measurements were collected from the mine site, ranging from 5,649 cpm to 10,202 cpm. The measurements are represented in Figures 1 and 2.

Gamma survey conducted 06/2010
Measured as counts per minute (cpm)

Average background = 6,948 cpm

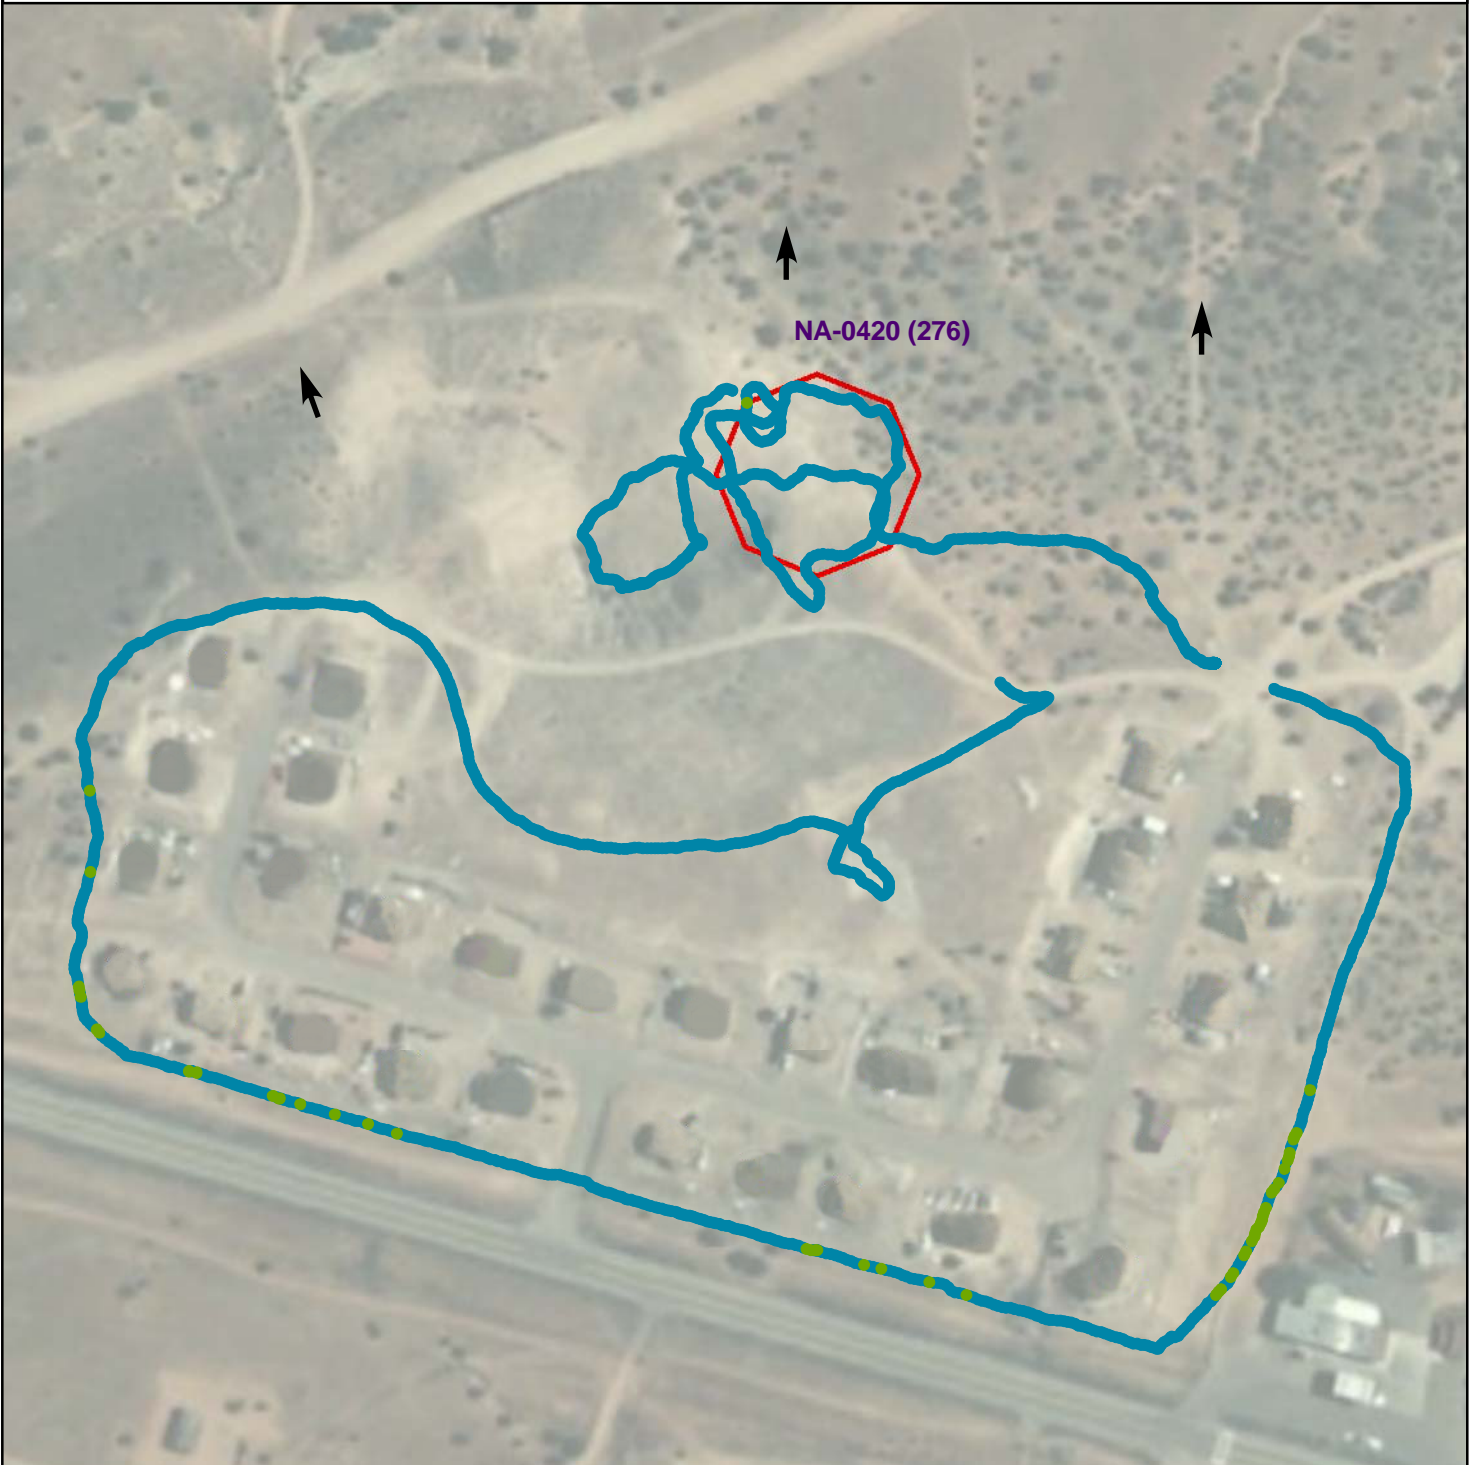
**Figure 2 - Gamma Radiation Measurements
NA-0420 (276)
Beclabito Chapter, Navajo Nation**

**Gamma survey conducted 06/2010
Measured as counts per minute (cpm)**

Average background 6,948 cpm
