Navajo Abandoned Uranium Mine

Site Screen Report

Captain Benally No. 4A AUM Site

August 2010

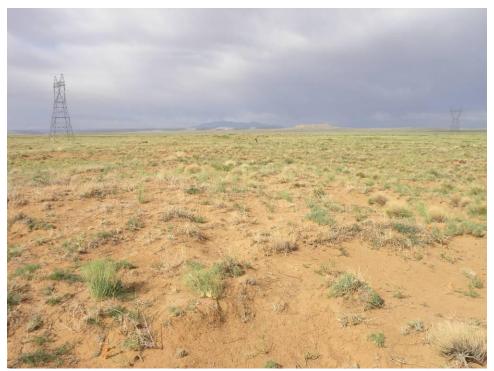
Photo 1. Captain Benally No. 4A site
