Navajo Abandoned Uranium Mine

Site Screen Report

Mine Name: Zhealy Tso, South Prospect
Mine ID: 297

August 2011

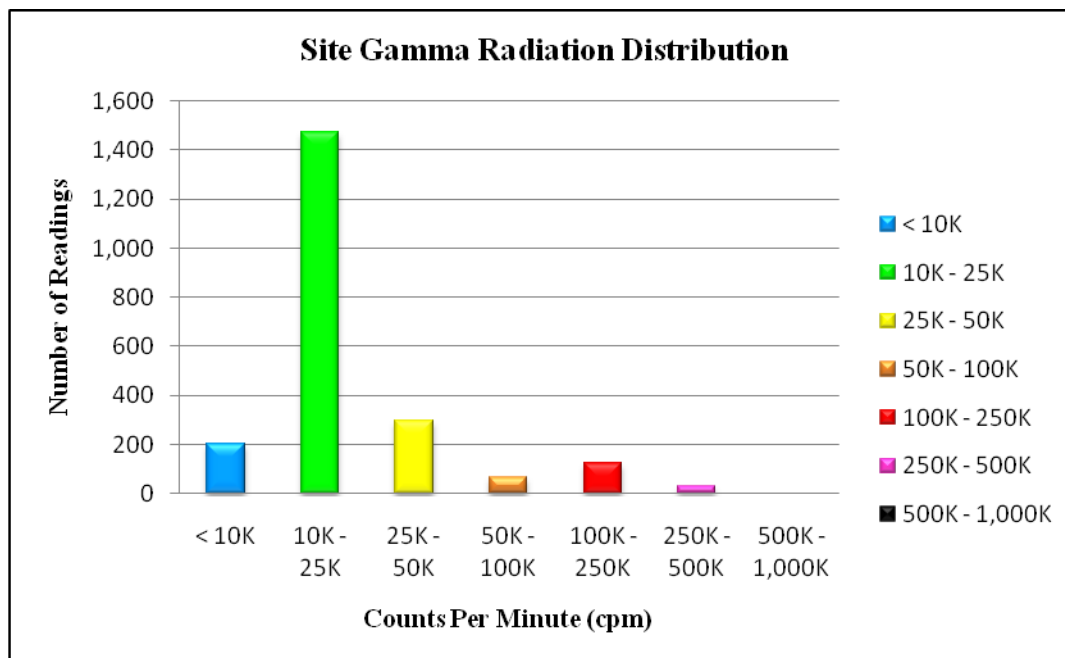
Distribution Chart and Statistics:

Site Gamma Radiation Statistics	
Number of Readings	2,190
Minimum (cpm)	6,814
Maximum (cpm)	408,475
Mean (cpm)	32,170
Median (cpm)	15,881
Standard Deviation	52,103

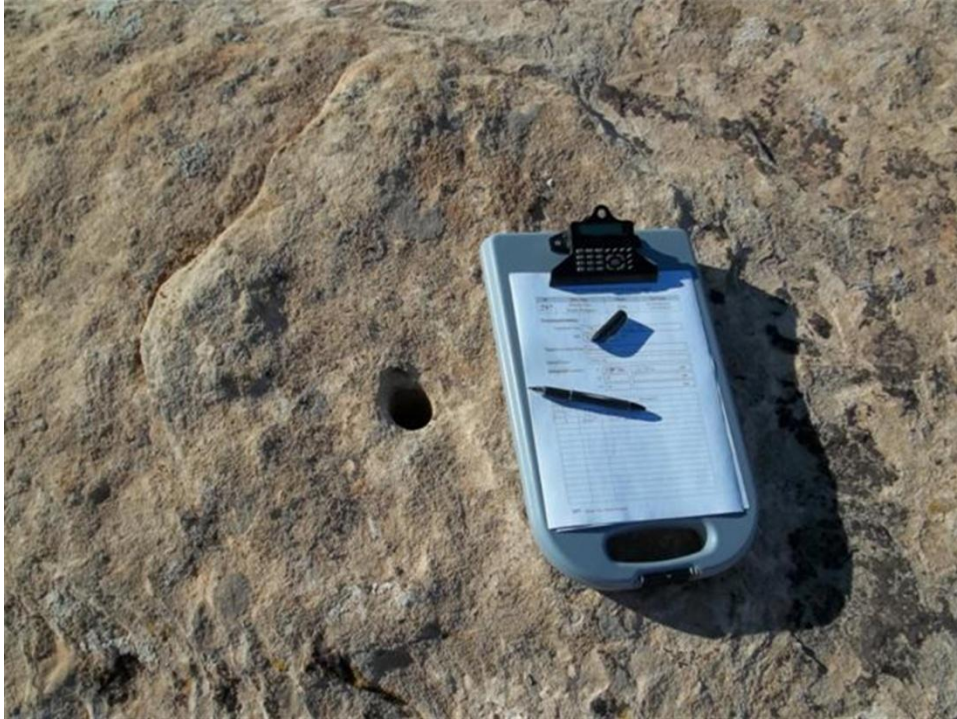
Photo 2: Mine Site #297; Test hole

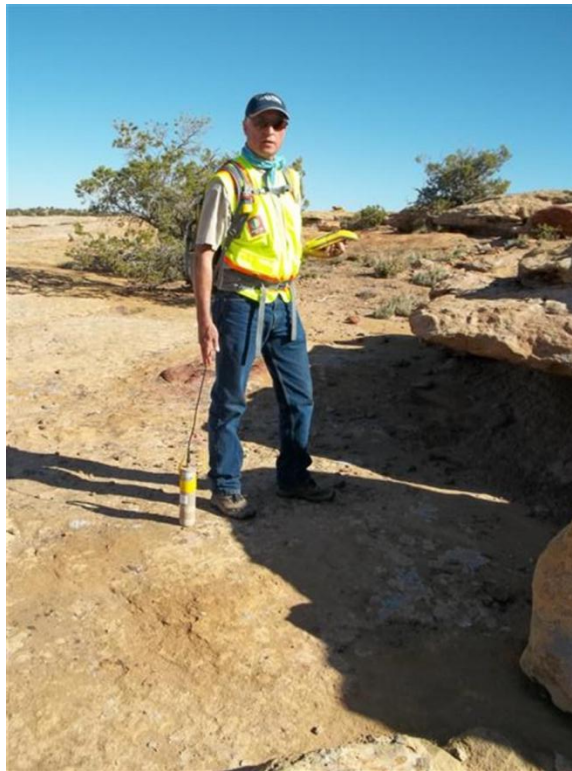
A total of 2,190 gamma radiation measurements were collected from the mine site, ranging from 6,814 cpm to 408,475 cpm. Measurements collected in the vicinity of the bedrock were found at a maximum level of approximately 400,000 cpm. The measurements are represented in Figures 1 and 2.

Photo 4: Mine Site #297; Bedrock with elevated readings

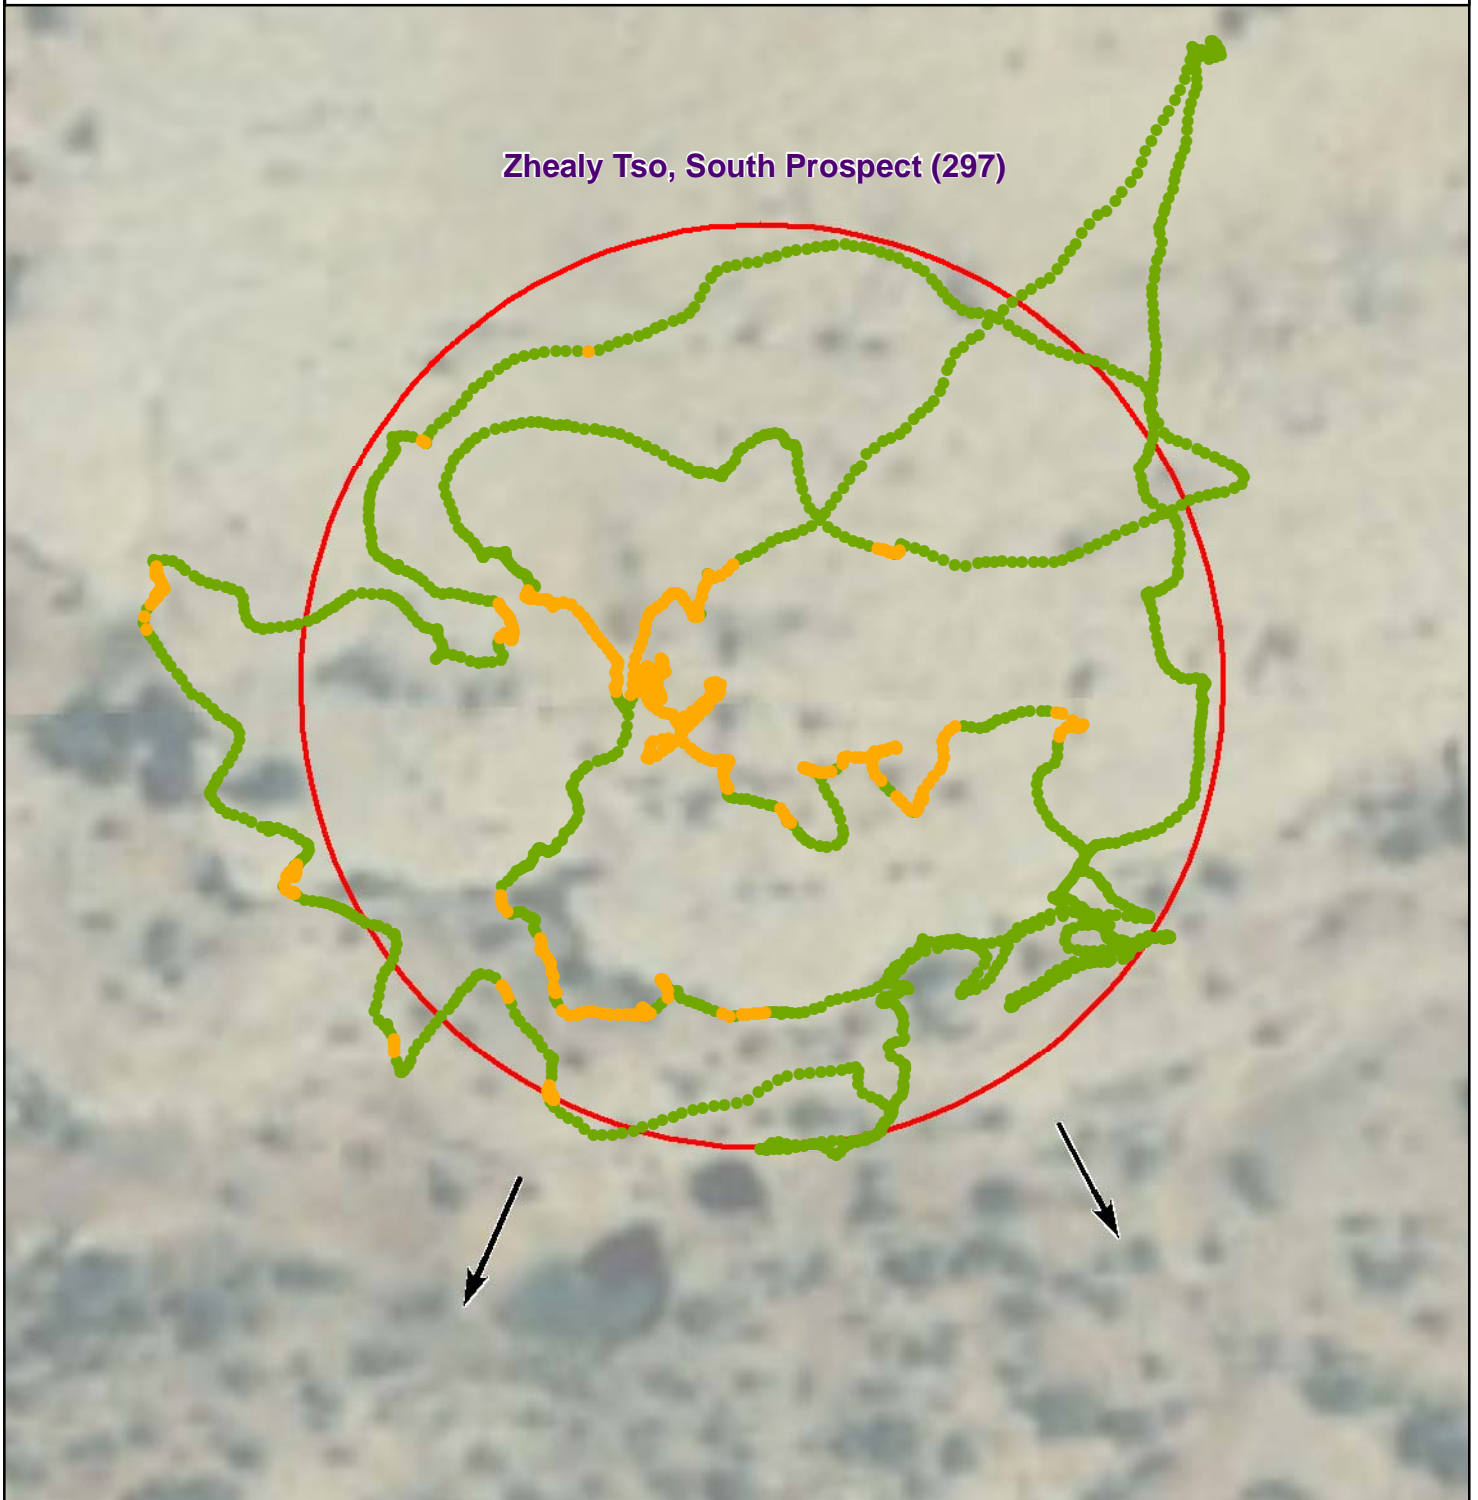
**Figure 1 - Gamma Radiation Measurements, Above Two Times Background
Zhealy Tso, South Prospect (297)
Chinle Chapter, Navajo Nation**

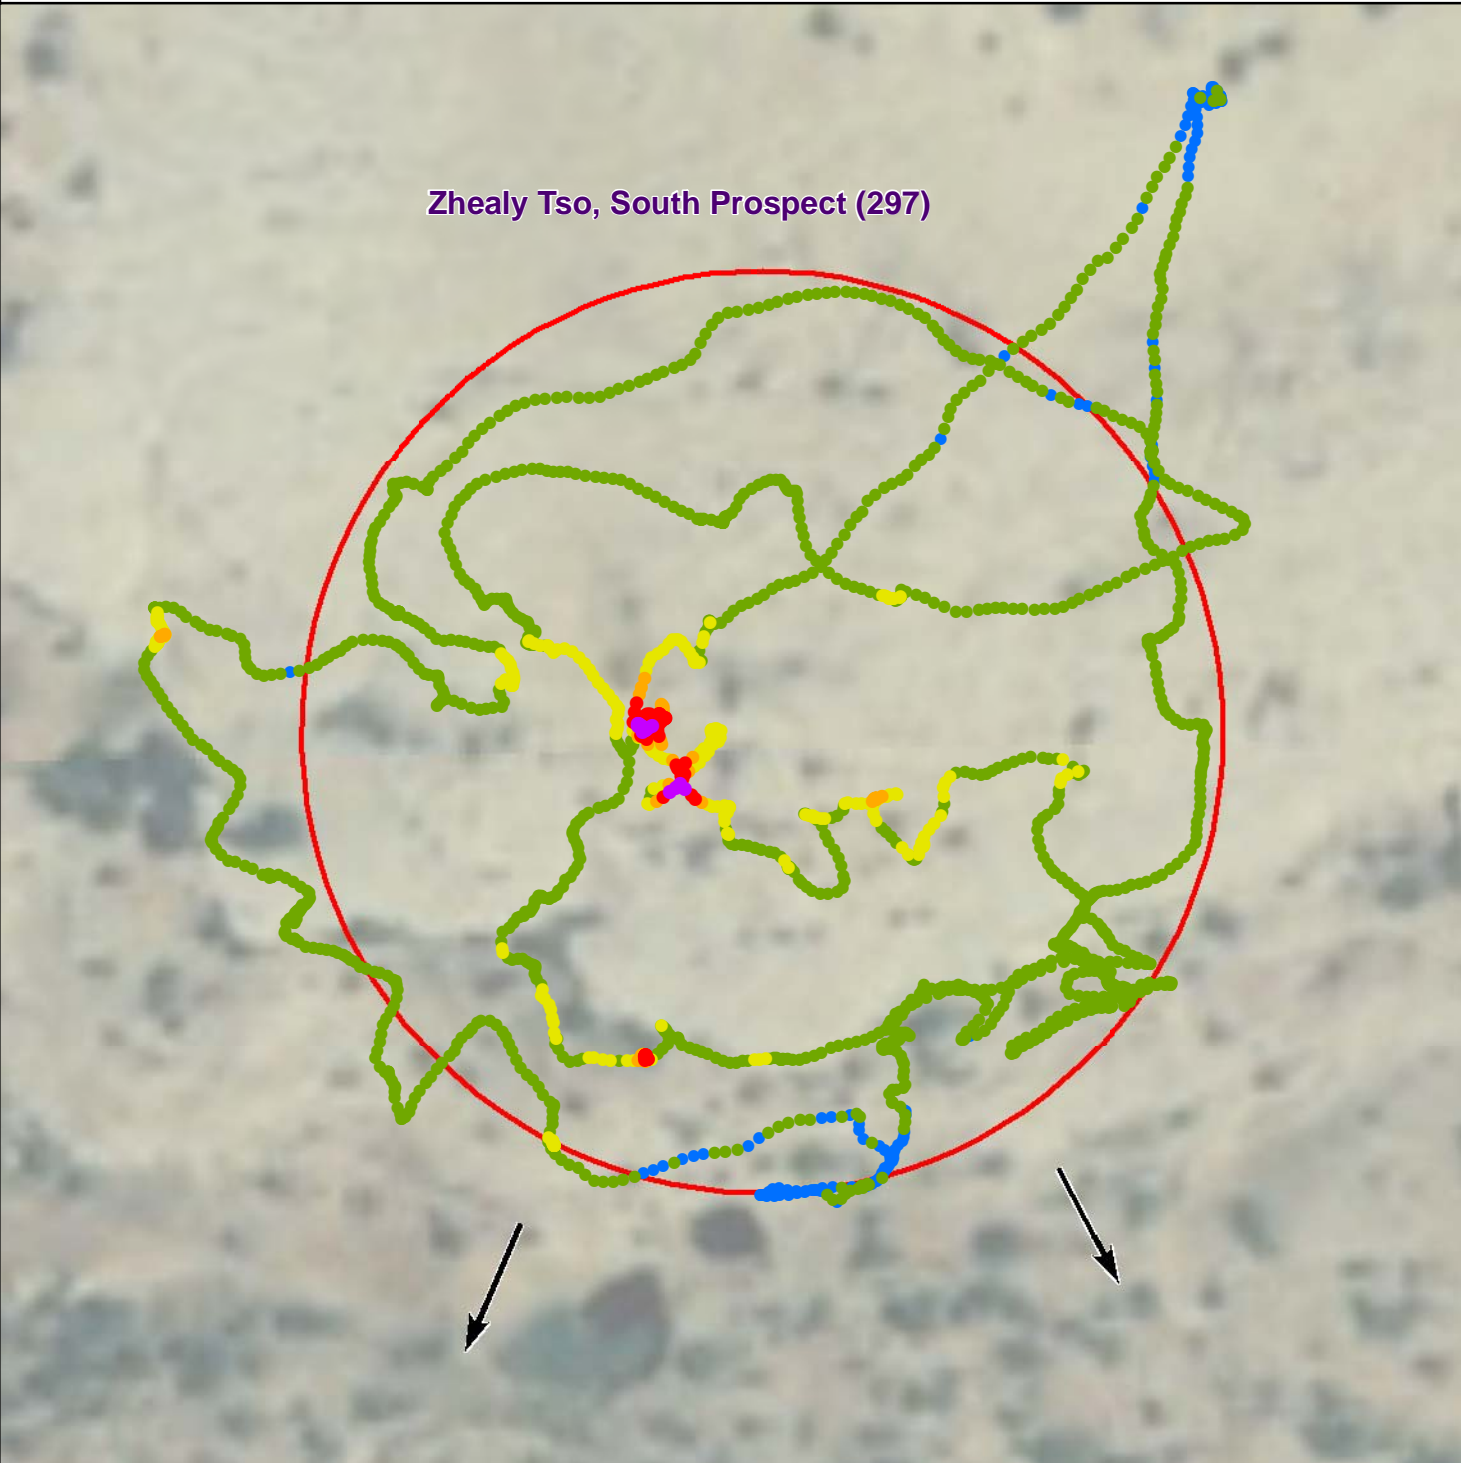
**Figure 2 - Gamma Radiation Measurements
Zhealy Tso, South Prospect (297)
Chinle Chapter, Navajo Nation**
