# Navajo Abandoned Uranium Mine

## Site Screen Report

**Mine Name: Tract 15**  
**Mine ID: 397**

**April 2012**

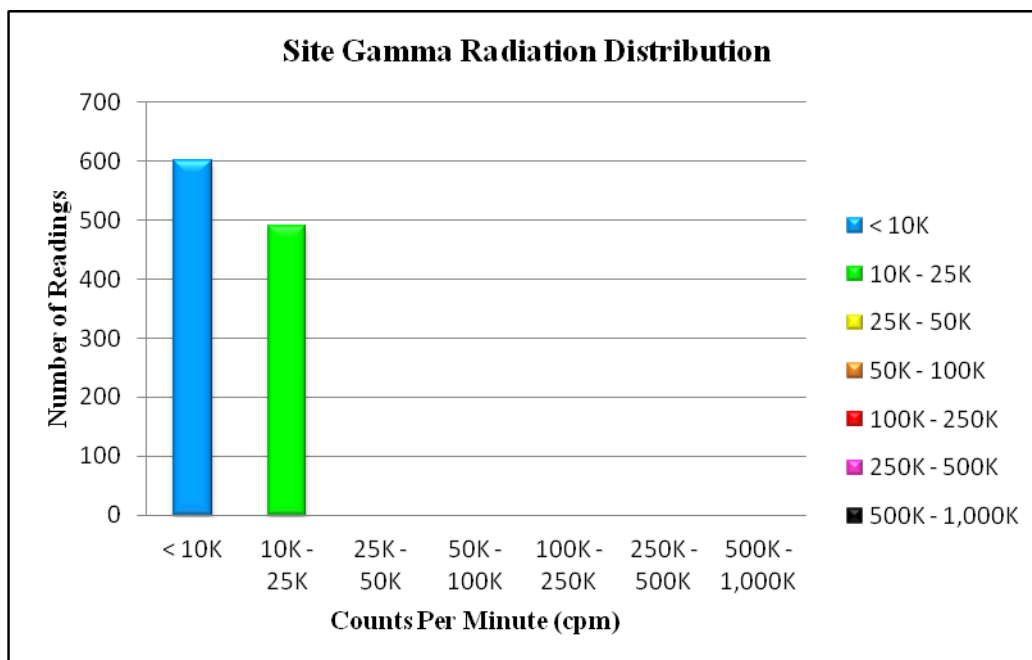
**Distribution Chart and Statistics:**

<b>Site Gamma Radiation Statistics</b>	
Number of Readings	1,091
Minimum (cpm)	7,091
Maximum (cpm)	13,836
Mean (cpm)	9,941
Median (cpm)	9,857
Standard Deviation	1,098

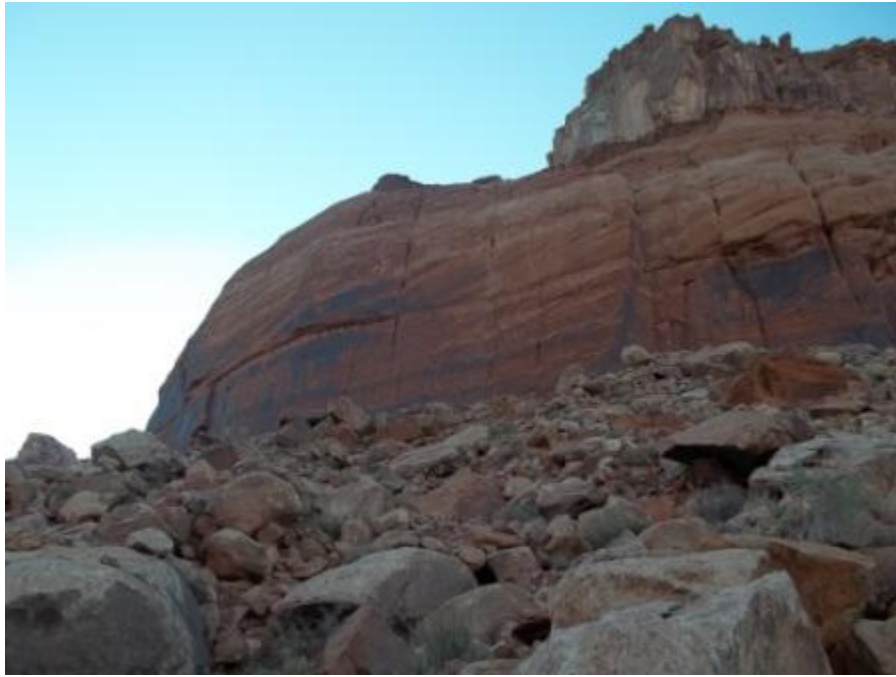
**Photo 1**

Mine Site #397 – From below

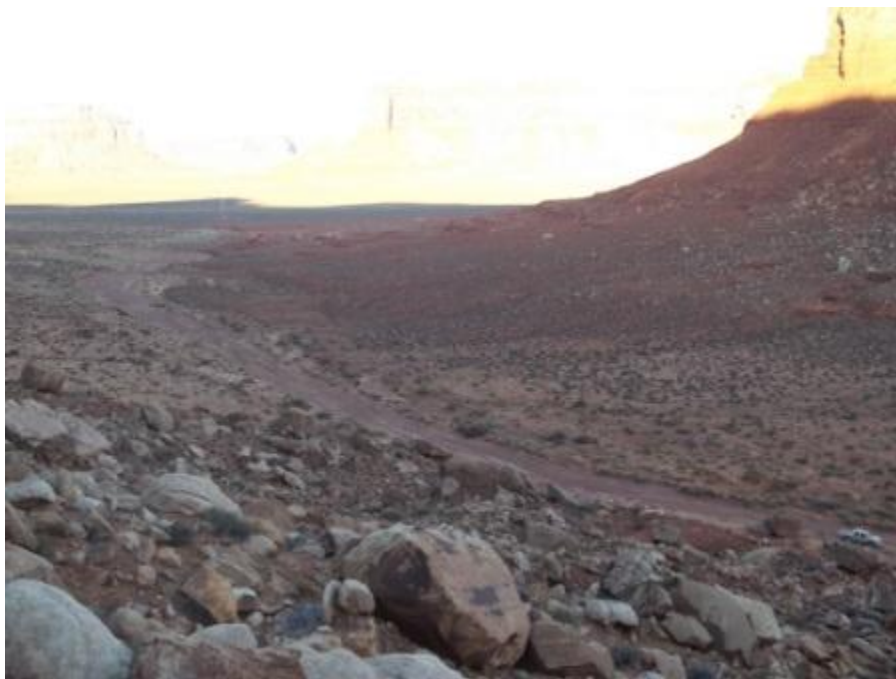
**Photo 2**

Mine Site #397

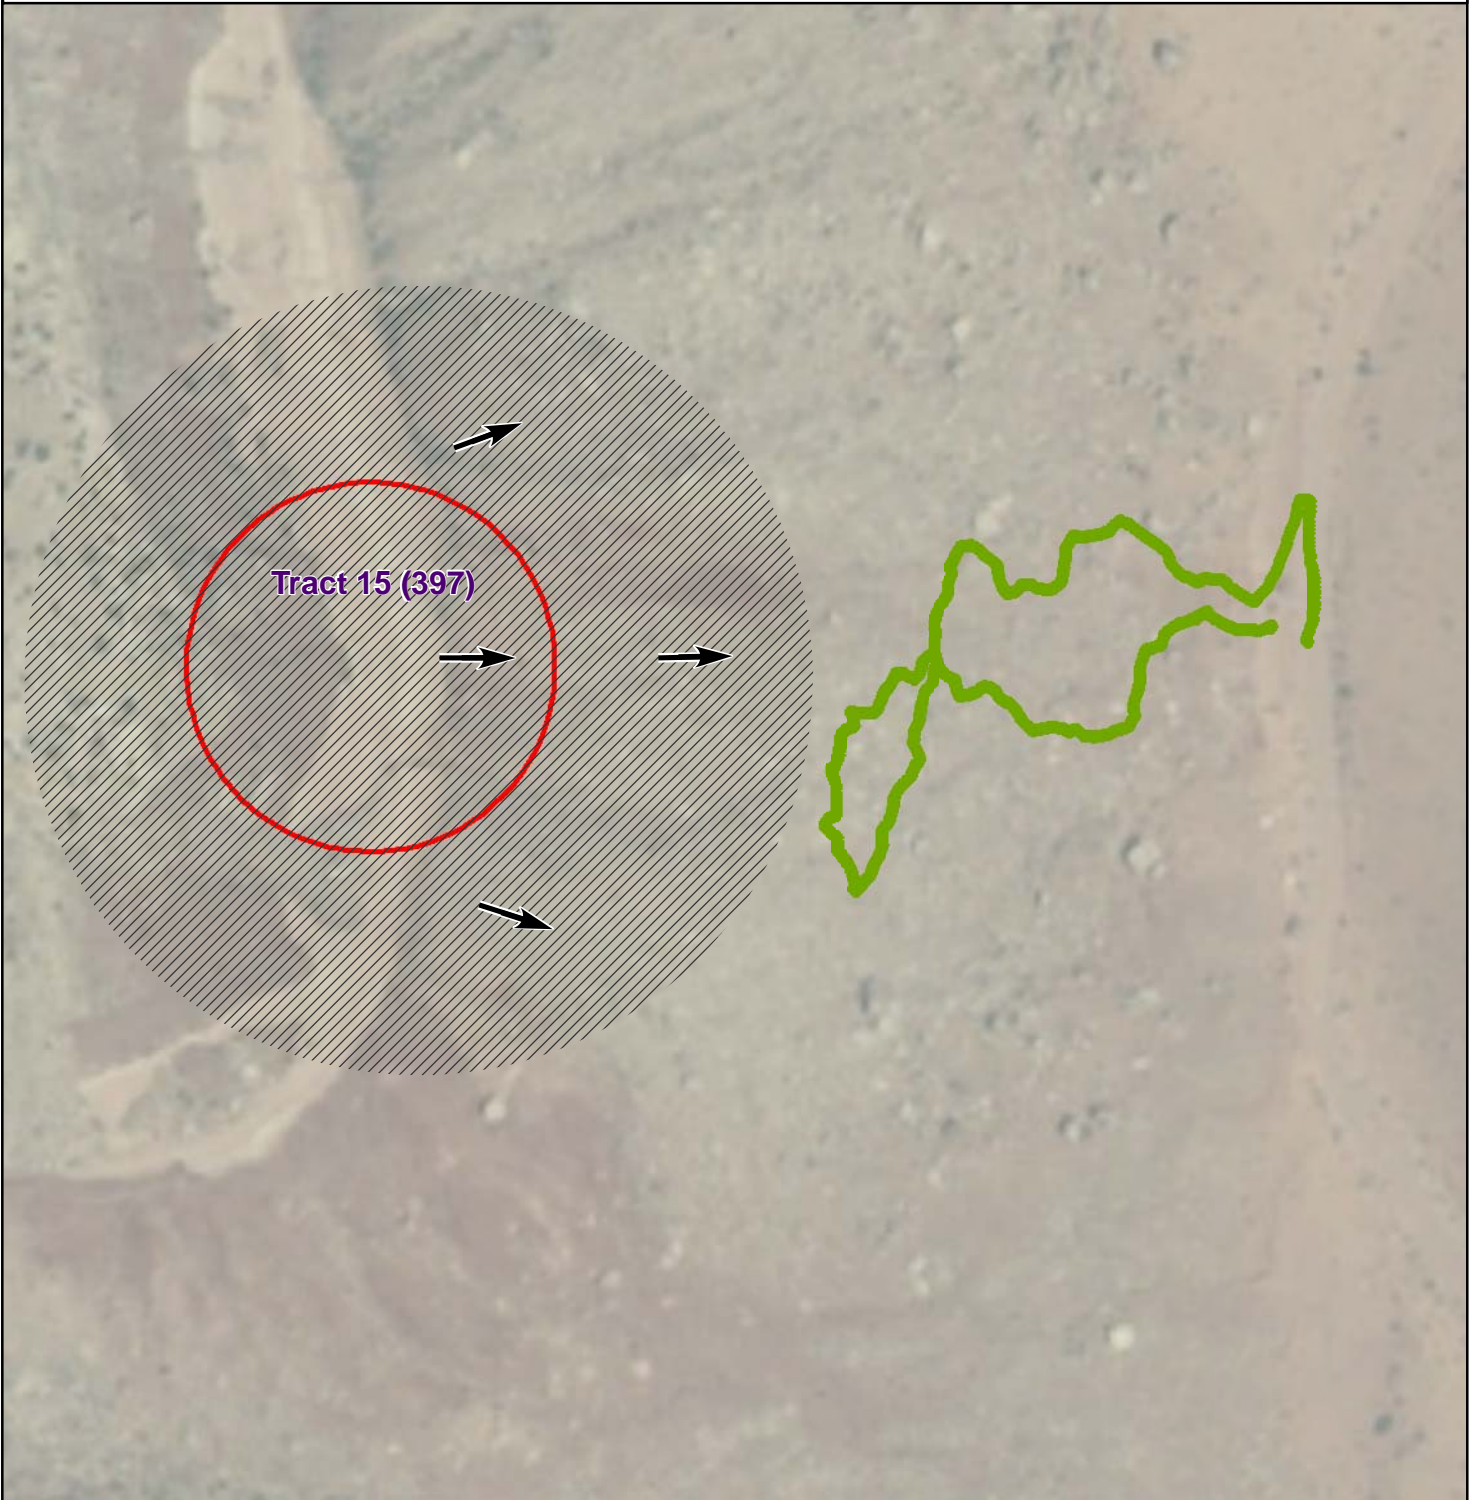
**Figure 1 - Gamma Radiation Measurements, Above Two Times Background  
Tract 15 (397)  
Shonto/Oljato Chapter, Navajo Nation**

Measured as counts per minute (cpm)

Average background 8,744 cpm

A total of 1,091 gamma radiation measurements were collected from the mine site, ranging from 7,091 cpm to 13,836 cpm. Weston was unable to access the site, but gamma radiation measurement were collected in the vicinity of the site. The measurements are represented in Figures 1 and 2.

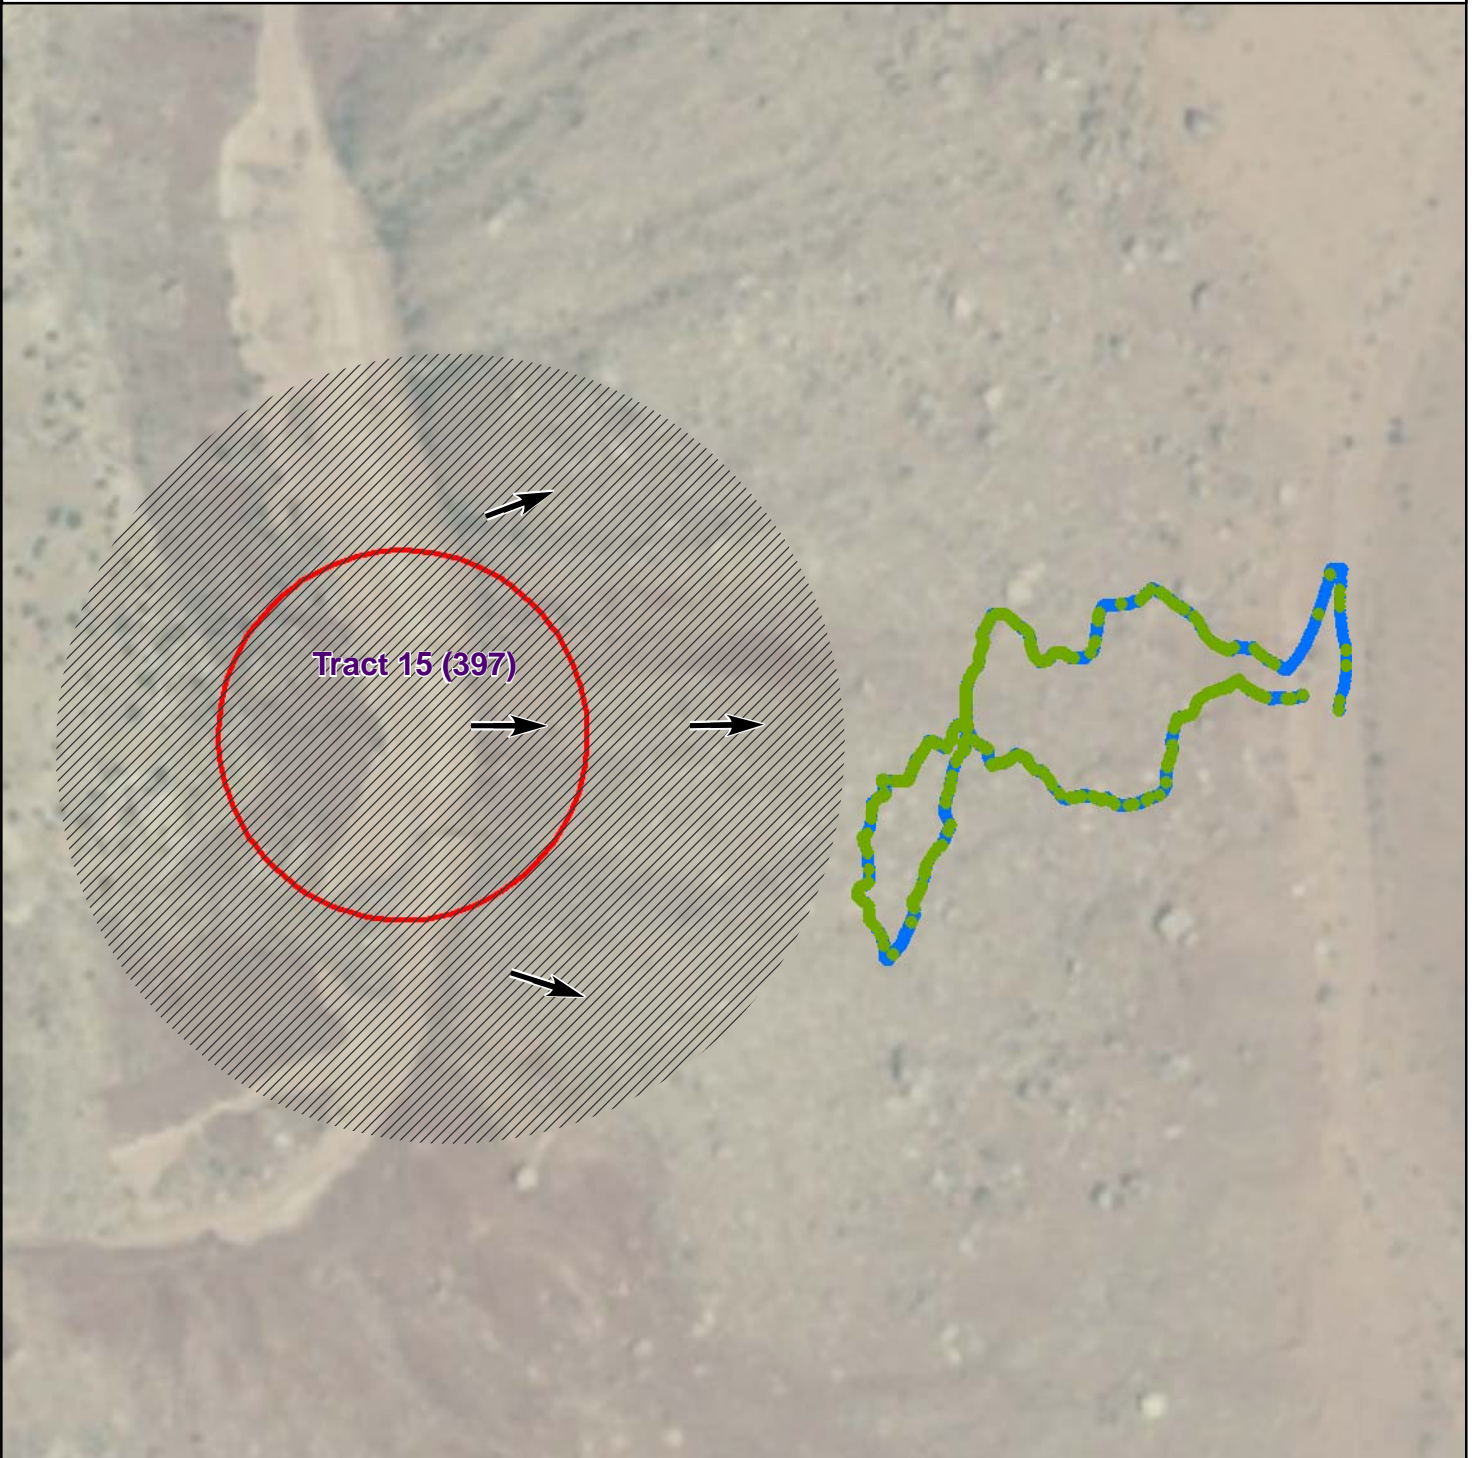
**Figure 2 - Gamma Radiation Measurements  
Tract 15 (397)  
Shonto/Oljato Chapter, Navajo Nation**

**Average background 8,744 cpm**

**Measured as counts per minute (cpm)**
