Navajo Abandoned Uranium Mine

Site Screen Report

Mesa IV, East Side AUM Site

March 2010

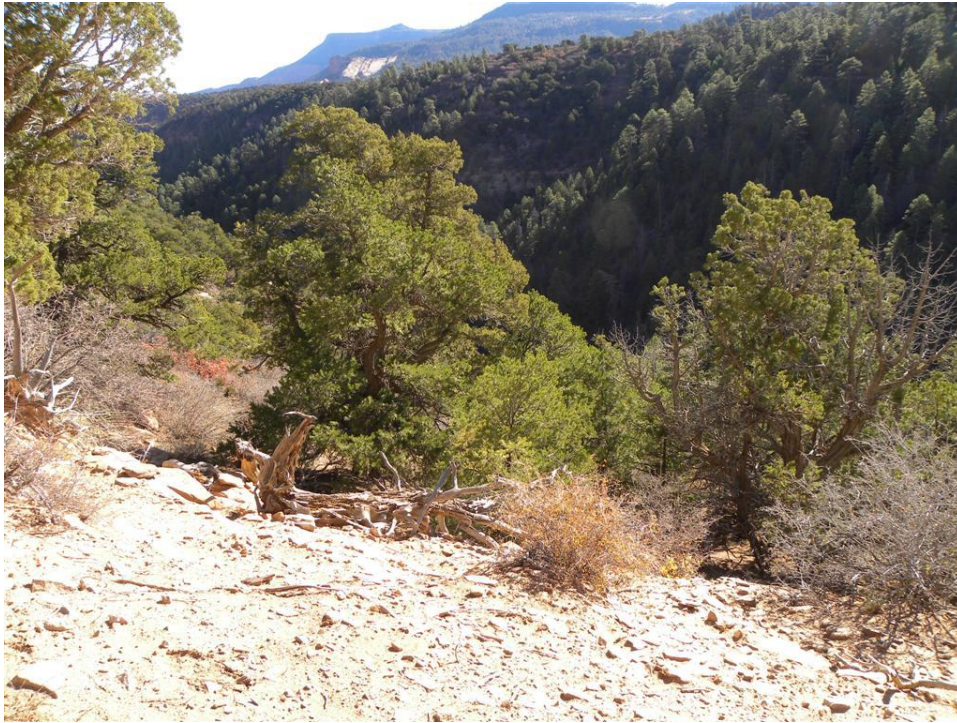
Photo 1. Mine site

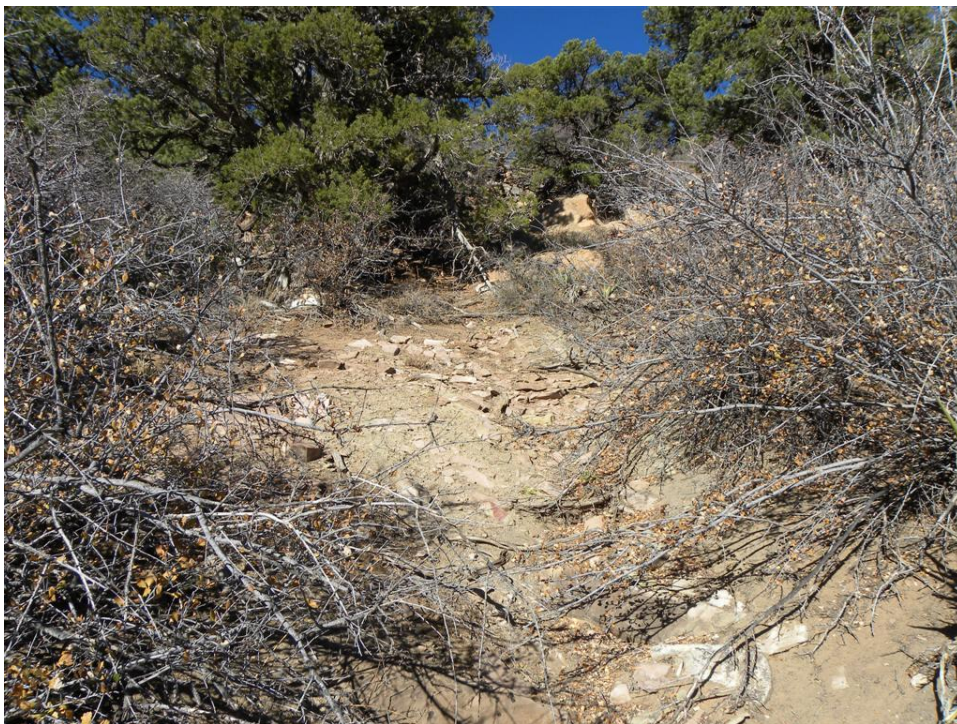
Photo 2. Mine site up slope

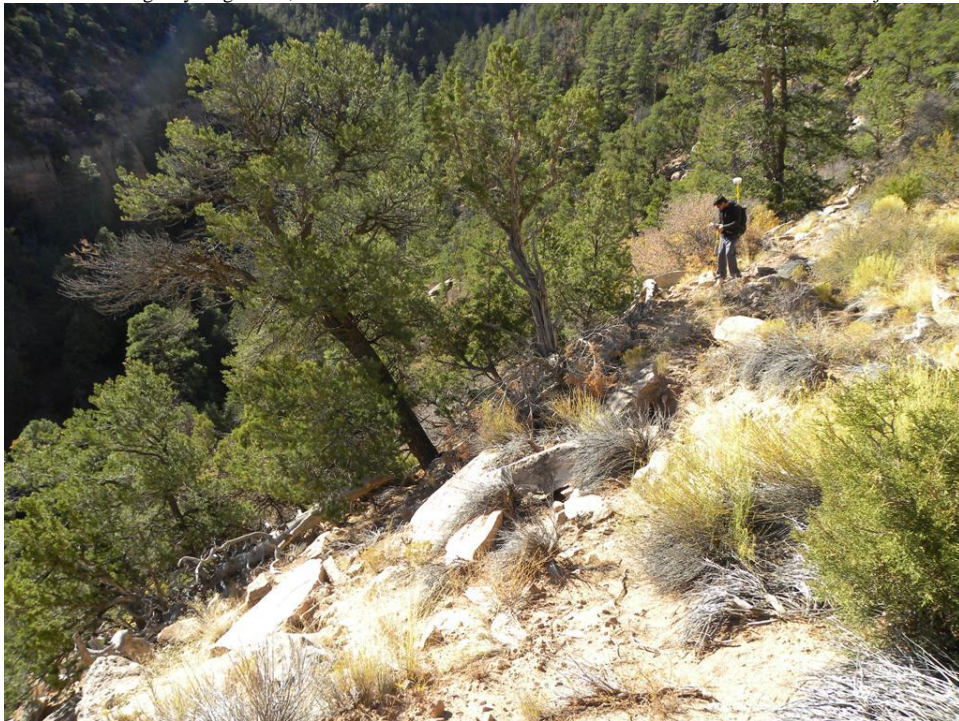
Photo 3. Mine site down slope
