# Navajo Abandoned Uranium Mine

## Site Screen Report

### Cato No. 1 Pit AUM Site

**March 2010**

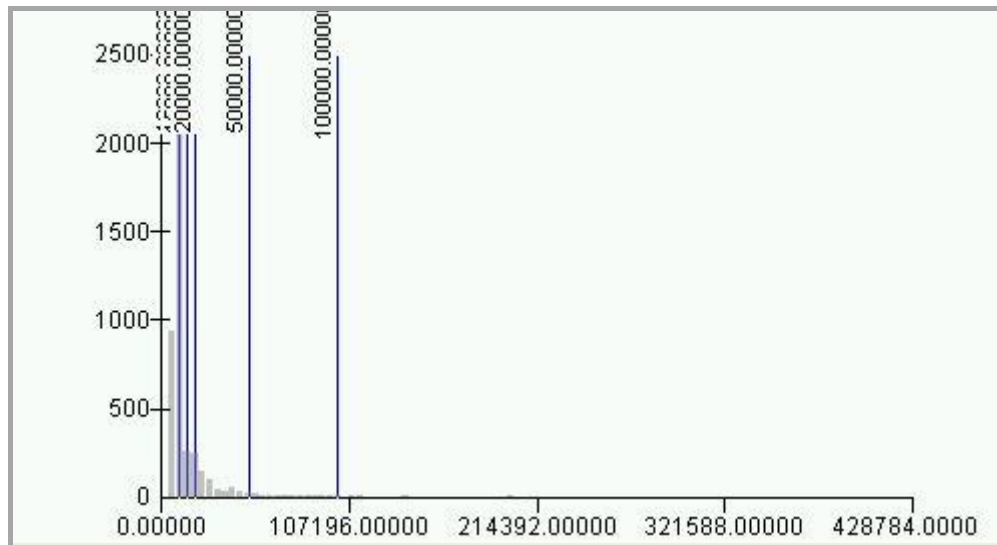
The following chart and statistics were generated by ESRI ArcGIS 9.3.1, and show the general distribution of the site gamma radiation measurements. The horizontal X axis represents the gamma radiation reading levels in cpm (lowest levels to the left). The vertical Y axis represents the frequency of each gamma radiation level.

Count:	4248
Minimum:	0.00000
Maximum:	428784.00000
Sum:	90023411.00000
Mean:	21191.95174
Median:	9934.00000
Standard Deviation:	39850.16593

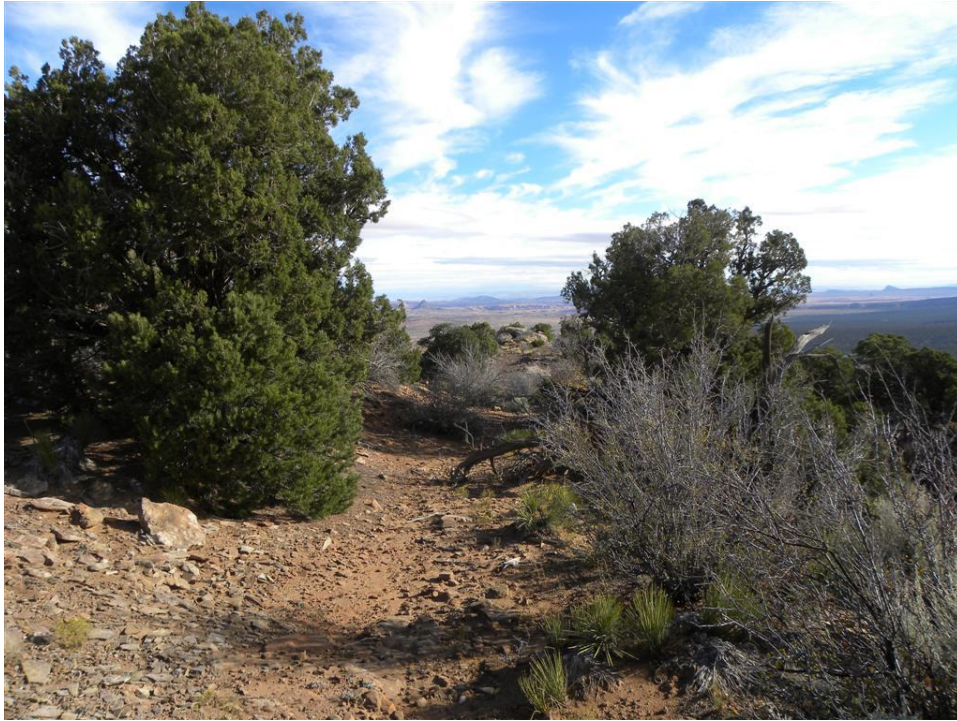
Photo 1. Mine site

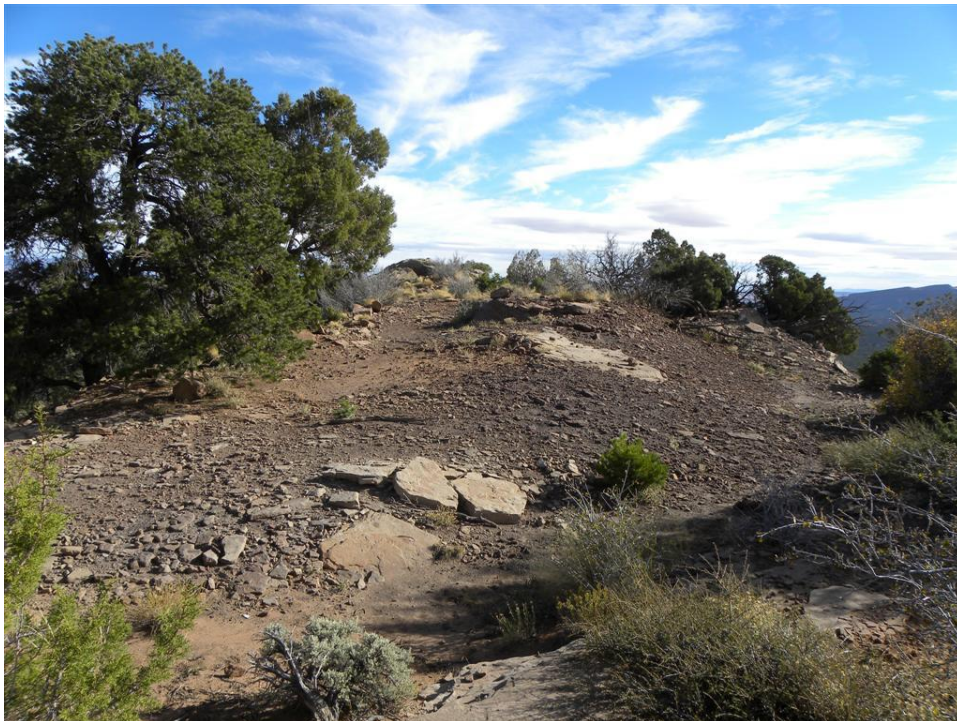
Photo 2. Waste rock

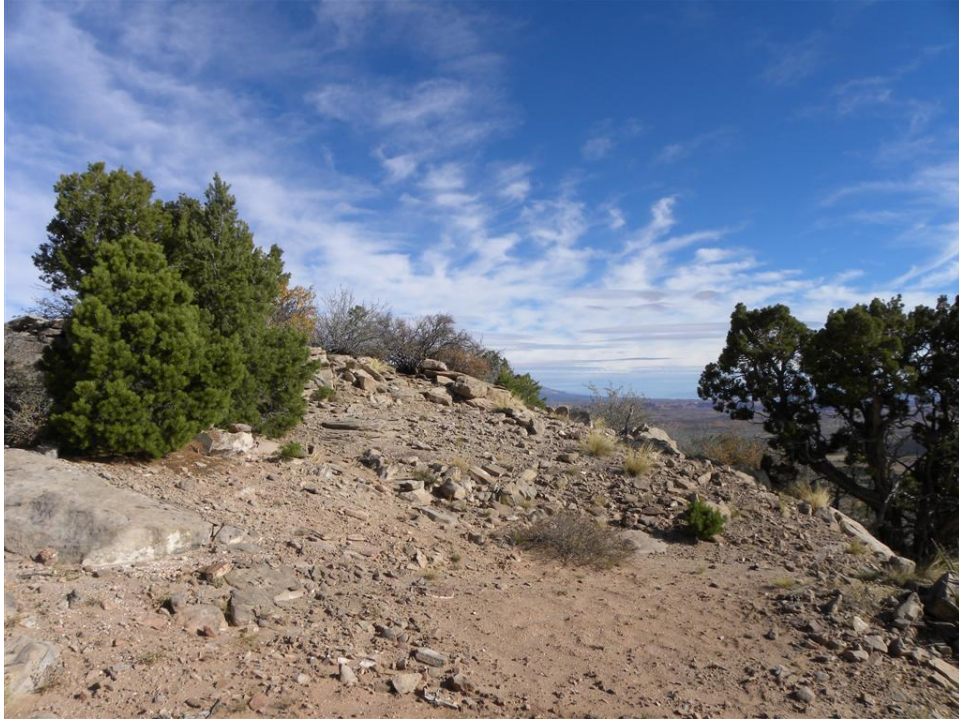
30' x 30' debris pile; 60' x 40' debris pile; 25' x 15' debris pile, with a total estimated volume of 680 yd<sup>3</sup>

Photo 3. Waste pile

3 unreclaimed waste piles

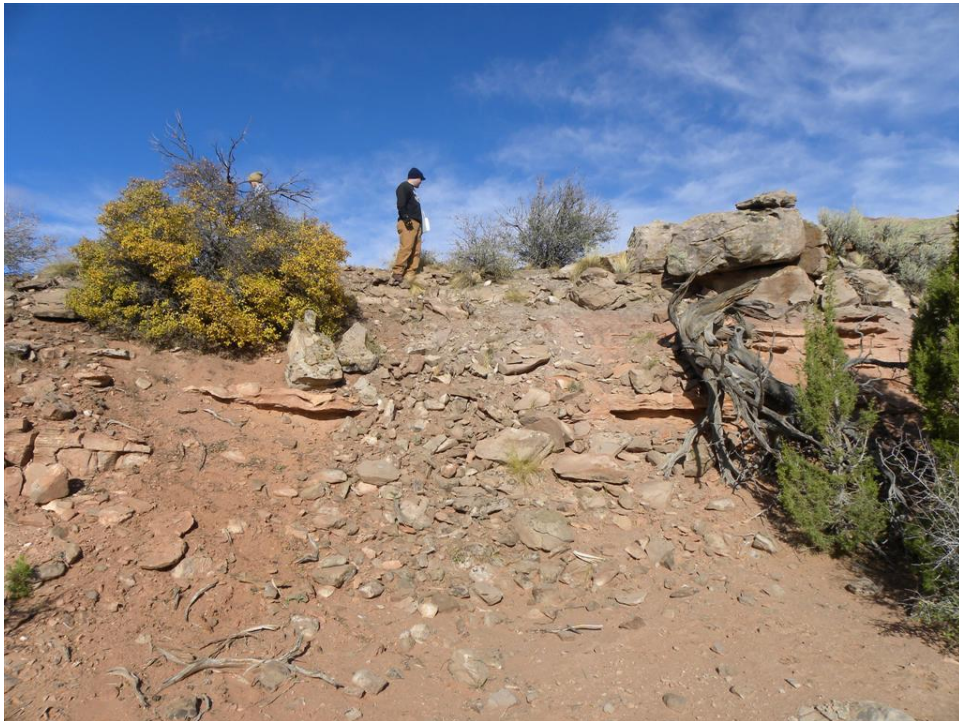
Photo 4. Waste pile

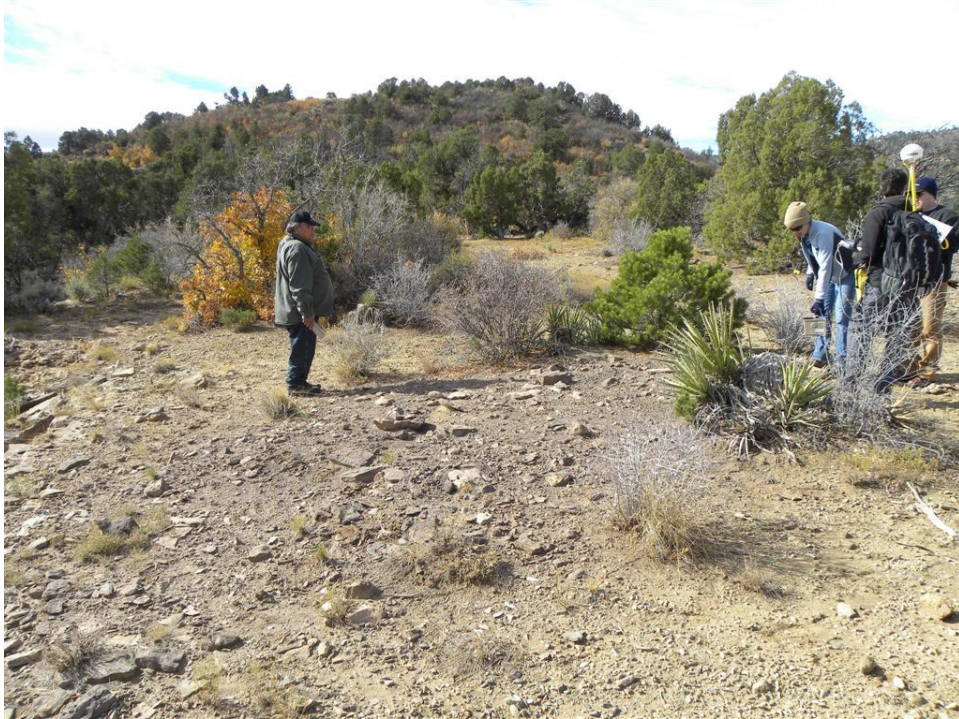
A cleared/burned area southwest of the site boundary had elevated gamma radiation measurements

Photo 5. Cleared area southwest of site with elevated radiation measurements

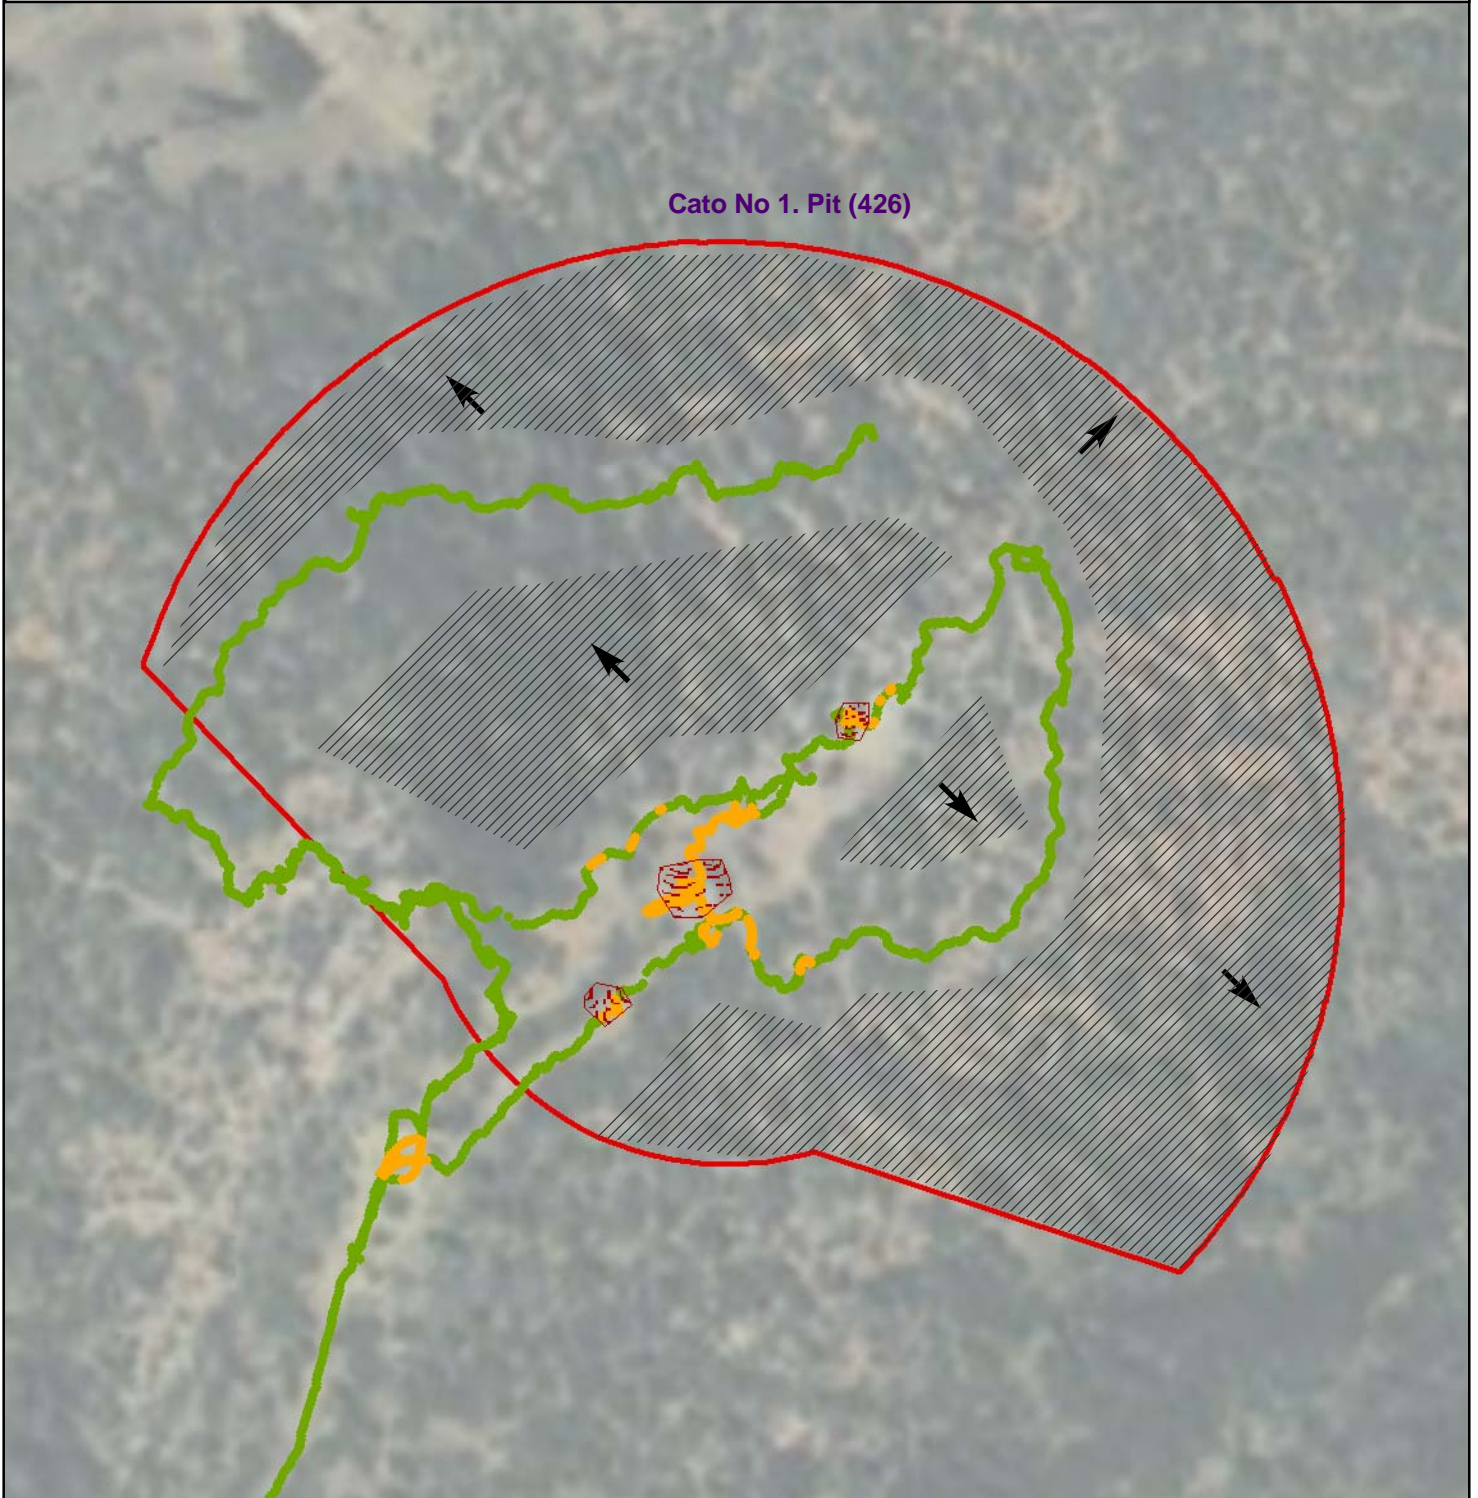
A total of 4,247 gamma radiation measurements were collected from the mine site, ranging from 5,361 cpm to 428,784 cpm. Measurements collected in the vicinity of the waste debris had maximum readings ranging from 140,000 cpm to 400,000 cpm. Elevated readings above 100,000 cpm were also found in a cleared area southwest of the site. The measurements are represented in Figures 1 and 2.

**Figure 1 - Gamma Radiation Measurements, Above Two Times Background  
Cato No. 1 Pit (426)  
Cove Chapter, Navajo Nation, Arizona**

Gamma survey conducted 10/2009  
Measured as counts per minute (cpm)

Average background = 14,086 cpm

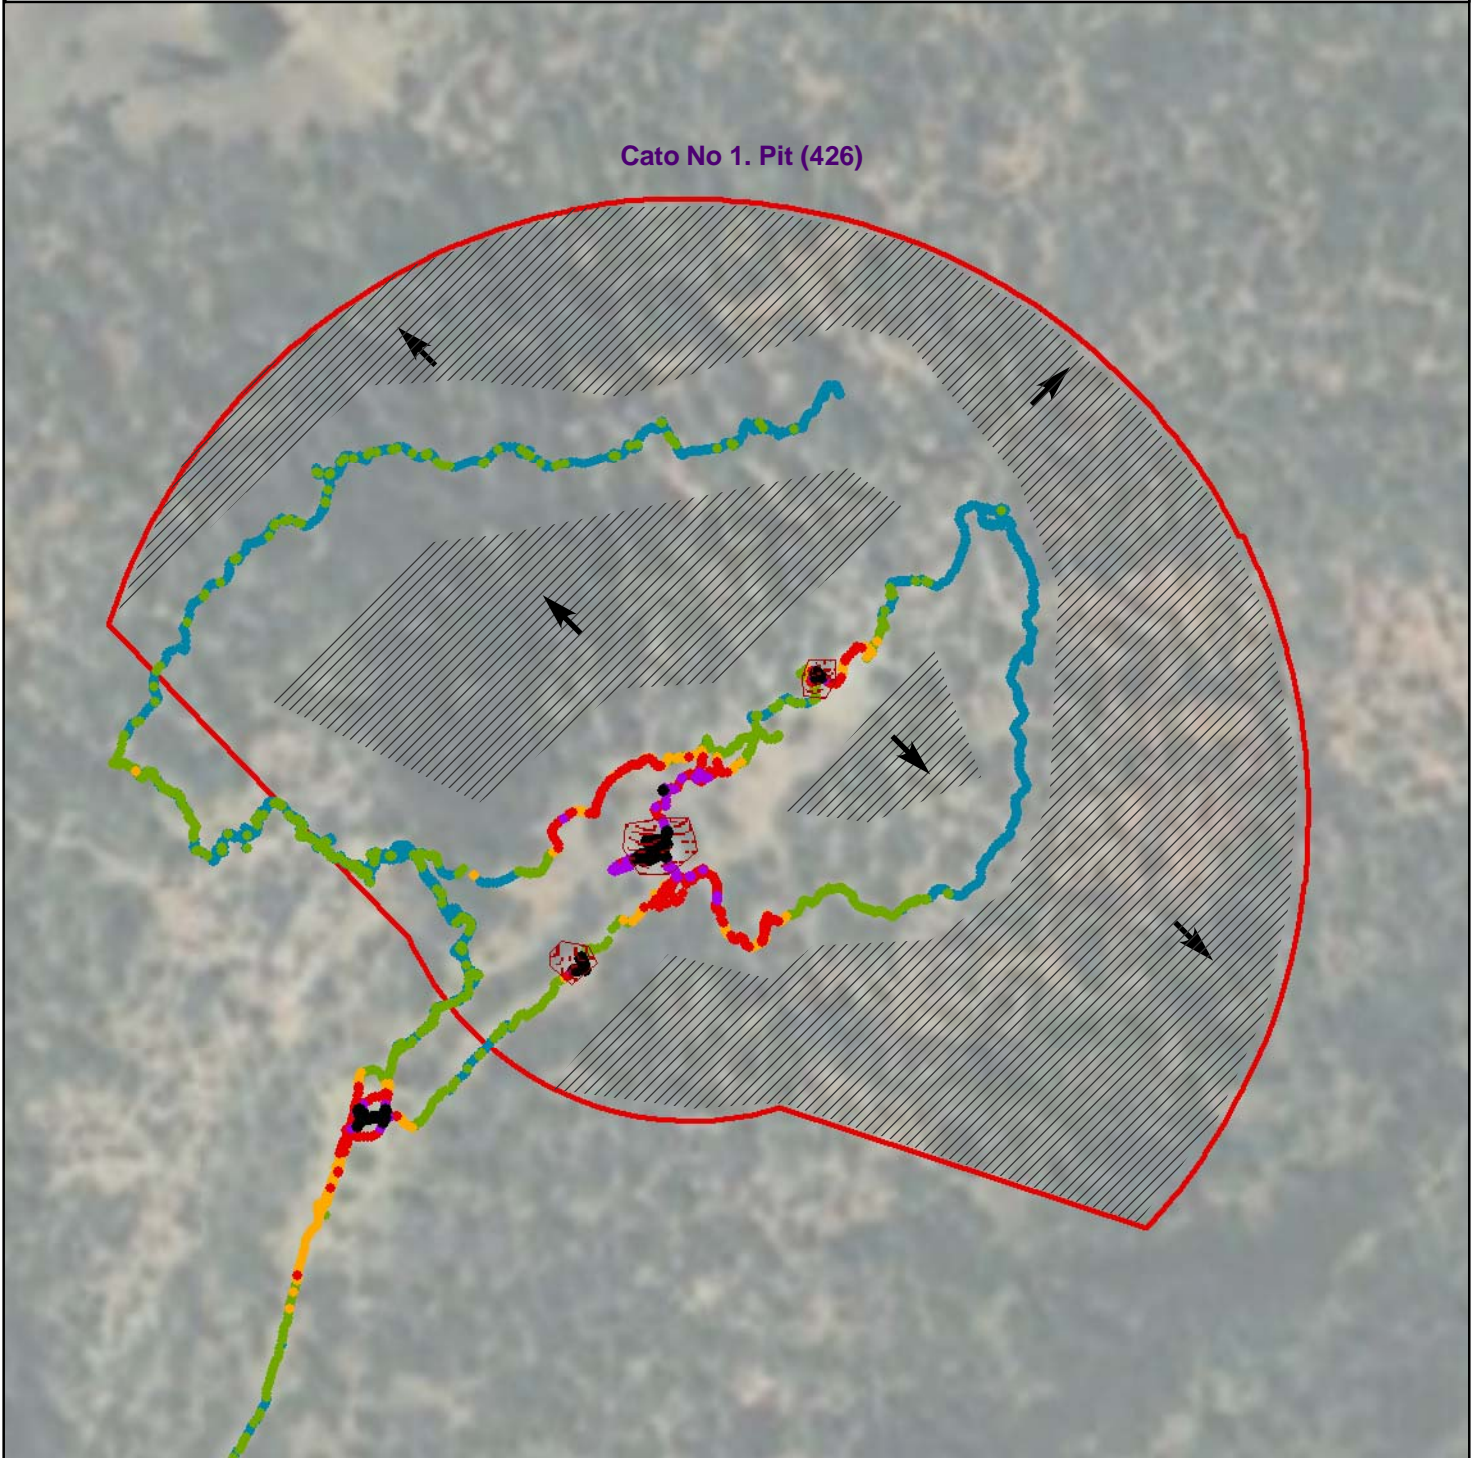
**Figure 2 - Gamma Radiation Measurements  
Cato No. 1 Pit (426)  
Cove Chapter, Navajo Nation, Arizona**

**Gamma survey conducted 10/2009  
Measured as counts per minute (cpm)**

**Average background = 14,086 cpm**
