# **Navajo Abandoned Uranium Mine**

## **Site Screen Report**

### **John Lee Benally AUM Site**

#### **Navajo AUM Northern Region**

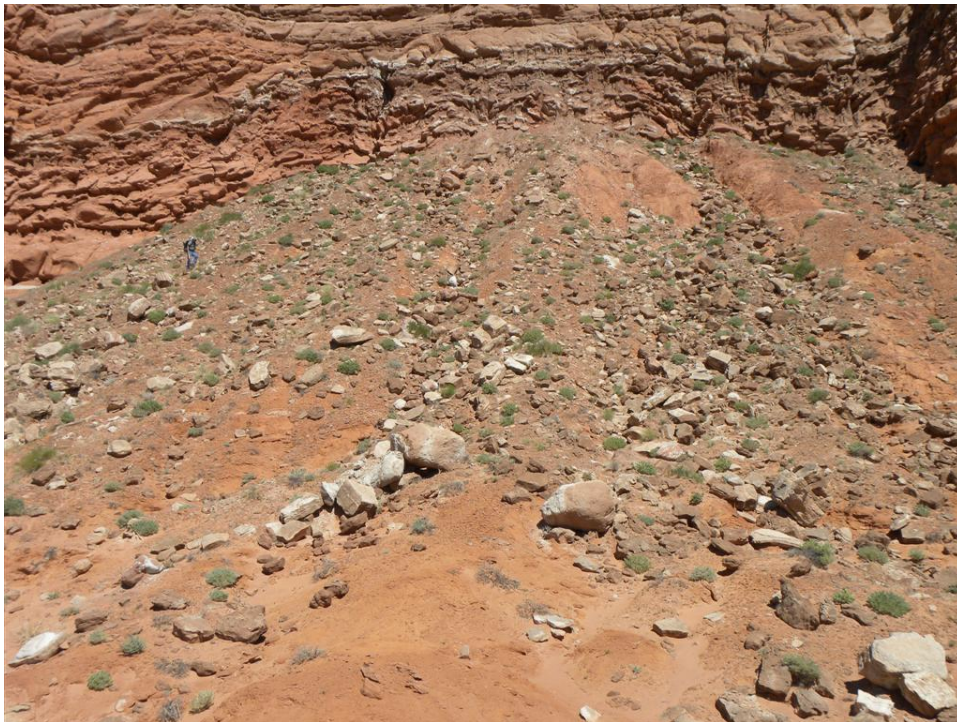
2 large slide areas (could be natural) 200' x 75' x 5' each

Photo 2. John Lee Benally site, possible waste rock

Possible unreclaimed waste rock

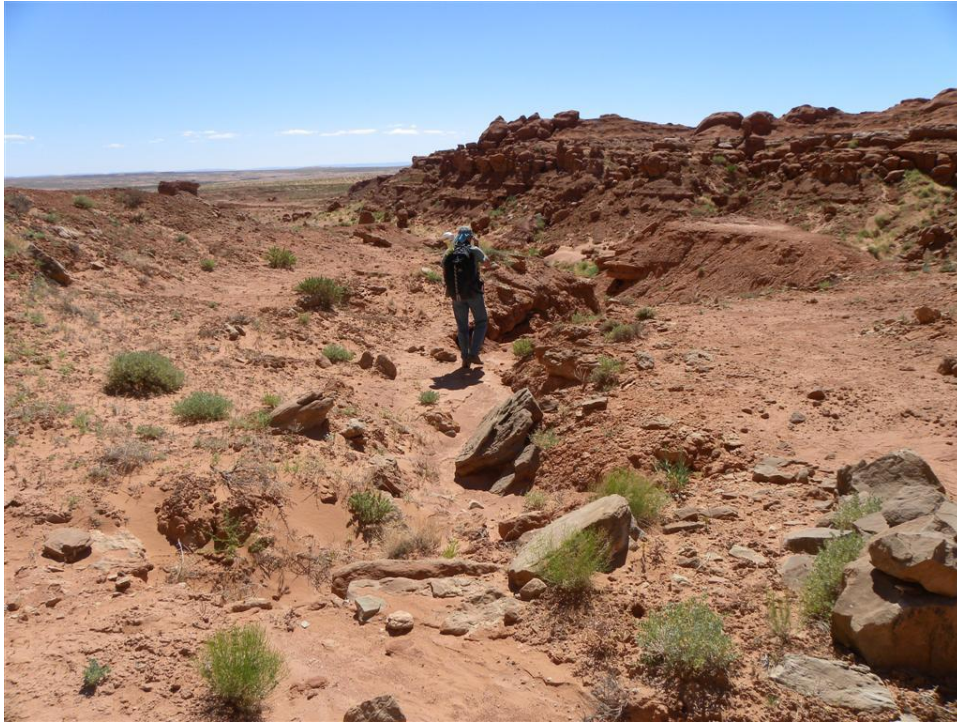
A total of 1,598 gamma radiation measurements were collected from the mine site, ranging from 6,490 cpm to 61,474 cpm. Measurements collected in the vicinity of the waste debris slide area were found at levels up to approximately 60,000 cpm, and in the drainage below the slide at levels up to approximately 15,000 cpm. The measurements are represented in Figures 1 and 2.

Photo 3. John Lee Benally site, drainage
