Navajo Abandoned Uranium Mine

Site Screen Report

Key and Tohe AUM Site

March 2010

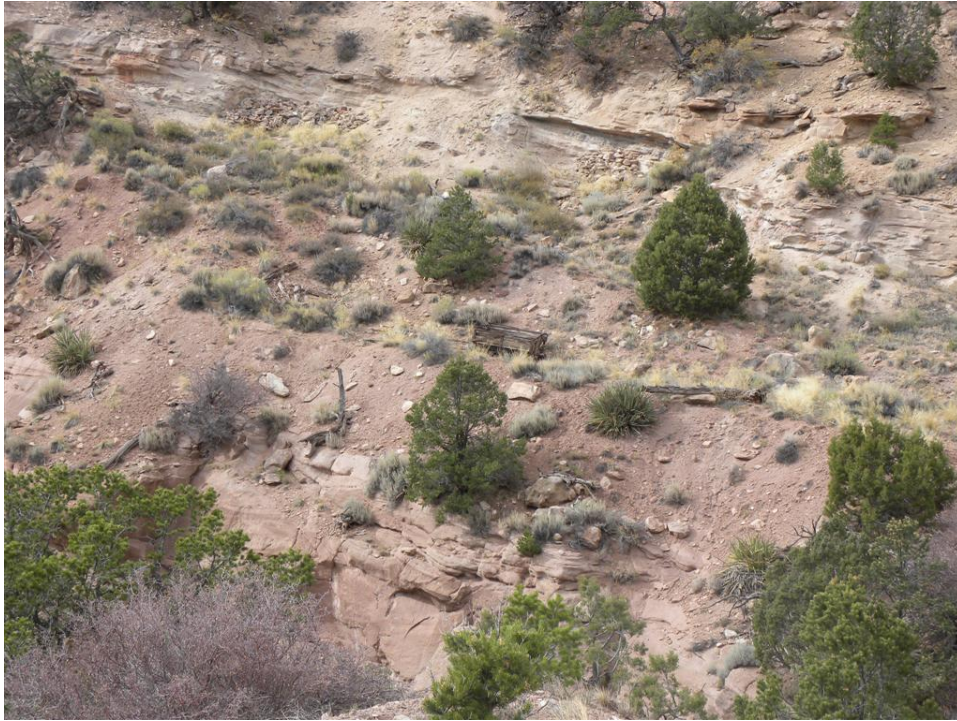
Waste debris extending southwest from adits down steep drainage, 200' x 50', with a total estimated volume of 1,852 yd³

Photo 1. Waste debris below two sealed adits

Unreclaimed waste pile; 2 sealed adits about the ravine

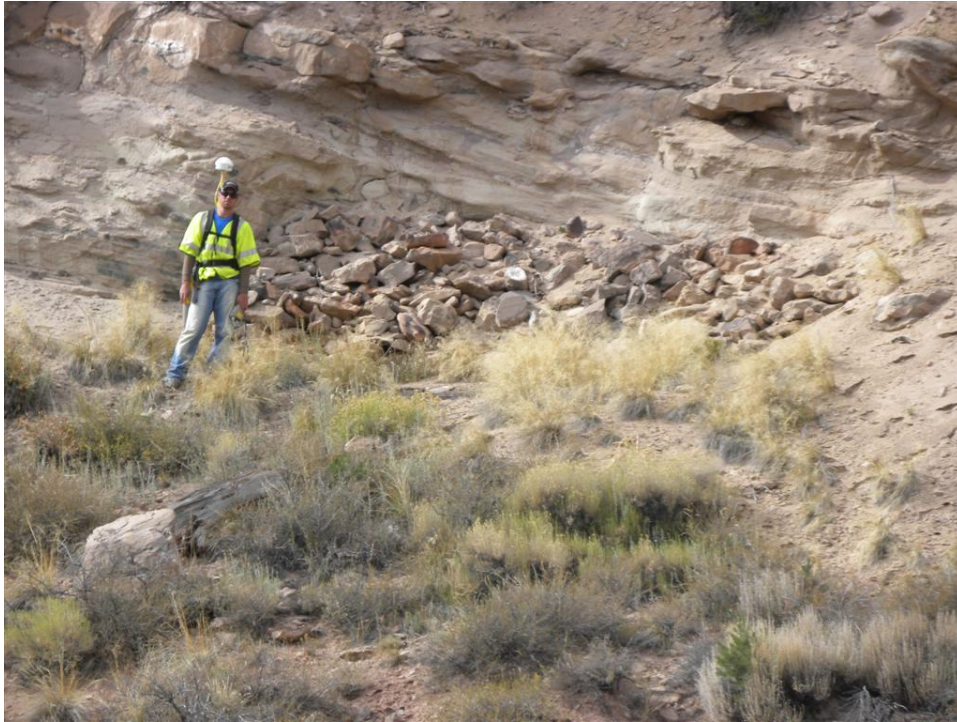
2 stone sealed adits above the ravine

Photo 3. Sealed adit (west)

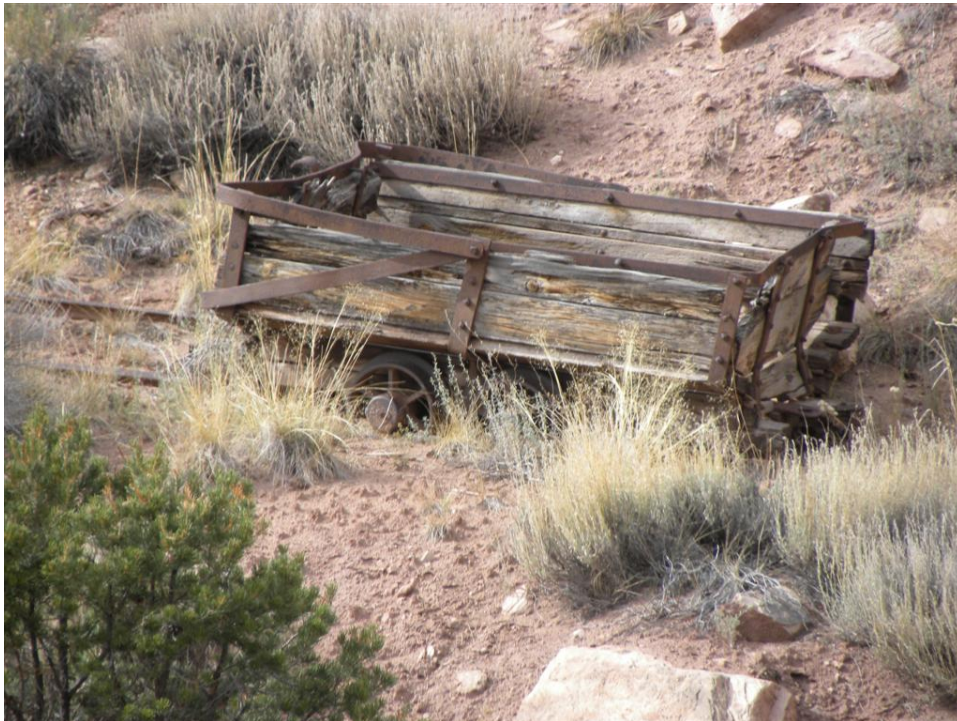
Various wood and metal mining debris, including carts, rails, and pipes

Photo 4. Mining cart

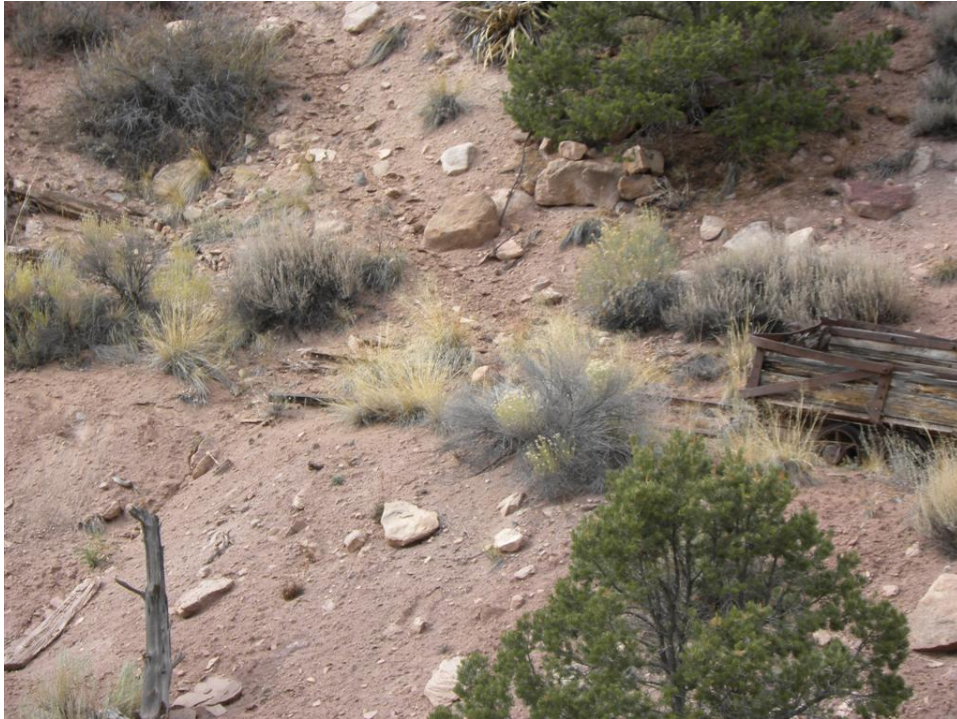
Photo 5. Mining and waste debris
