Navajo Abandoned Uranium Mine

Site Screen Report

Barton and BegayAUM Site

Weston Solutions, Inc.

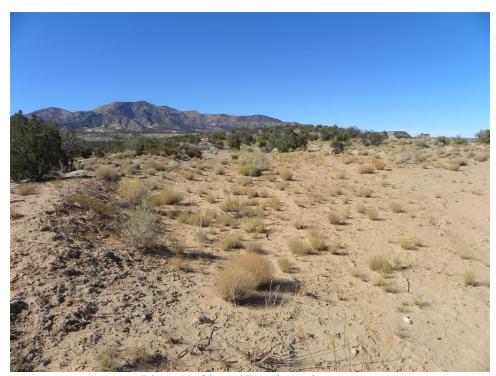
Photo 4. Site #47 reclamation cap

Possible reclamation cap

Possible reclamation cap at site #47

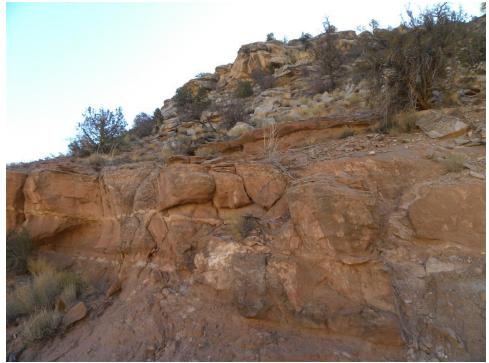
Photo 5. Site #443

Large waste debris pile cascading down inaccessible cliff face, 250' x 25', with a total estimated volume of $1,157 \text{ yd}^3$
