Navajo Abandoned Uranium Mine

Site Screen Report

East Mesa Mines AUM Site

March 2010

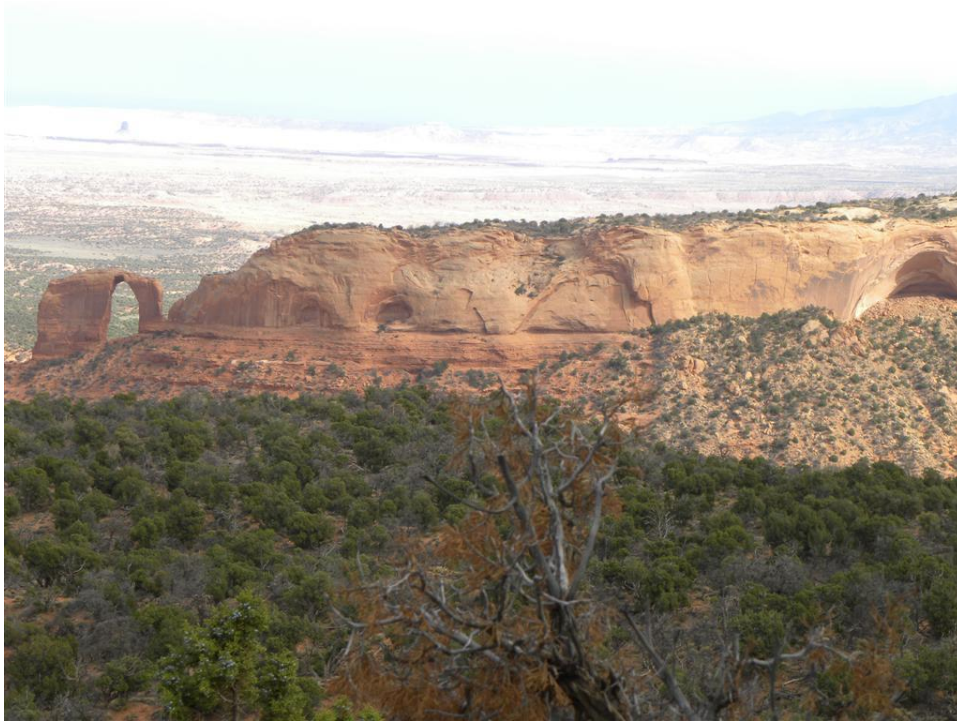
Photo 1. View from top of mine site

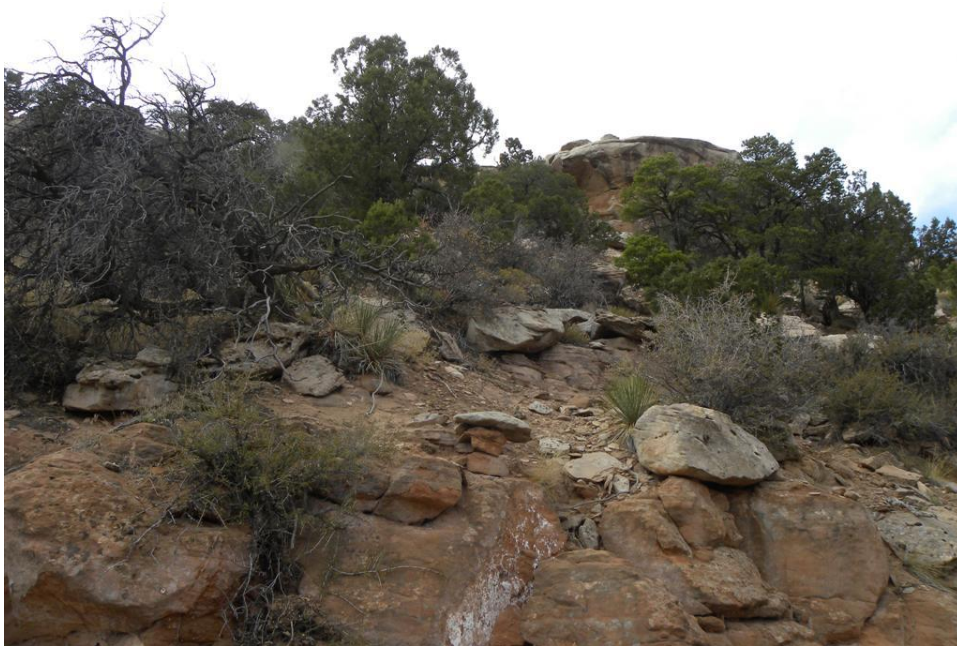
Waste debris below mine workings on cliffs, 600' x 75', with a total estimated volume of 8,333 yd³

Photo 2. Portion of waste debris pile

Unreclaimed waste pile

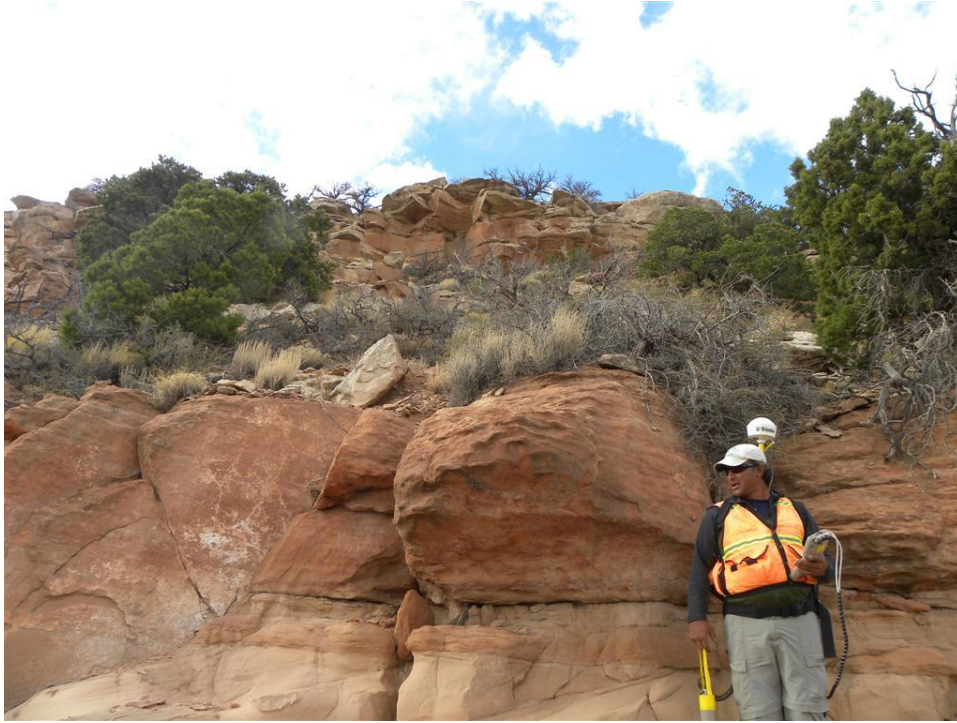
Photo 3. Below waste debris pile

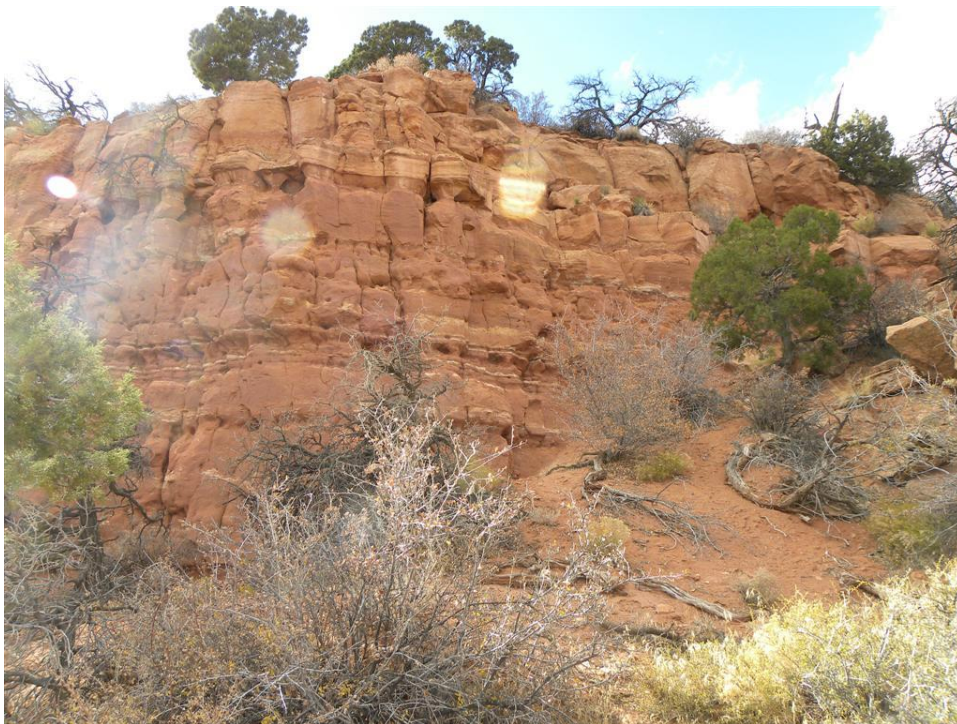
Photo 4. Cliff area
