Navajo Abandoned Uranium Mine

Site Screen Report

North Portal, Frank No. 1 MineAUM Site

March 2010

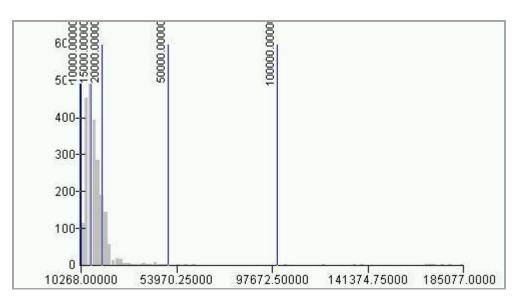
The following chart and statistics were generated by ESRI ArcGIS 9.3.1, and show the general distribution of the site gamma radiation measurements. The horizontal X axis represents the gamma radiation reading levels in cpm (lowest levels to the left). The vertical Y axis represents the frequency of each gamma radiation level.

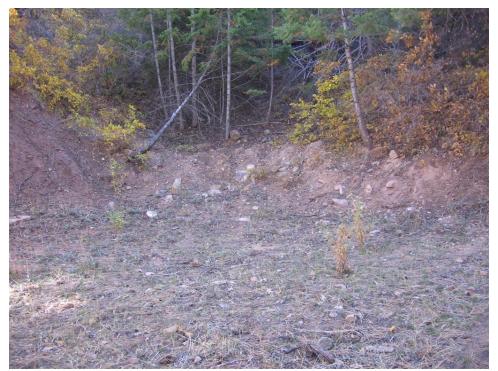
Photo 2. "Cul-de-sac" area in the center of the site

A total of 2,331 gamma radiation measurements were collected from the mine site, ranging from 10,268 cpm to 185,077 cpm. Measurements in the vicinity of the 'Cul-de -sac' area near center of site were found at levels of approximately 25,000 cpm, a rocky outcropping southeast of the site was found at levels of approximately 170,000 cpm. The measurements are represented in Figures 1 and 2.

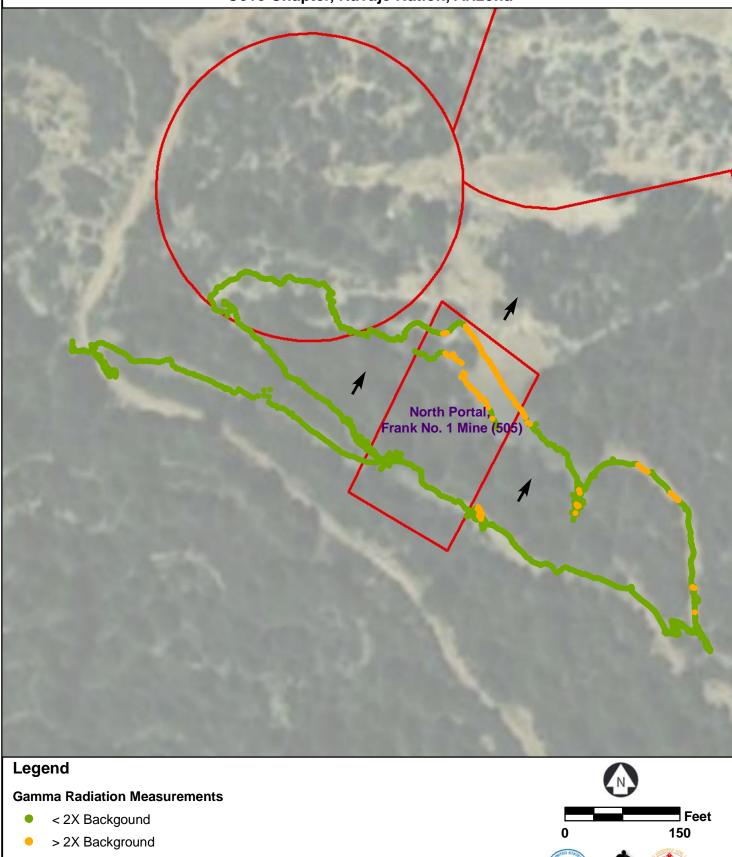
Figure 1 - Gamma Radiation Measurements, Above Two Times Background North Portal, Frank No. 1 Mine (505) Cove Chapter, Navajo Nation, Arizona

Gamma survey conducted 10/2009 Measured as counts per minute (cpm)

Average background = 12,000 cpm

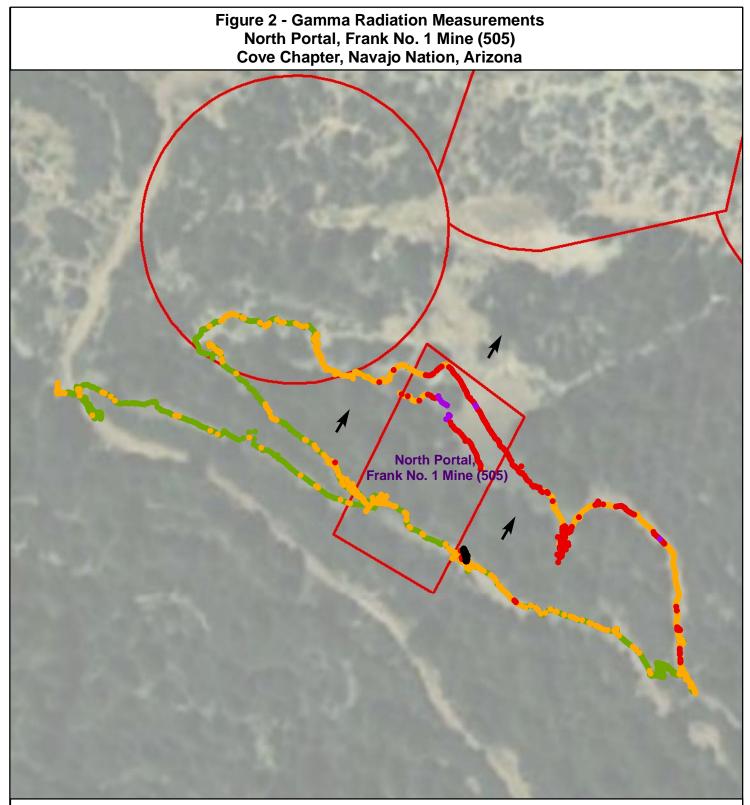
Gamma Radiation Measurements

- 0 10,000
- 10,000 15,000
- 15,000 20,000
- 20,000 50,000
- 50,000 100,000
- > 100,000

Gamma survey conducted 10/2009 Measured as counts per minute (cpm)
