Navajo Abandoned Uranium Mine

Site Screen Report

Flag No. 1 Mine AUM Site

March 2010

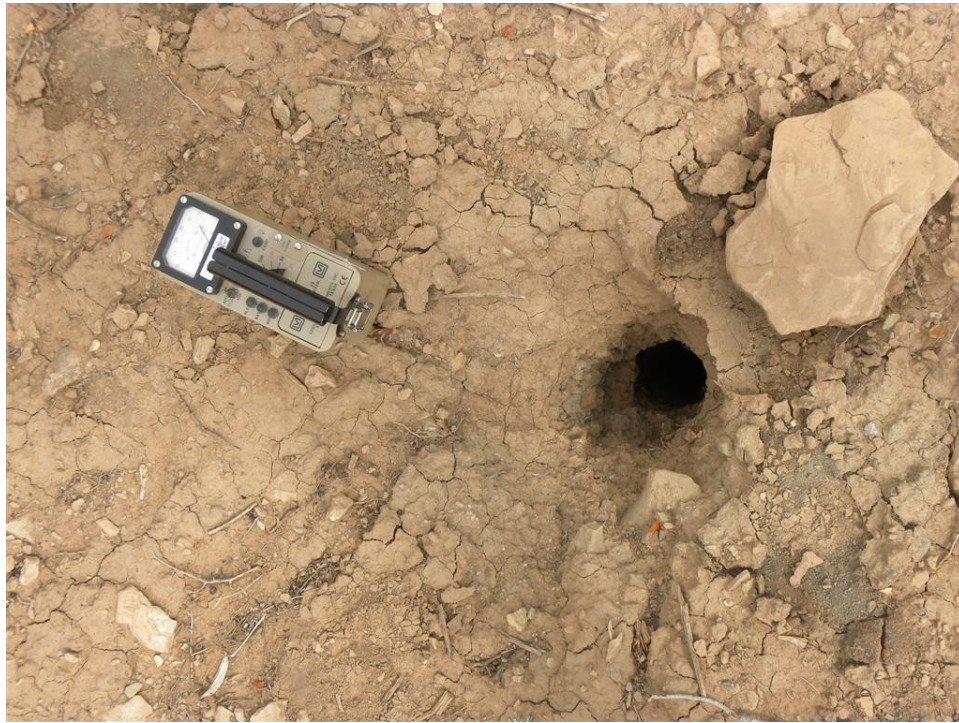
Some wood mining debris and ventilation holes

Photo 1. Ventilation hole

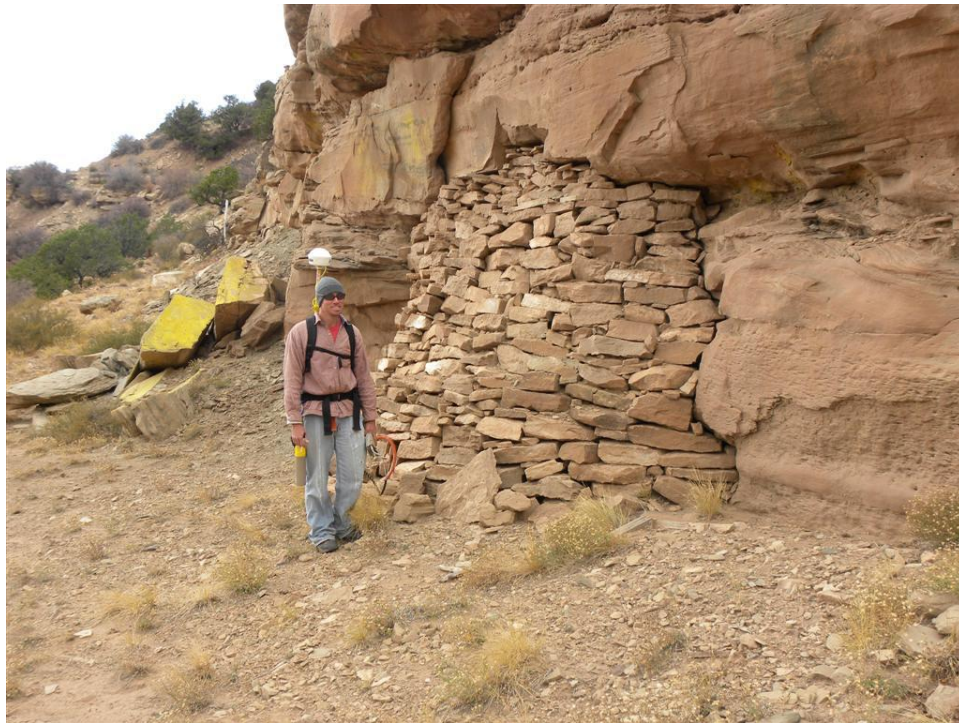
Stone sealed adit with painted yellow rocks

Photo 2. Sealed adit and yellow painted rock

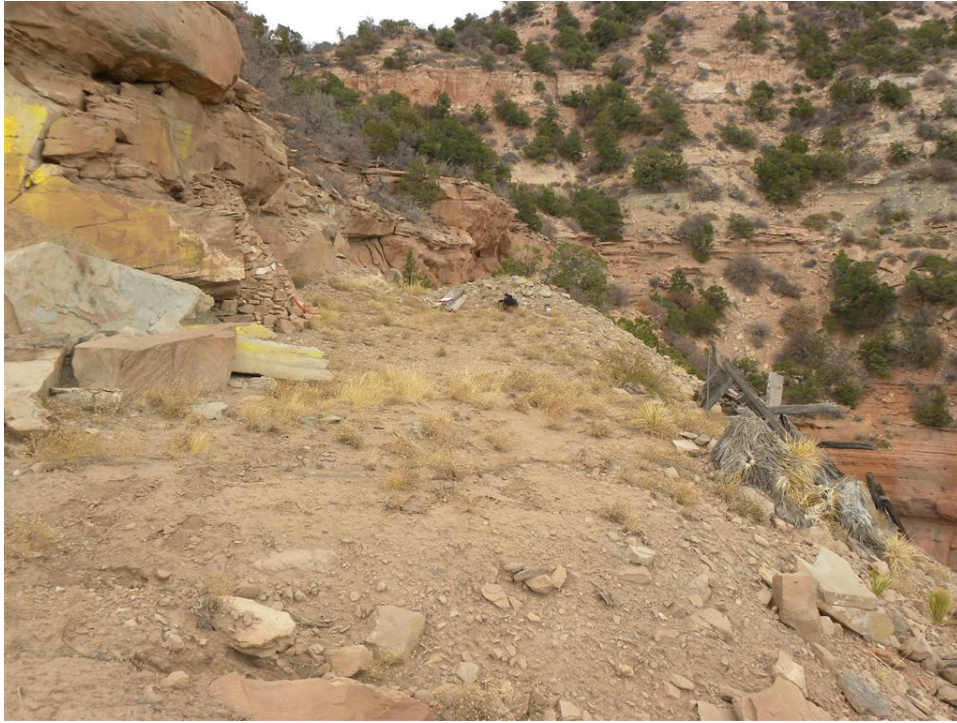
Waste pile stretches from end of haul road down slope (inaccessible) to upper edge of >100' sheer rock face, 100' x 100', with a total estimated volume of 1,852 yd³

Photo 3. Waste pile below adit

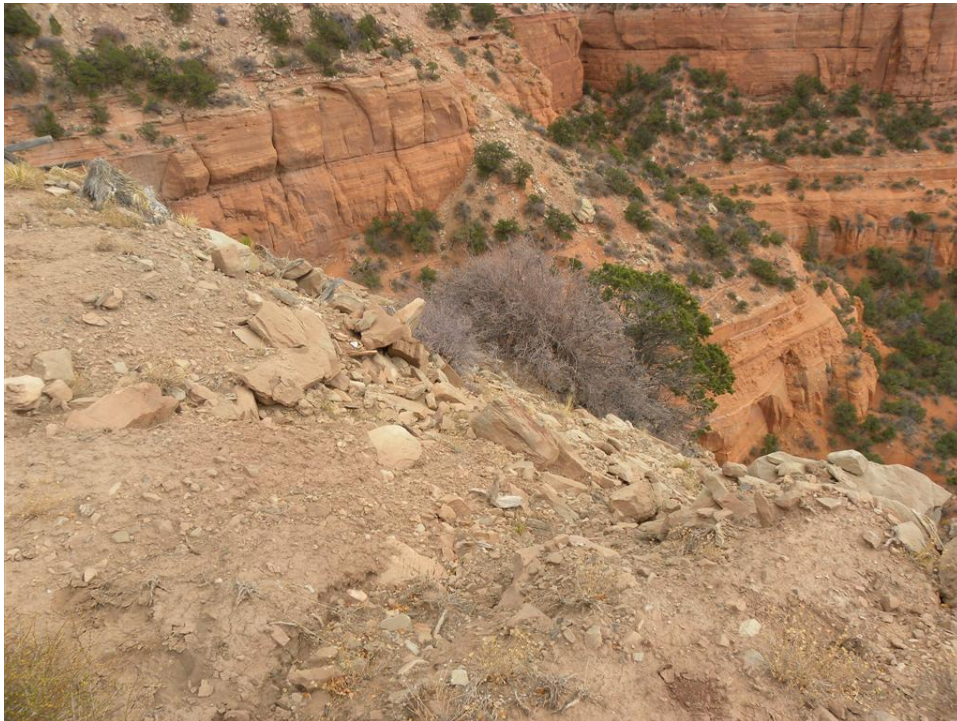
Photo 4. Waste pile

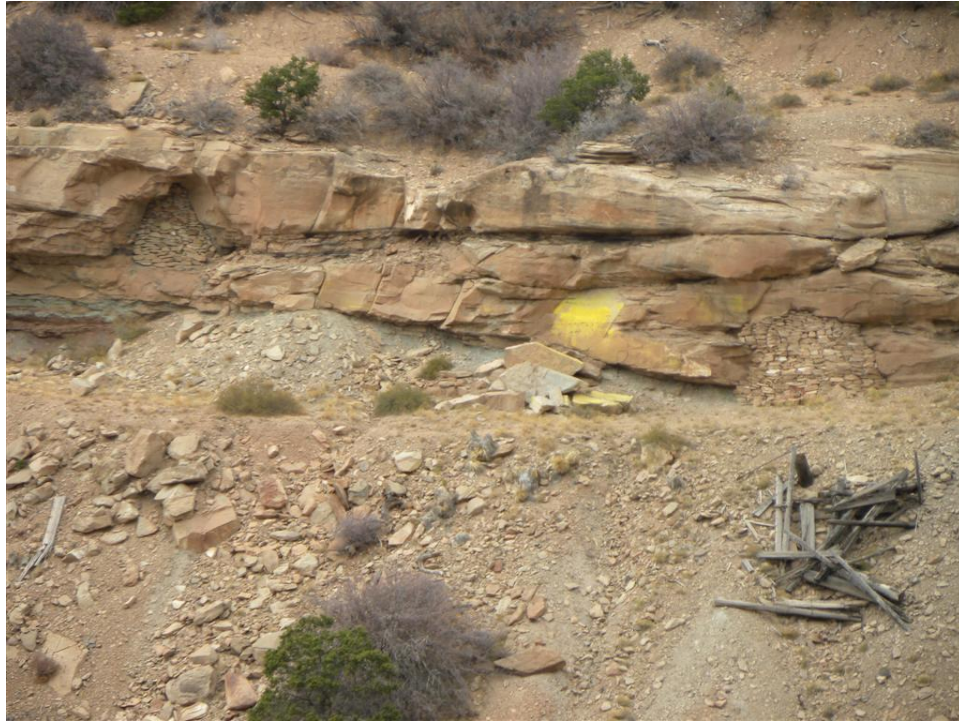
Sealed adit with yellow painted rock; mining debris, unreclaimed waste pile

Photo 5. Sealed adit, wood mining debris, waste pile, and yellow painted rock
