Navajo Abandoned Uranium Mine

Site Screen Report

Martin Mine and George Simpson No. 1 AUM Site

August 2010

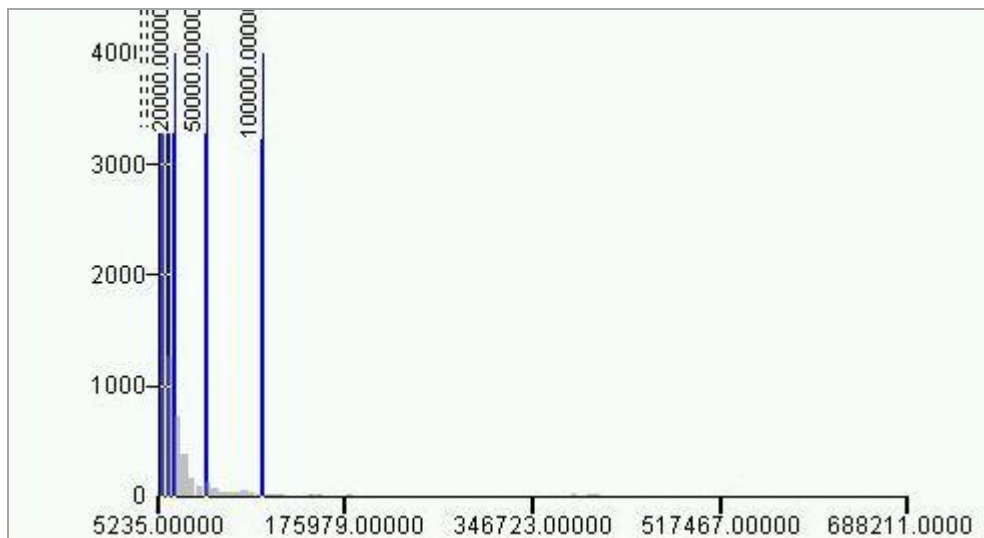
The following chart and statistics were generated by ESRI ArcGIS 9.3.1, and show the general distribution of the site gamma radiation measurements. The horizontal X axis represents the gamma radiation reading levels in cpm (lowest levels to the left). The vertical Y axis represents the frequency of each gamma radiation level.

Count:	6647
Minimum:	5235.00000
Maximum:	688211.00000
Sum:	198081357.00000
Mean:	29800.11389
Median:	12288.00000
Standard Deviation:	62898.11147

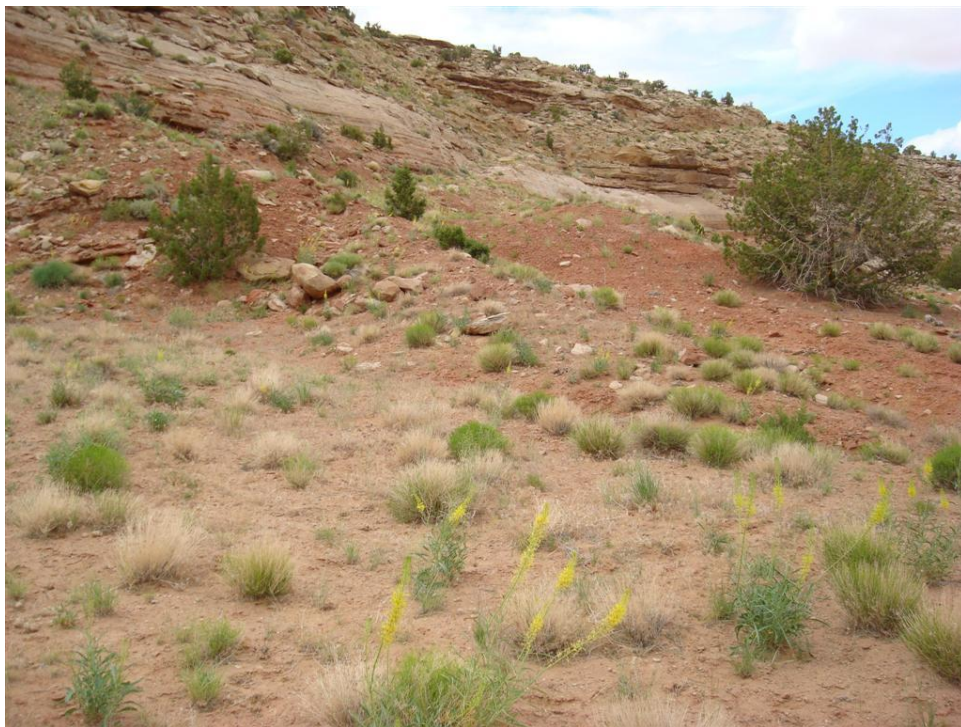
2 large waste piles off lower road: 200'x50'x5'; 20'x30'x5' (bench area)

Photo 2. Martin Mine and George Simpson No. 1 mine site, waste piles

Unreclaimed waste rock; 2collapsed adits

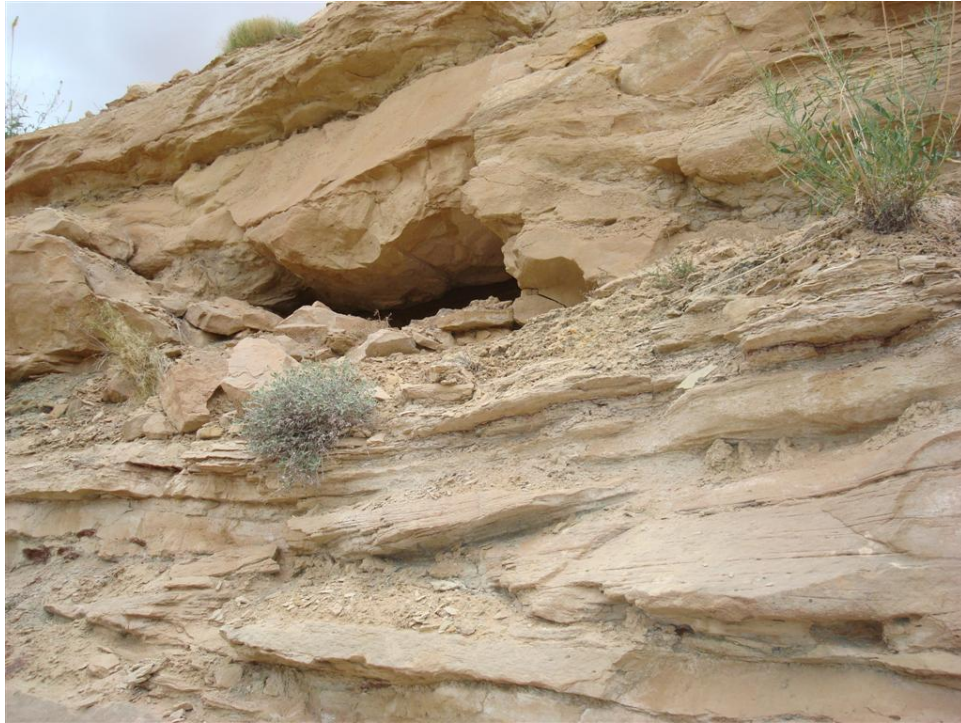
2 collapsed adits atop mesa, one is labeled "117"

Photo 3. Martin Mine and George Simpson No. 1 mine site, adit

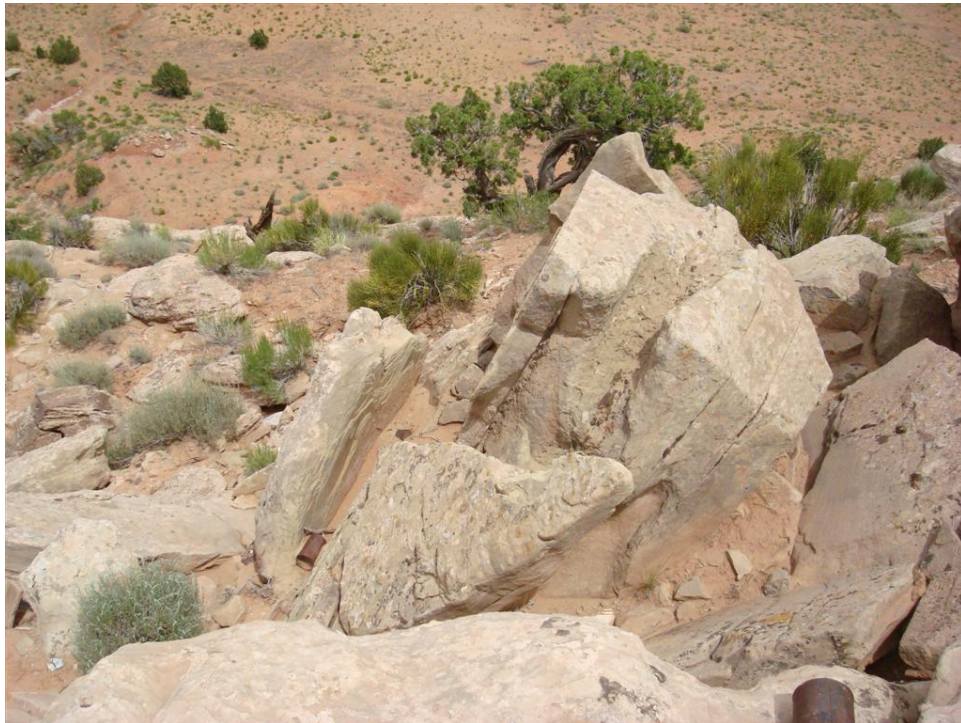
Photo 4. Martin Mine and George Simpson No. 1 mine site, down-slope

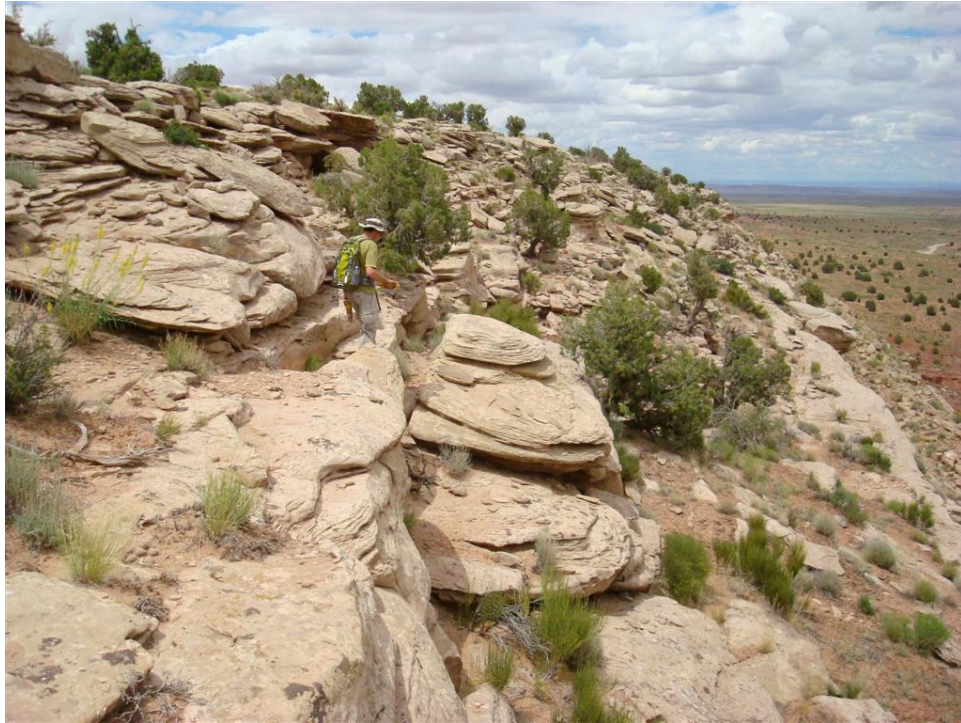
Photo 5. Martin Mine and George Simpson No. 1 mine site, down-slope

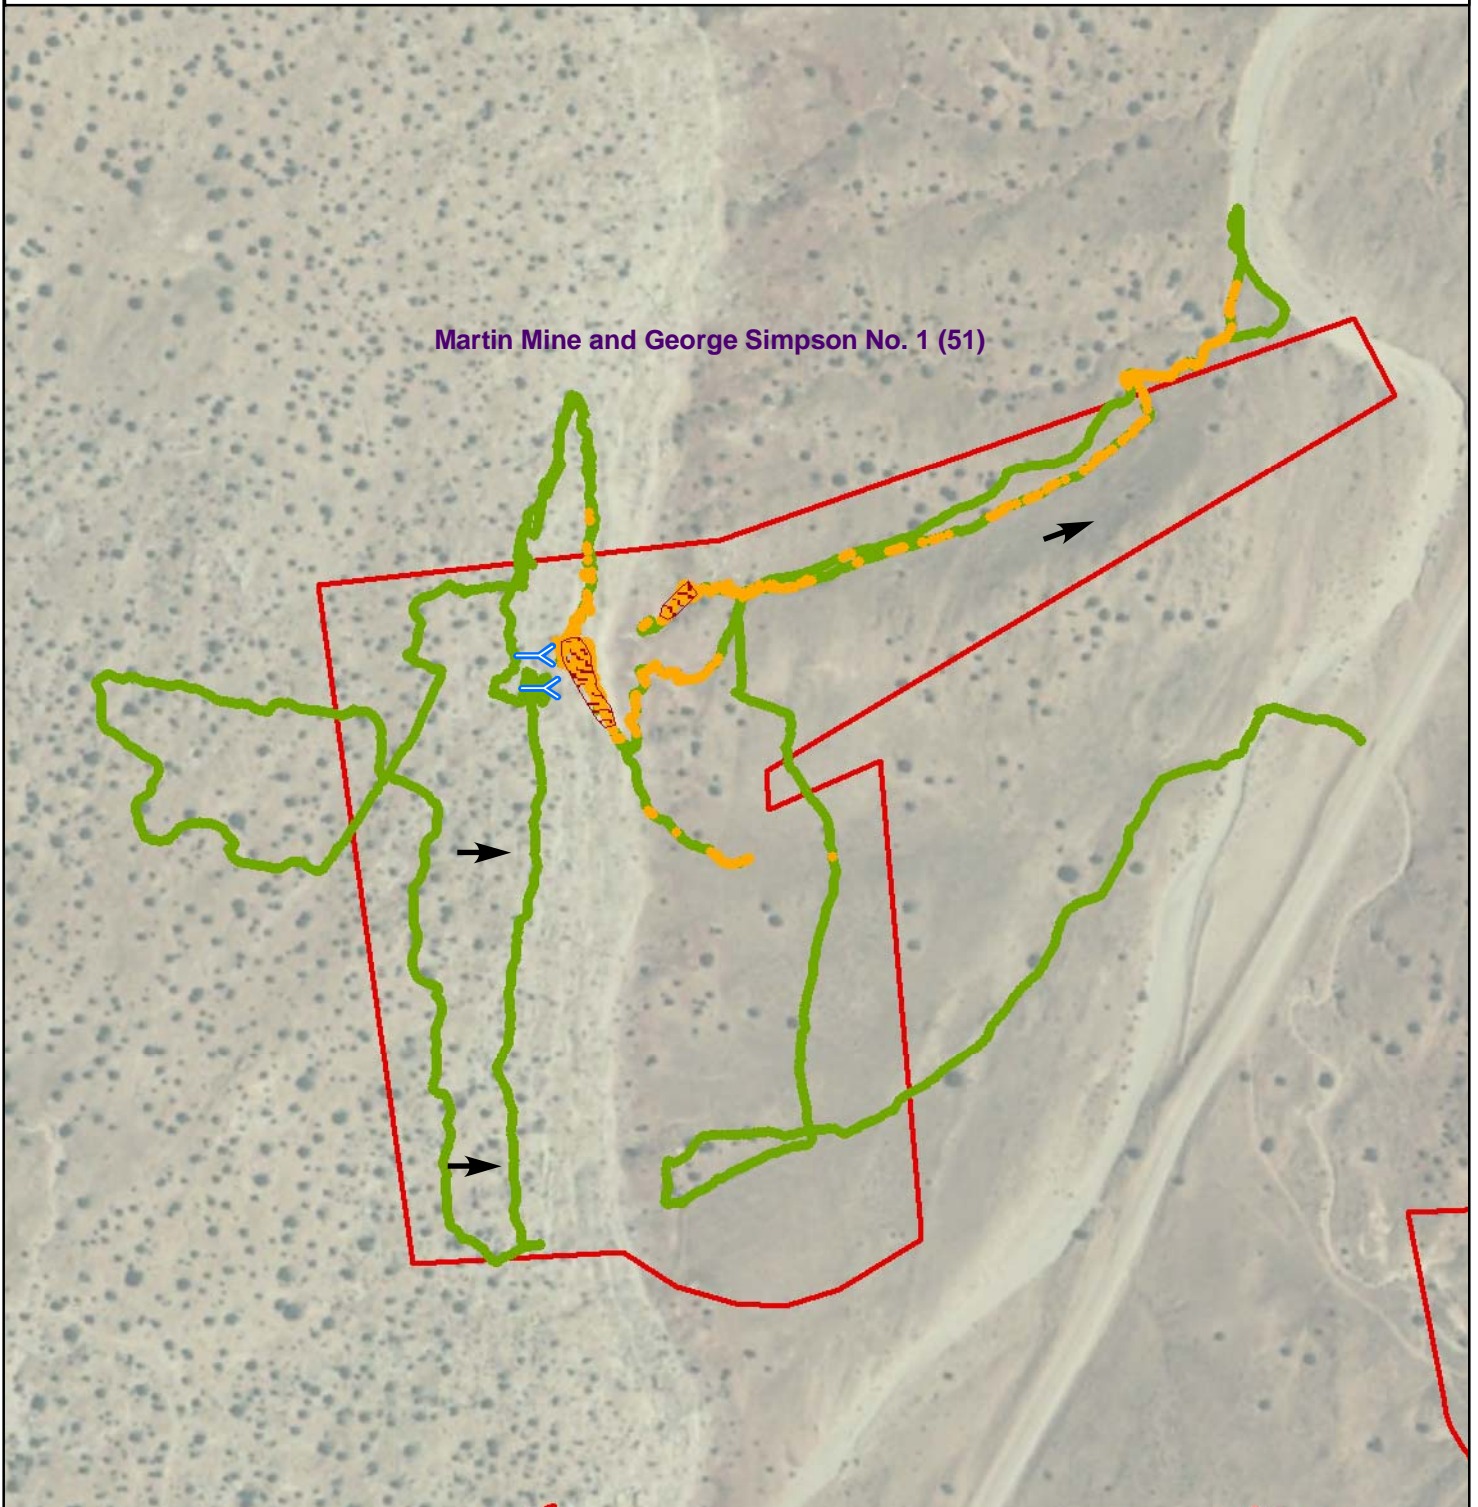
A total of 6,647 gamma radiation measurements were collected from the mine site, ranging from 5,235 cpm to 688,211 cpm. Measurements collected in the vicinity of the waste debris were found at levels ranging from approximately 50,000 cpm to 680,000 cpm, and near the adits at levels up to approximately 400,000 cpm. The measurements are represented in Figures 1 and 2.

**Figure 1 - Gamma Radiation Measurements, Above Two Times Background
 Martin Mine and George Simpson No. 1 (51)
 Sweetwater / Teec Nos Pos Chapters, Navajo Nation**

Gamma survey conducted 06/2010
 Measured as counts per minute (cpm)

Average background = 9,014 cpm

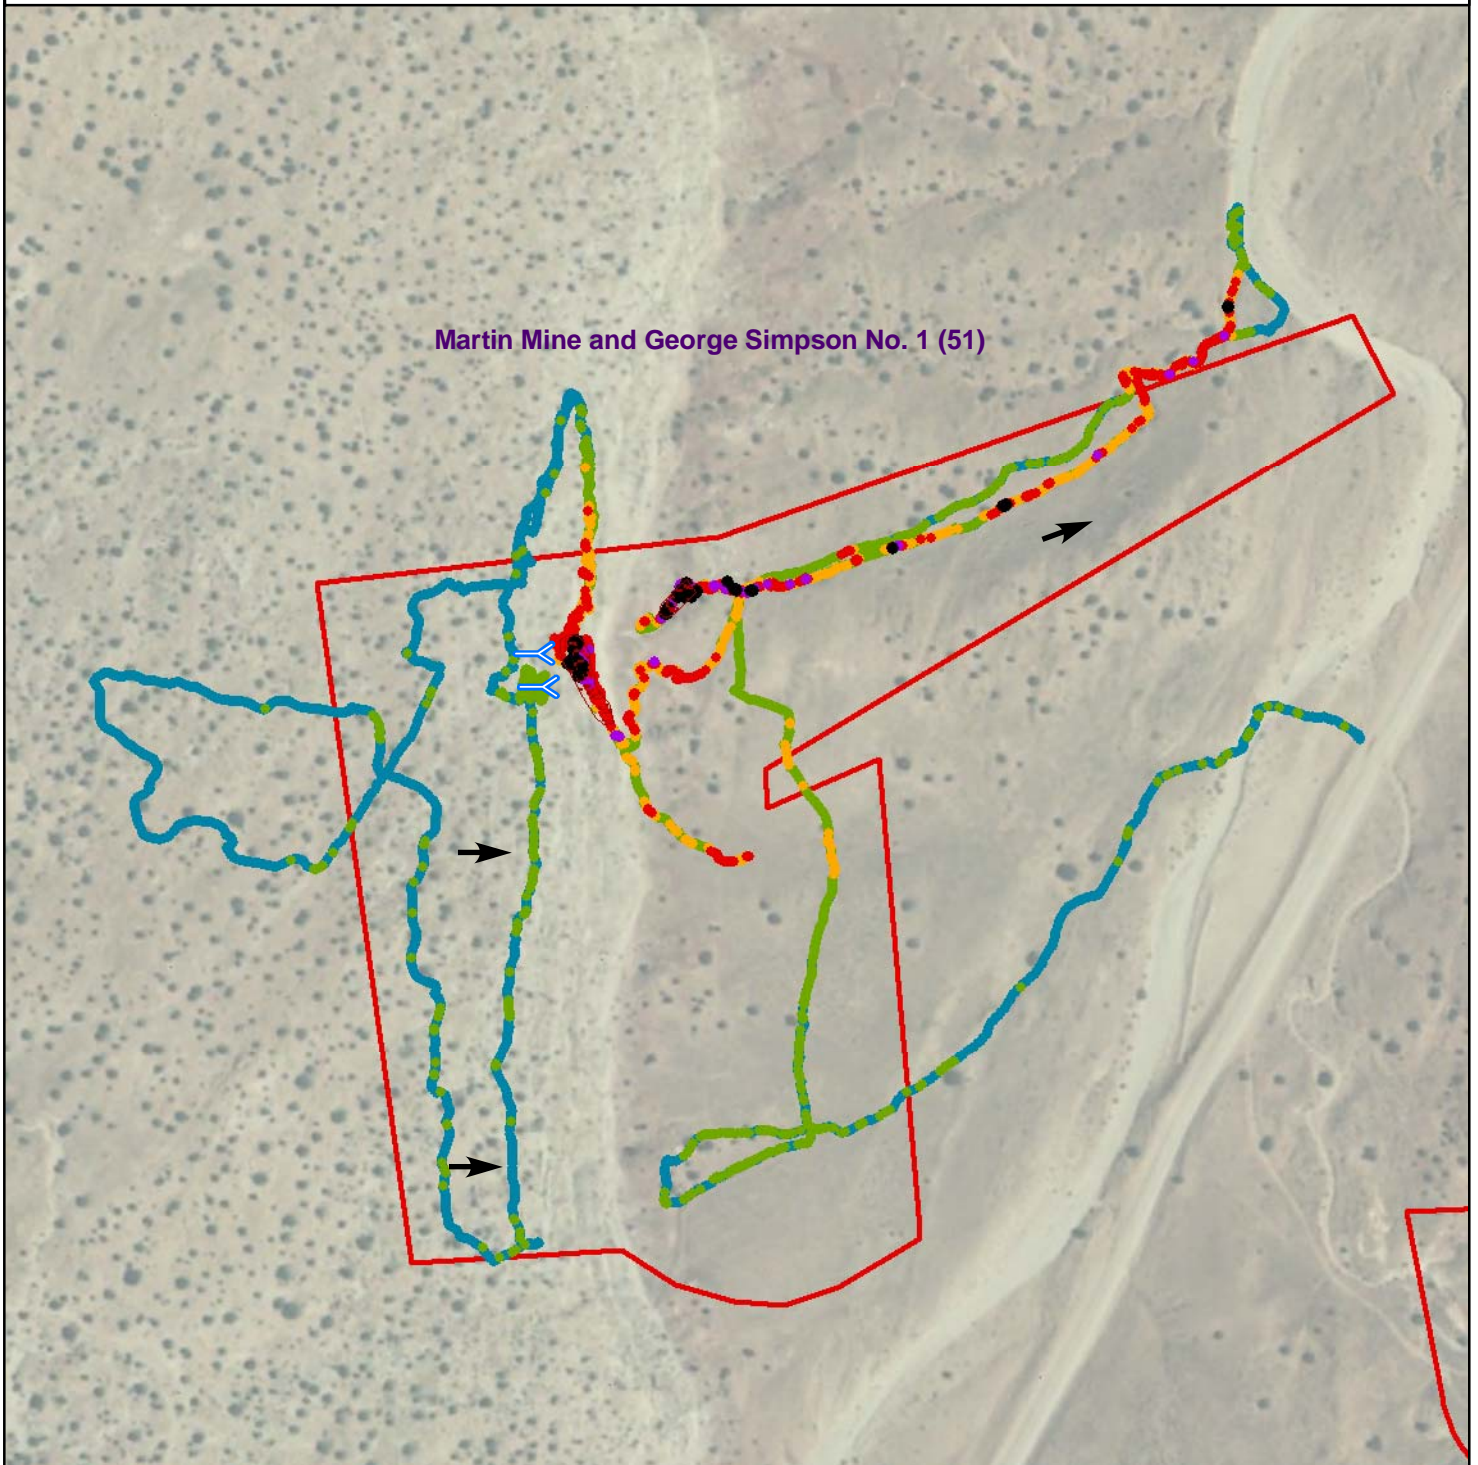
**Figure 2 - Gamma Radiation Measurements
 Martin Mine and George Simpson No. 1 (51)
 Sweetwater / Teec Nos Pos Chapters, Navajo Nation**

**Gamma survey conducted 06/2010
 Measured as counts per minute (cpm)**

Average background 9,014 cpm
