Navajo Abandoned Uranium Mine

Site Screen Report

Amos Chee No. 2 and No. 3 AUM Site

January 2011

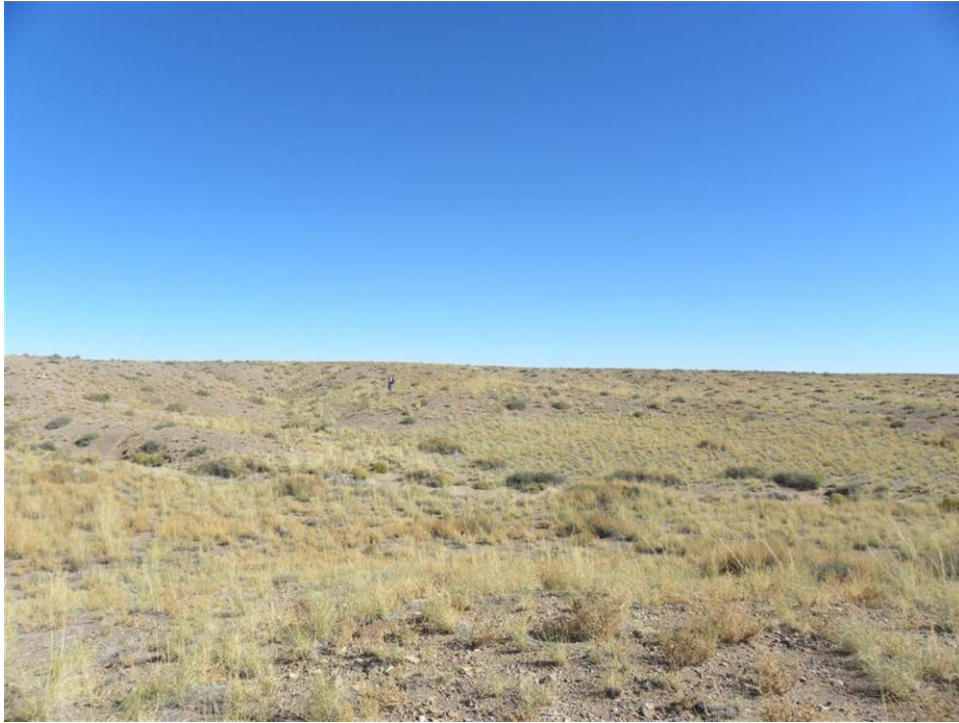
Photo 1. Amos Chee No. 2 and No. 3 mine site

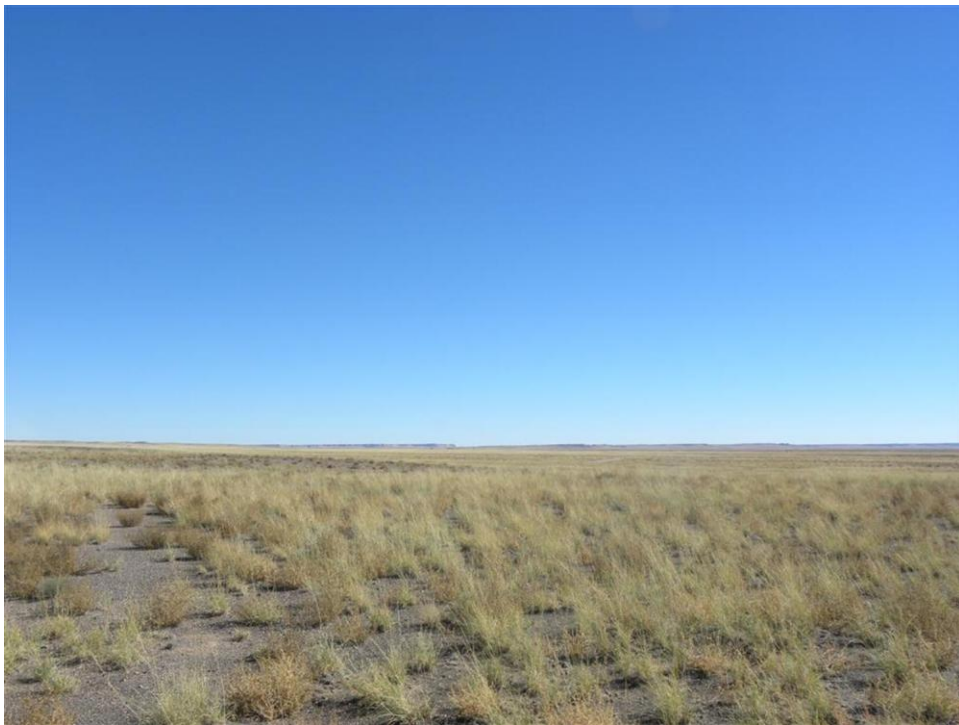
Photo 2. Amos Chee No. 2 and No. 3 mine site

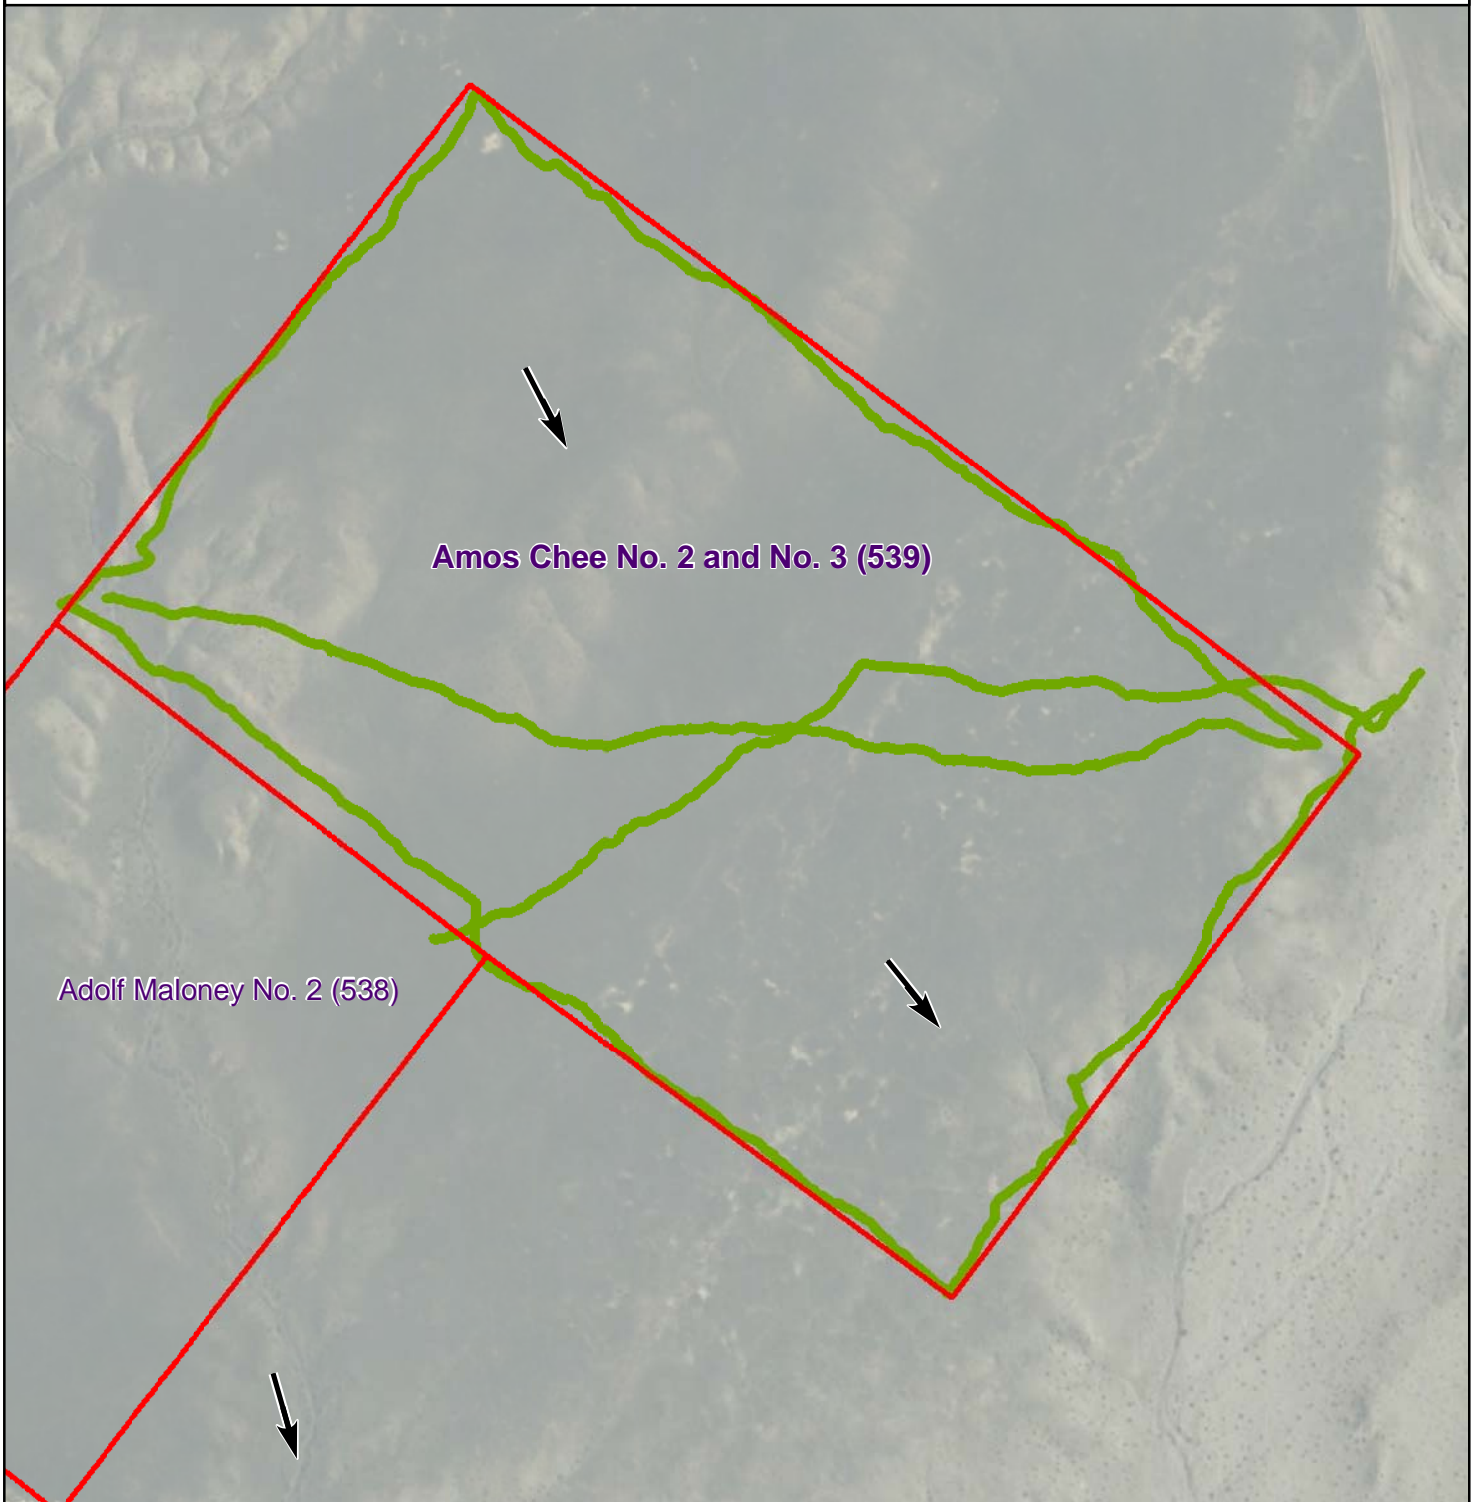
**Figure 1 - Gamma Radiation Measurements, Above Two Times Background
Amos Chee No. 2 and No. 3 (539)
Leupp Chapter, Navajo Nation**

Gamma survey conducted 11/2010
Measured as counts per minute (cpm)

Average background 9,212 cpm

A total of 4,500 gamma radiation measurements were collected from the mine site, ranging from 6,770 cpm to 11,755 cpm. The measurements are represented in Figures 1 and 2.

No
