# Navajo Abandoned Uranium Mine

## Site Screen Report

**Mine Name: Max Huskon No. 1**  
**Mine ID: 546**

**August 2011**

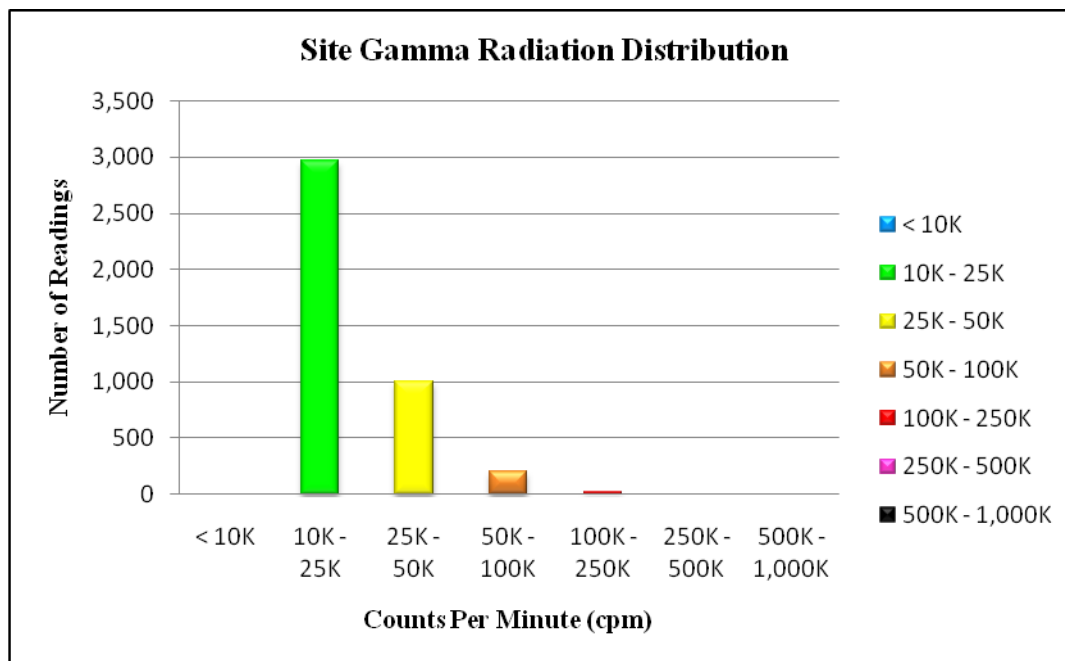
### Distribution Chart and Statistics:

A total of 4,200 gamma radiation measurements were collected from the mine site, ranging from 12,944 cpm to 152,751 cpm. Measurements collected in the vicinity of the waste rock were found at a maximum level of approximately 40,000 cpm. The measurements are represented in Figures 1 and 2.

<b>Site Gamma Radiation Statistics</b>	
Number of Readings	4,200
Minimum (cpm)	12,944
Maximum (cpm)	152,751
Mean (cpm)	25,646
Median (cpm)	20,990
Standard Deviation	14,236

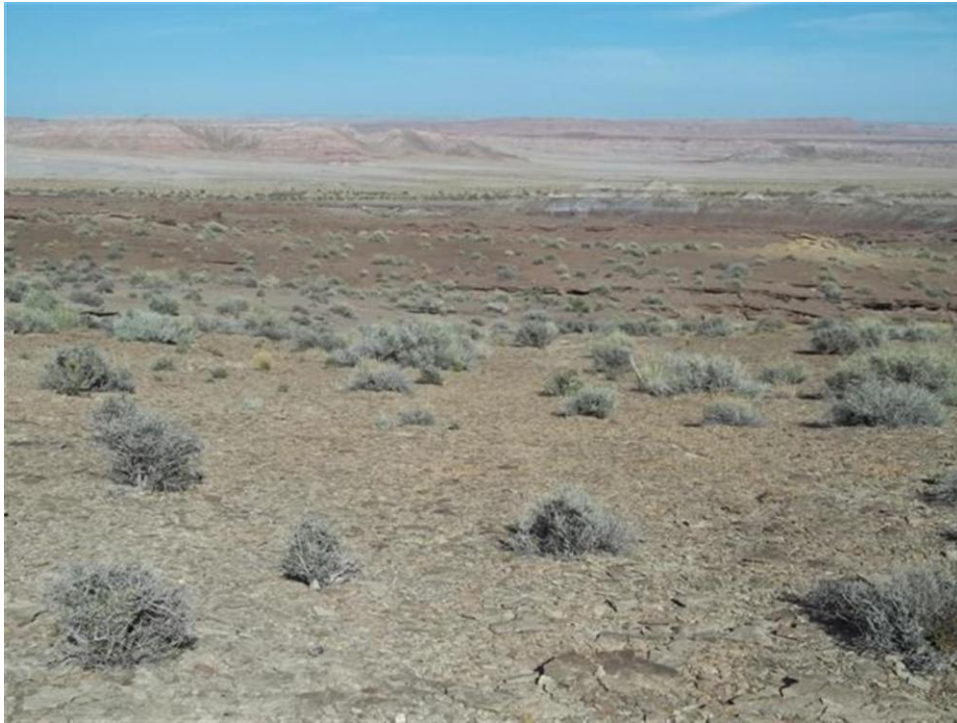
**Photo 1: Mine Site #546**

4 waste rock piles: Pile 1 - 8'dia x 1.5h; Pile 2 - 6' x 10' x 4'; Pile 3 - 15'dia x 5'h; Pile 4 - 5' x 8' x 3' (piles 2 are 4 may be connected)

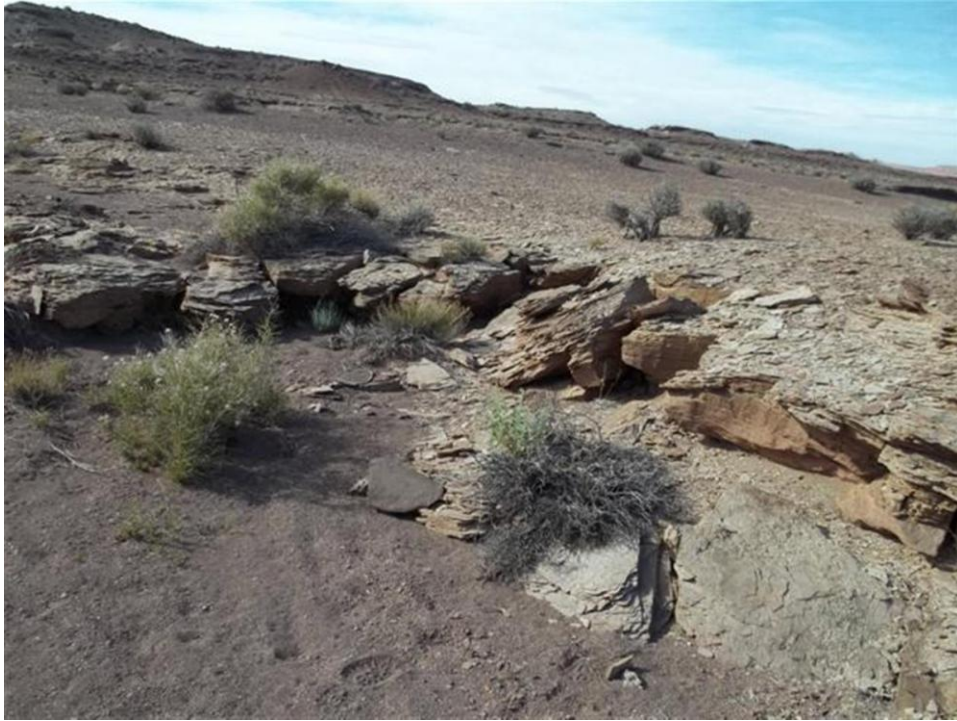
**Photo 3:** Mine Site #546; Elevated readings

**Highest gamma radiation measurement:** 152,751 counts per minute (cpm)

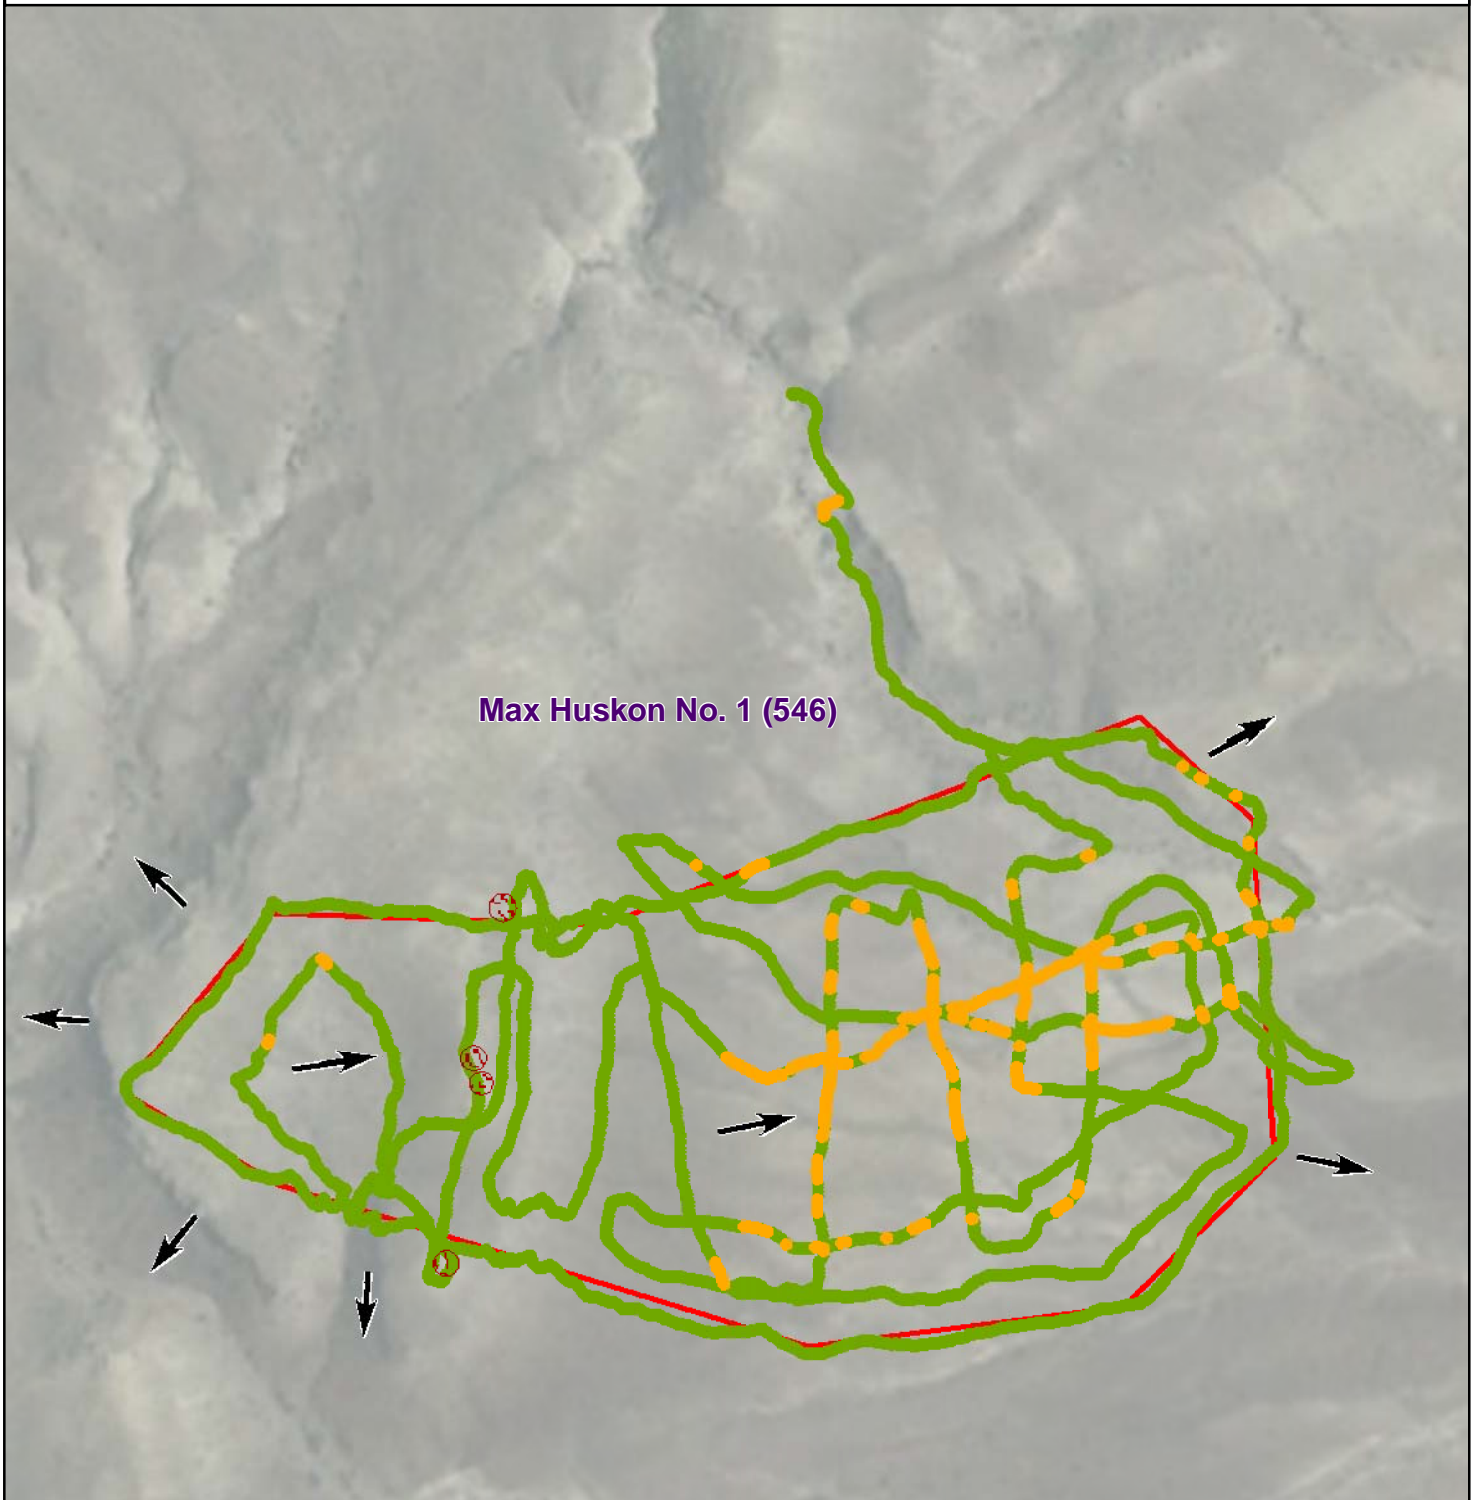
**Figure 1 - Gamma Radiation Measurements, Above Two Times Background  
 Max Huskon No. 1 (546)  
 Bodaway / Gap Chapter, Navajo Nation**

Average background 20,041 cpm

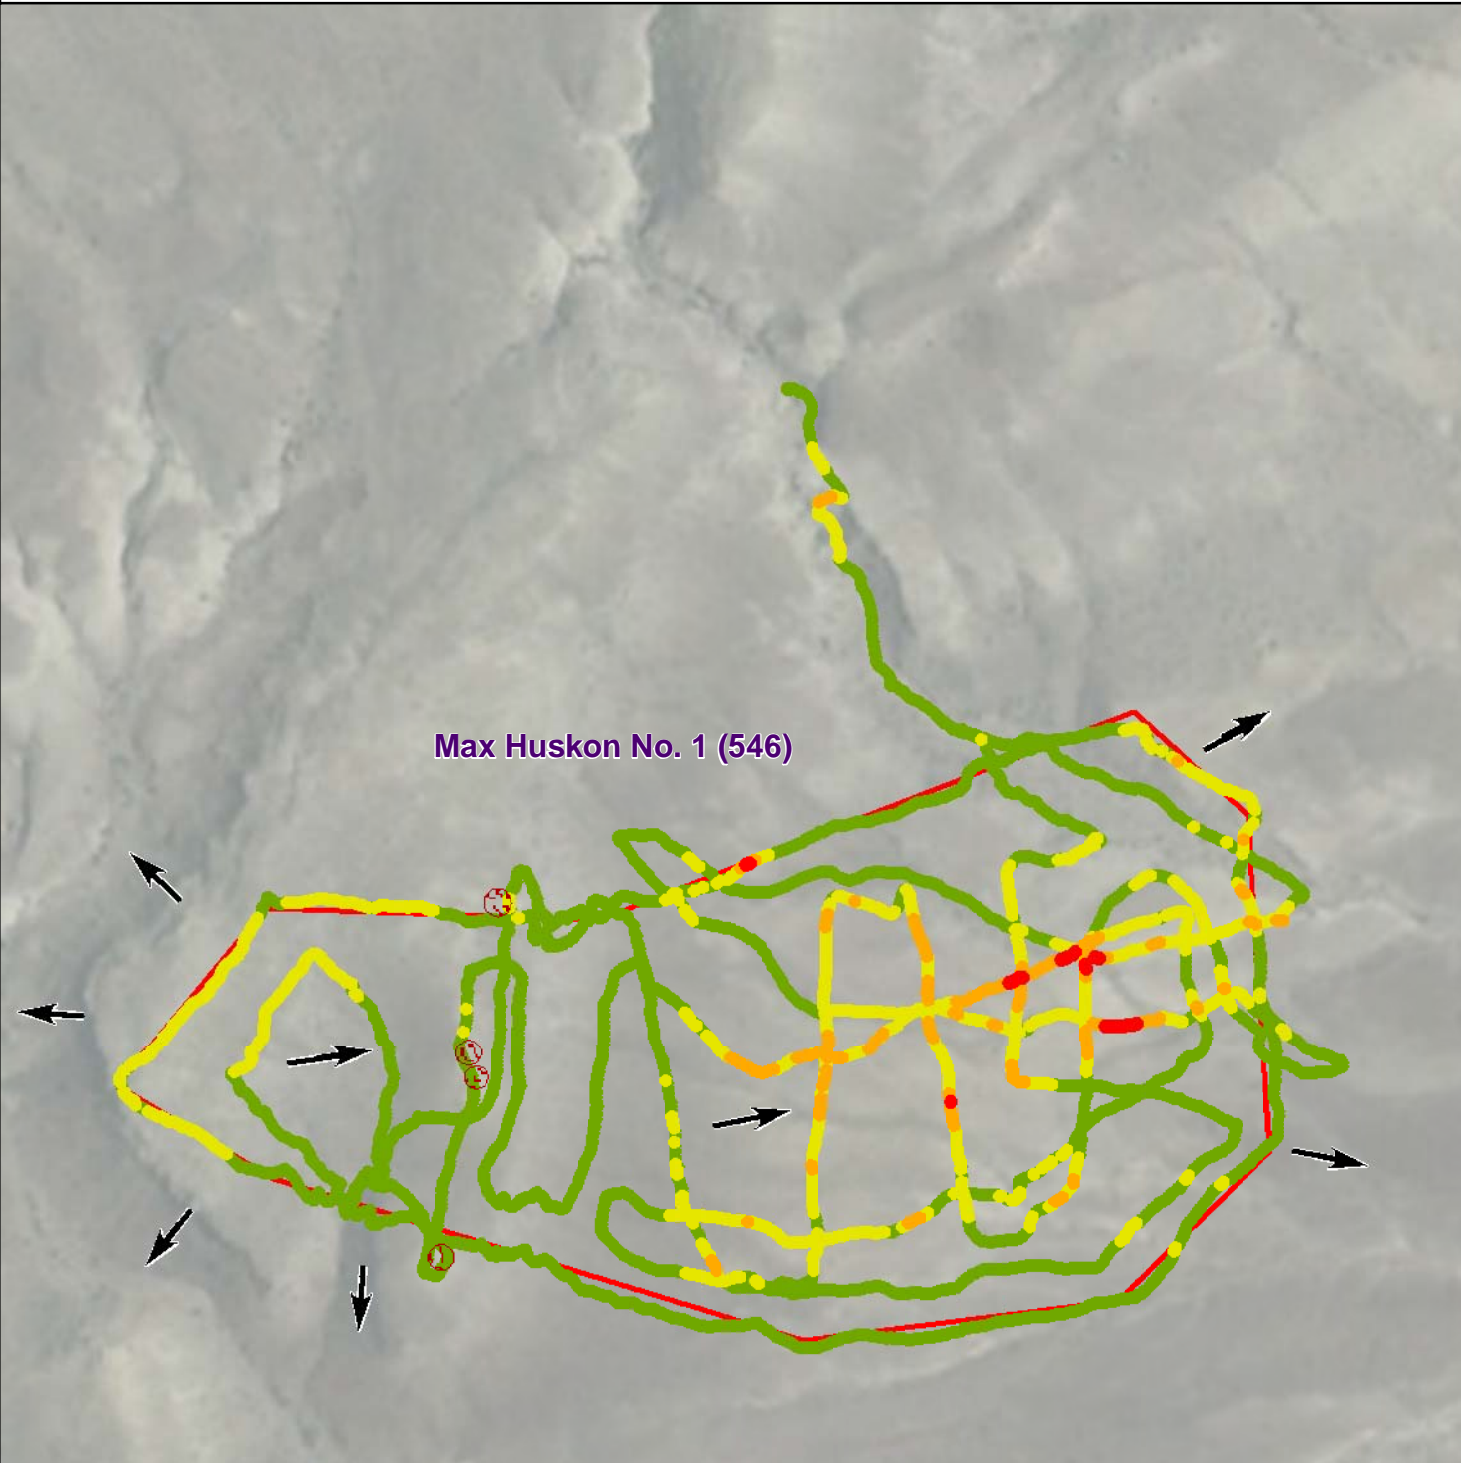
**Figure 2 - Gamma Radiation Measurements  
Max Huskon No. 1 (546)  
Bodaway / Gap Chapter, Navajo Nation**

Measured as counts per minute (cpm) Average background 20,041 cpm
