Navajo Abandoned Uranium Mine

Site Screen Report

Rattlesnake No. 8 AUM Site

August 2010

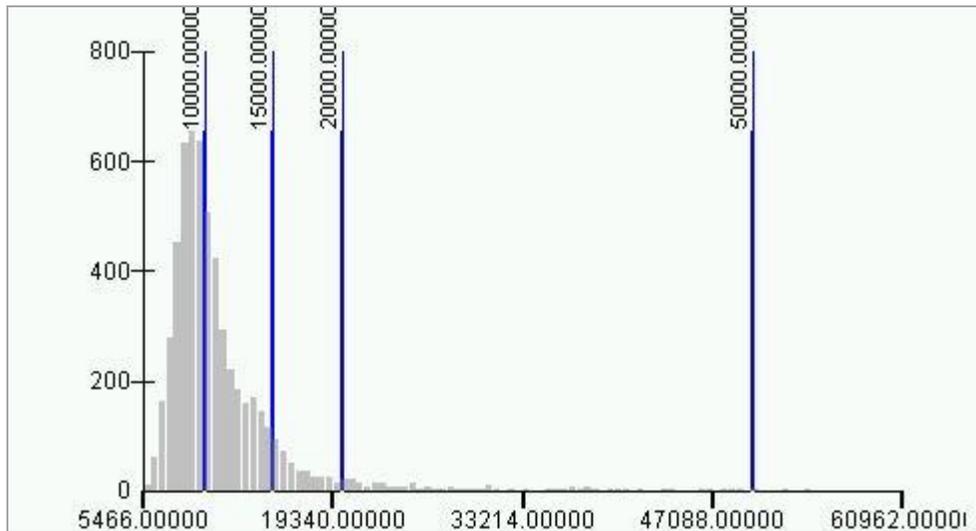
The following chart and statistics were generated by ESRI ArcGIS 9.3.1, and show the general distribution of the site gamma radiation measurements. The horizontal X axis represents the gamma radiation reading levels in cpm (lowest levels to the left). The vertical Y axis represents the frequency of each gamma radiation level.

Count:	5783
Minimum:	5466.00000
Maximum:	60962.00000
Sum:	65374330.00000
Mean:	11304.57029
Median:	9882.00000
Standard Deviation:	5284.30276

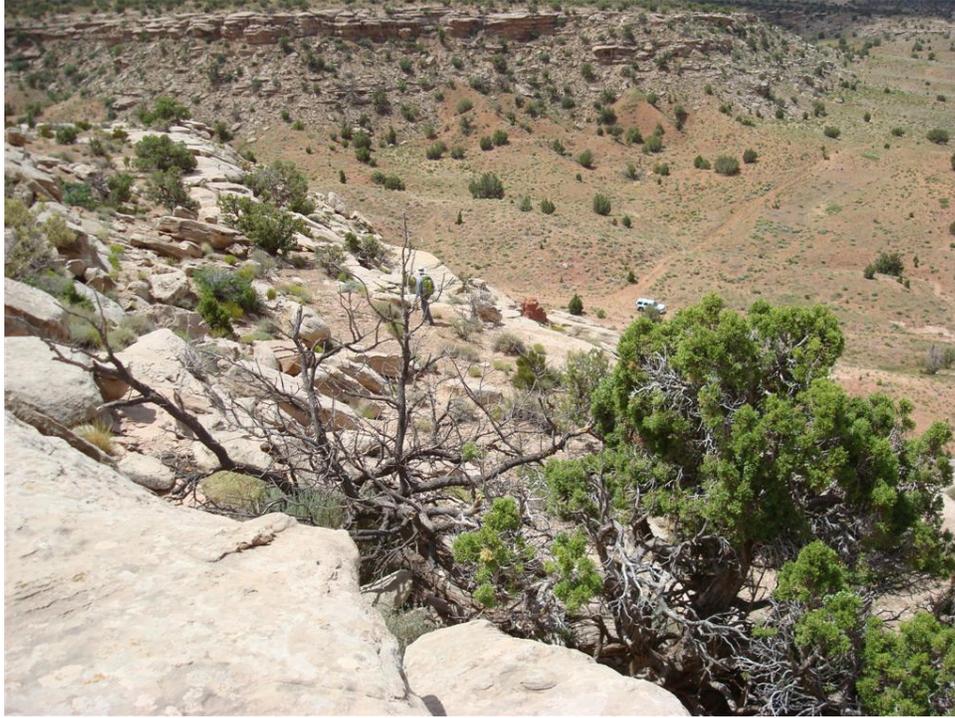
Photo 1. Rattlesnake No. 8 mine site

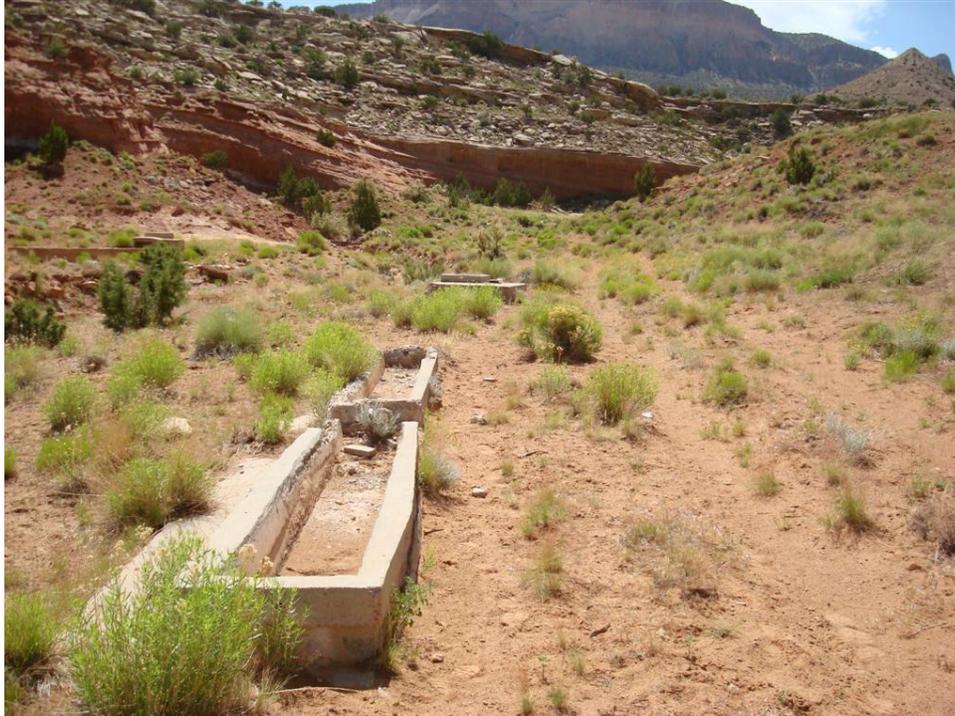
Excavation pit atop mesa

Concrete troughs and debris

Photo 2. Rattlesnake No. 8 mine site, pit area and concrete troughs

Excavation pit atop mesa

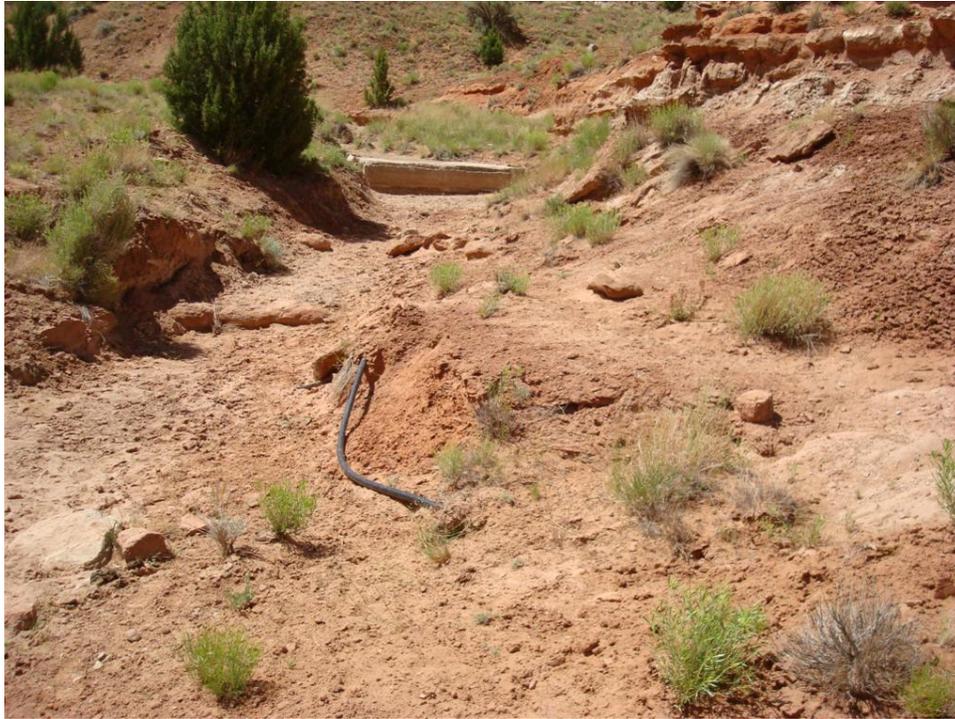
Photo 3. Rattlesnake No. 8 mine site, pit area

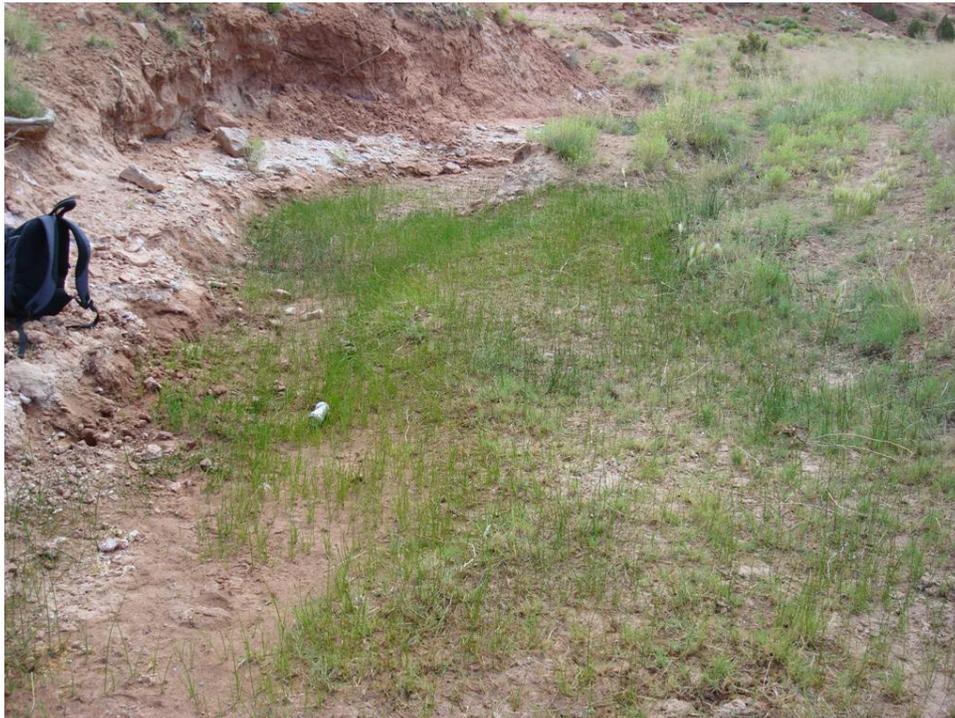
Photo 4. Rattlesnake No. 8 mine site, pit area

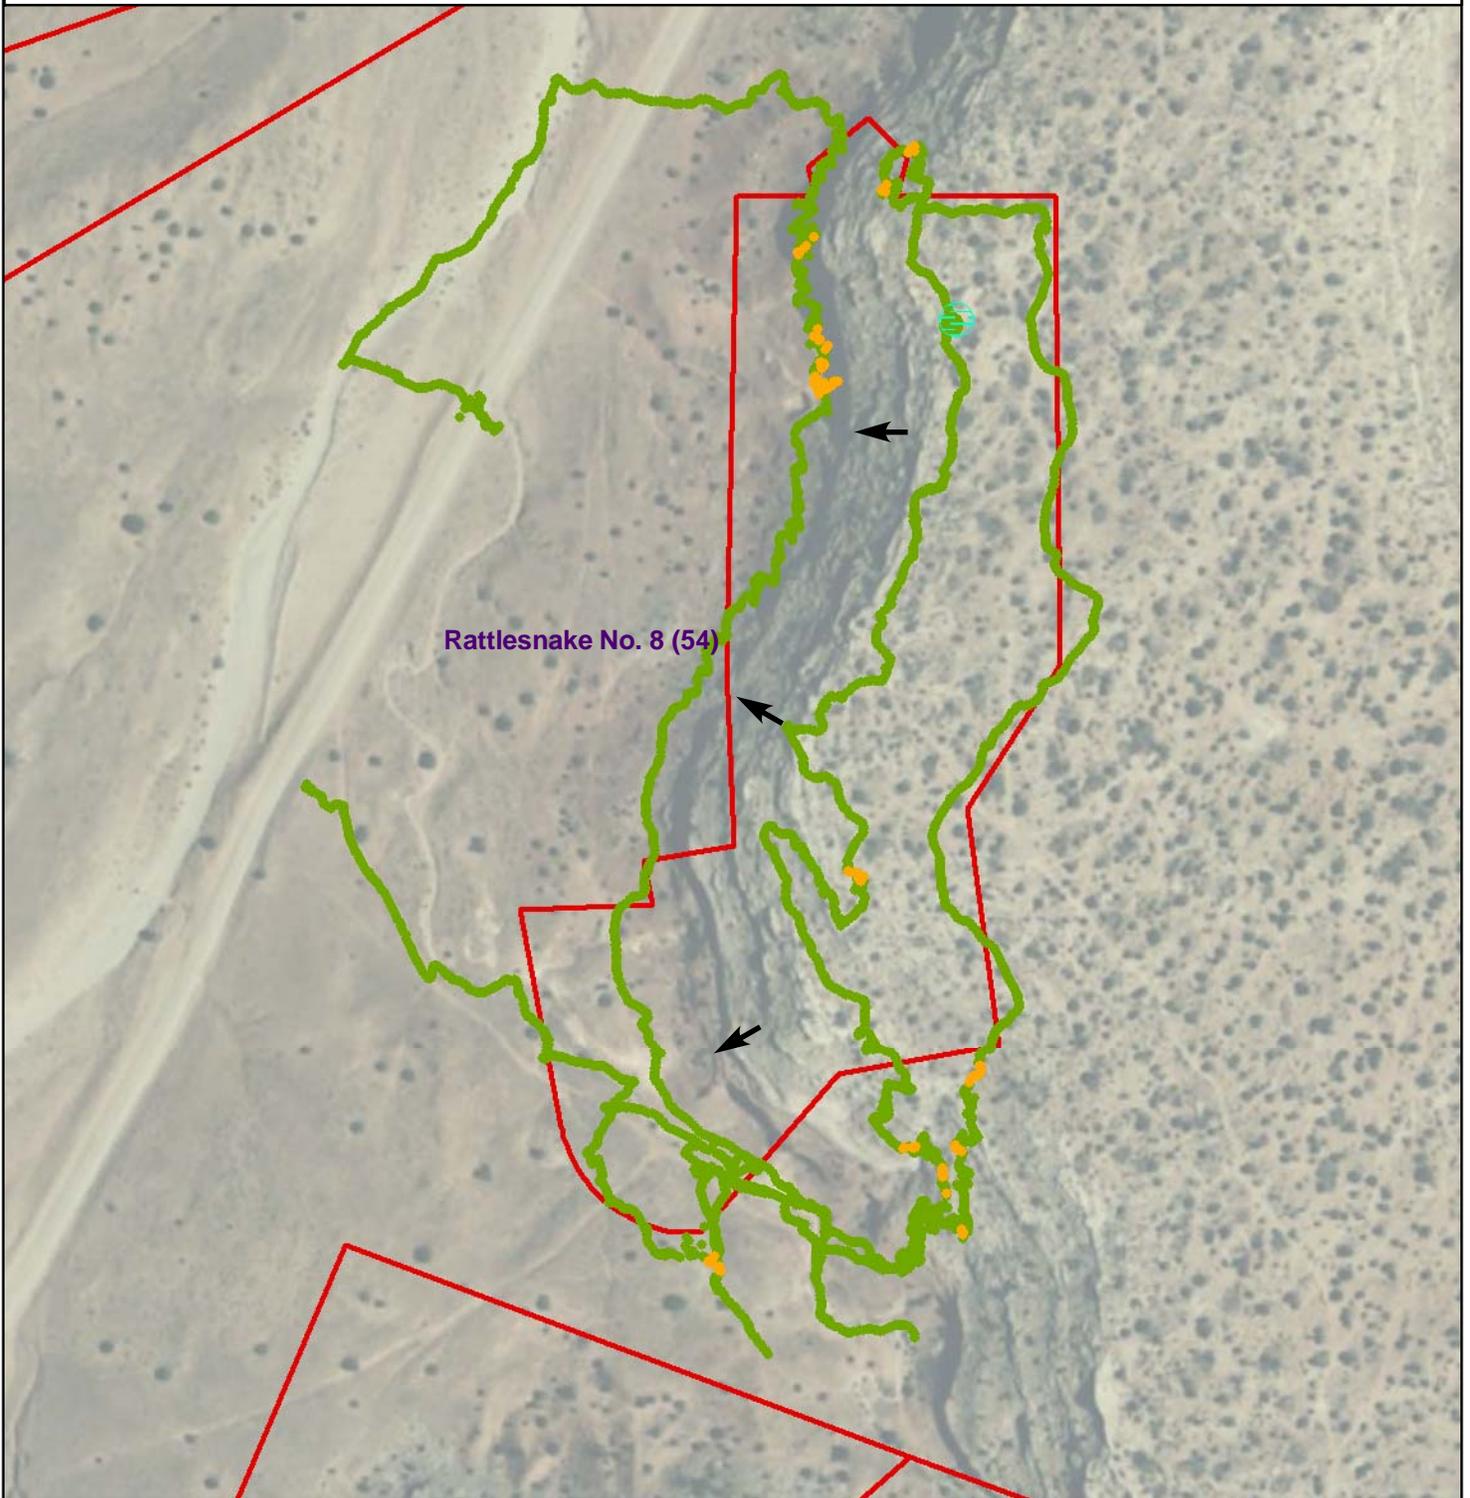
A total of 5,783 gamma radiation measurements were collected from the mine site, ranging from 5,466 cpm to 60,962 cpm. The measurements are represented in Figures 1 and 2.

**Figure 1 - Gamma Radiation Measurements, Above Two Times Background
Rattlesnake No. 8 (54)
Sweetwater / Teec Nos Pos Chapter, Navajo Nation**

Gamma survey conducted 06/2010
Measured as counts per minute (cpm)

Average background = 9,634 cpm

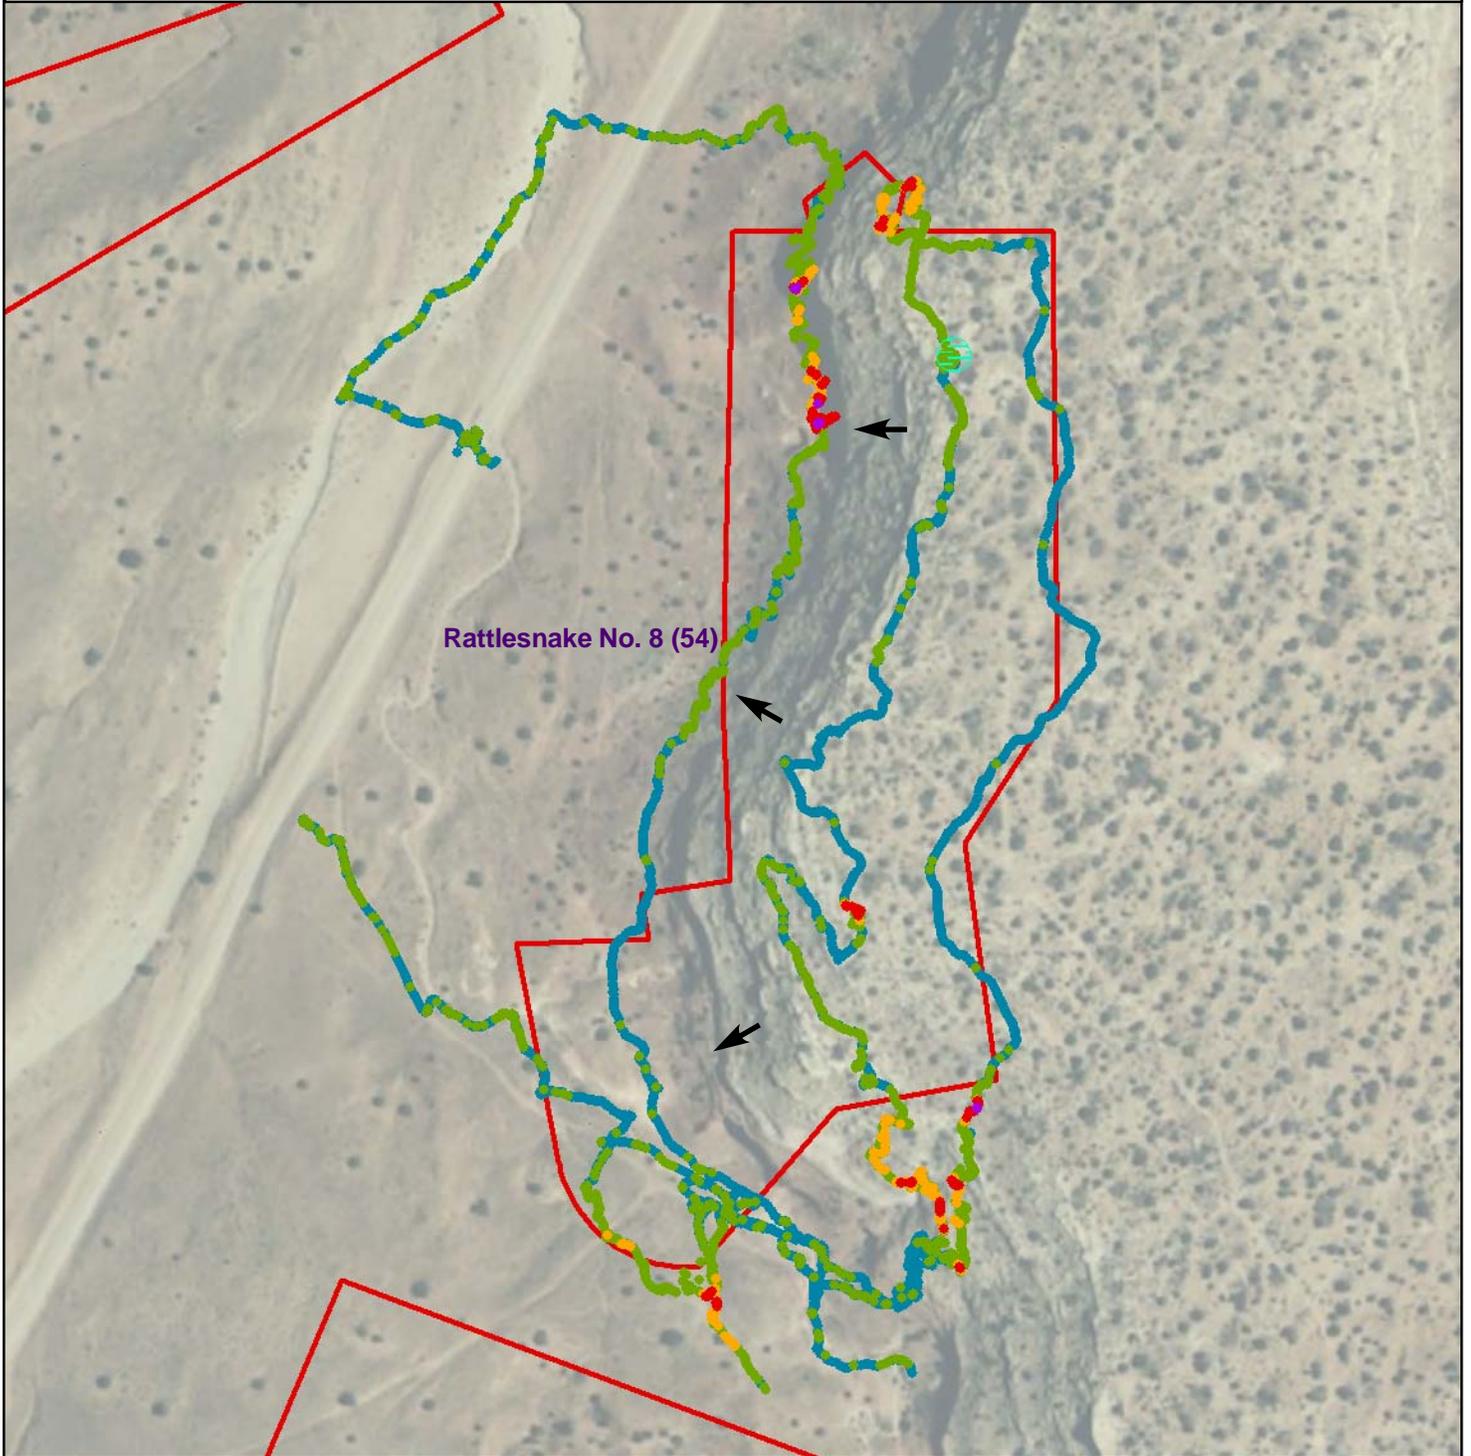
**Figure 2 - Gamma Radiation Measurements
Rattlesnake No. 8 (54)
Sweetwater / Teec Nos Pos Chapter, Navajo Nation**

Gamma survey conducted 06/2010
Measured as counts per minute (cpm)

Average background 9,634 cpm
