Navajo Abandoned Uranium Mine

Site Screen Report

Tsosie 1 AUM Site

August 2010

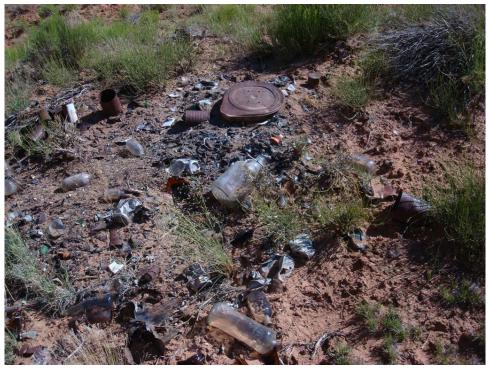
Photo 4. Tsosie 1 mine site, trash

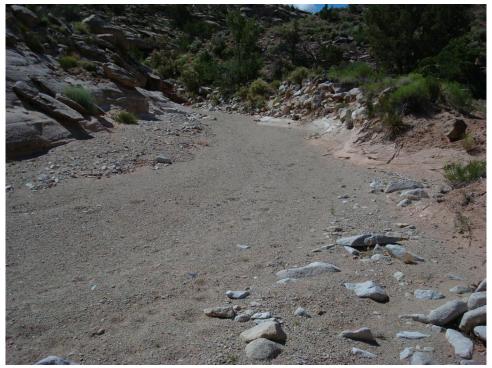
Photo 6. Tsosie 1 mine site, wash area
