# Navajo Abandoned Uranium Mine

## Site Screen Report

### Mesa IV, Mine No. 3 AUM Site

**March 2010**

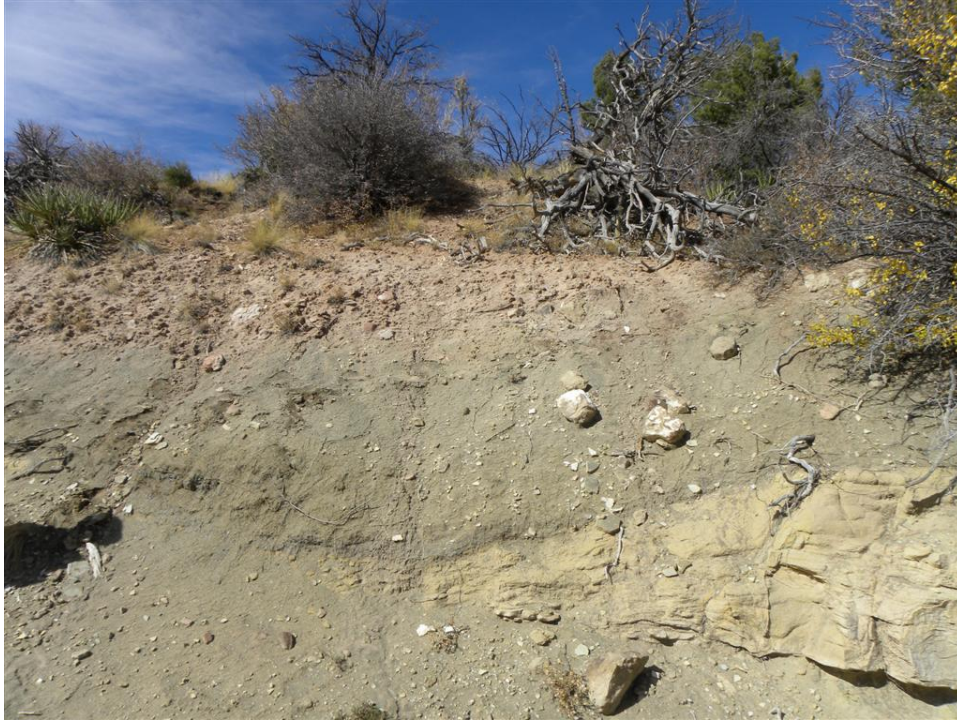
Waste debris extends through center strip of site, with a total estimated volume of 1,000 yd<sup>3</sup>

Photo 1. Waste pile

Unreclaimed waste pile

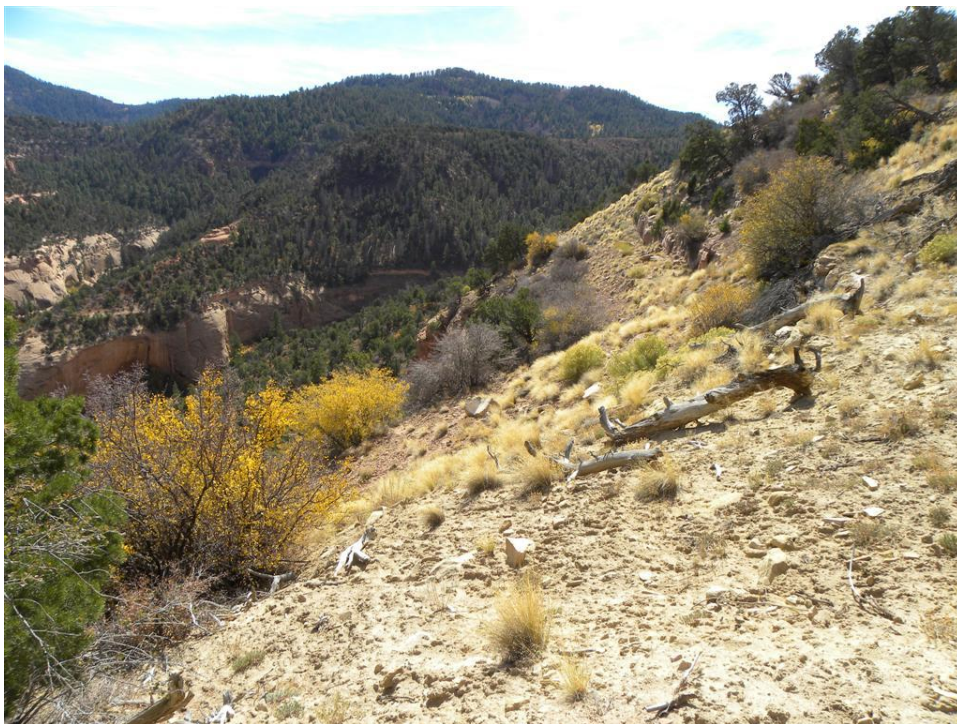
Photo 2. Waste debris and sloping area

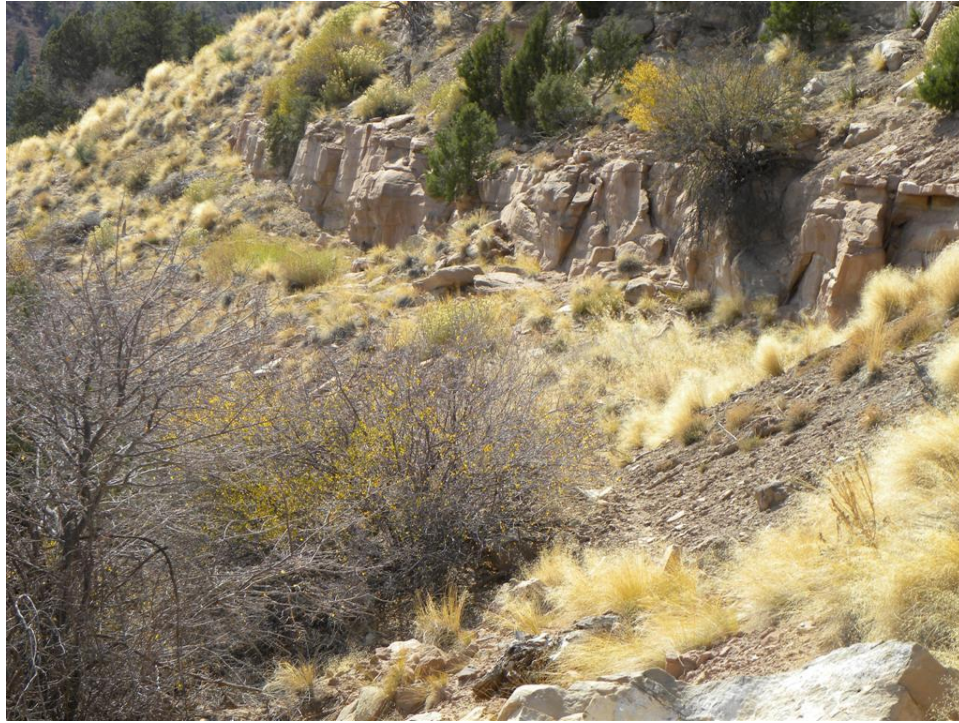
Photo 3. Waste debris and sloping area
