Navajo Abandoned Uranium Mine

Site Screen Report

Mesa V Incline AUM Site

March 2010

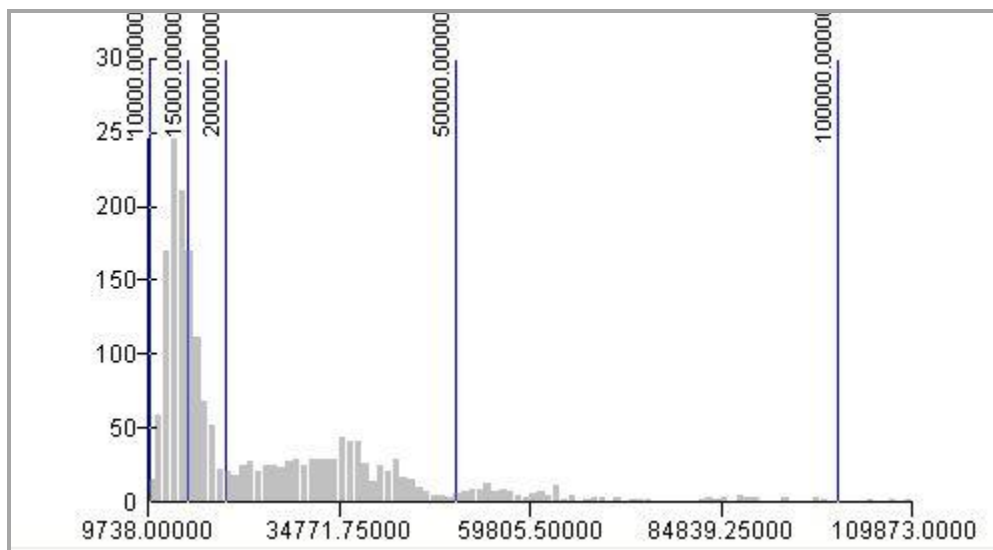
The following chart and statistics were generated by ESRI ArcGIS 9.3.1, and show the general distribution of the site gamma radiation measurements. The horizontal X axis represents the gamma radiation reading levels in cpm (lowest levels to the left). The vertical Y axis represents the frequency of each gamma radiation level.

Count:	1928
Minimum:	9738.00000
Maximum:	109873.00000
Sum:	46708483.00000
Mean:	24226.39160
Median:	16558.00000
Standard Deviation:	15116.64122

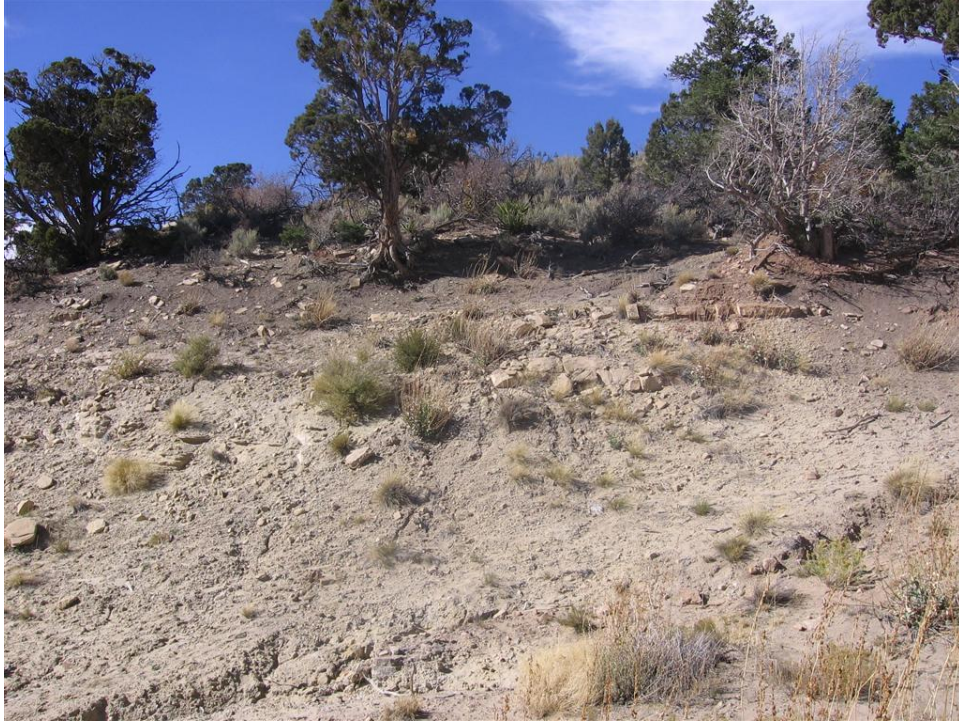
300' x 100' rock pile (w/ soft clay) at southern Mesa V Adit border (#609); more debris with high readings along southern rim of mesa, with a total estimated volume of 5,556 yd³

Photo 3. Waste rock

Unreclaimed waste pile

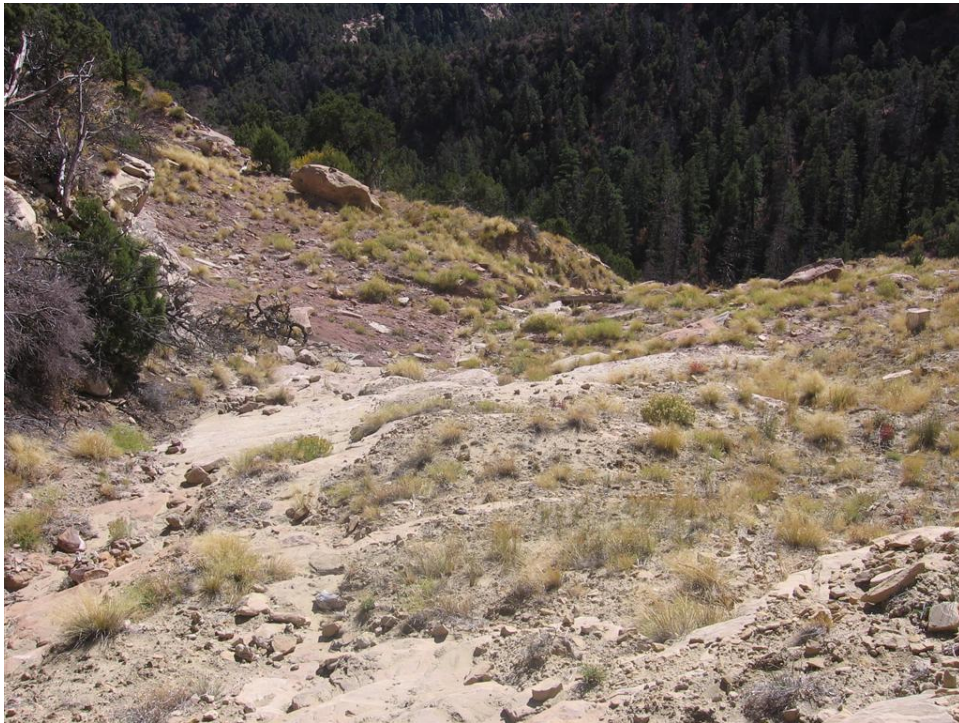
Photo 4. Mine site

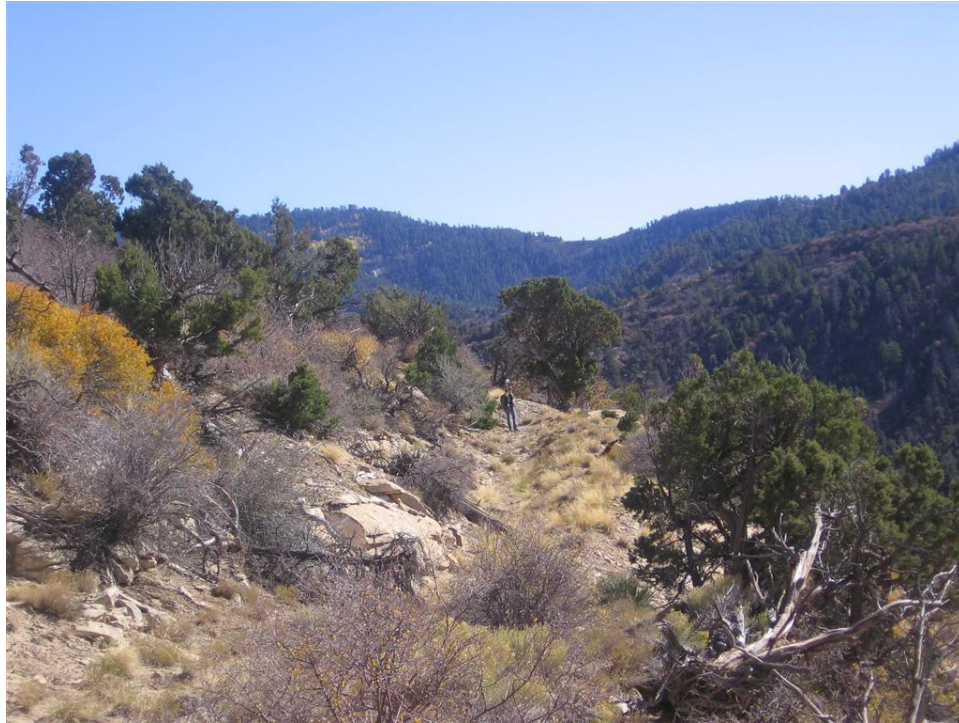
Photo 5. Mine site pathway

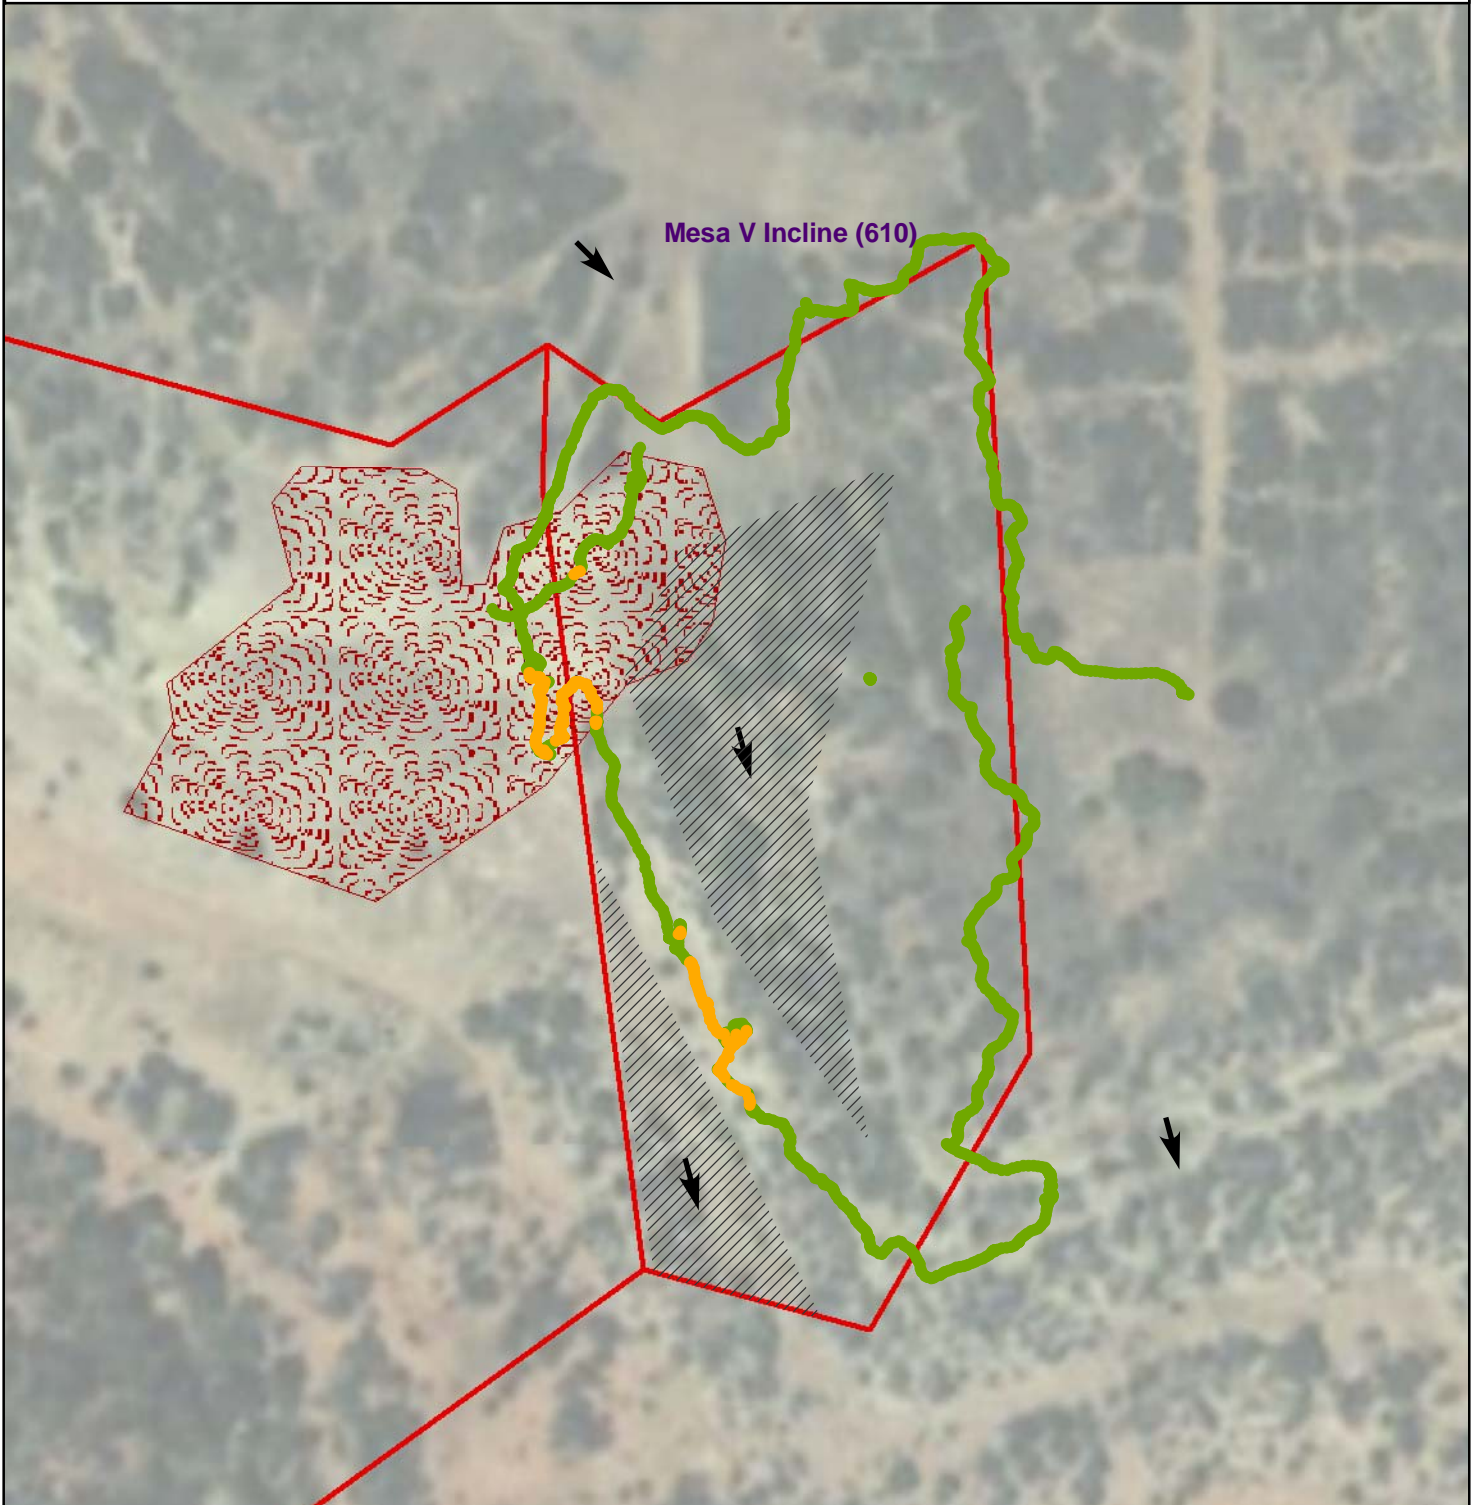
A total of 4,108 gamma radiation measurements were collected from the mine site, ranging from 5,133 cpm to 160,961 cpm. Measurements in the vicinity of the waste debris were found at levels ranging from 40,000 to 100,000 cpm. The measurements are represented in Figures 1 and 2.

**Figure 1 - Gamma Radiation Measurements, Above Two Times Background
Mesa V Incline (610)
Cove Chapter, Navajo Nation, Arizona**

Gamma survey conducted 10/2009
Measured as counts per minute (cpm)

Average background = 19,012 cpm

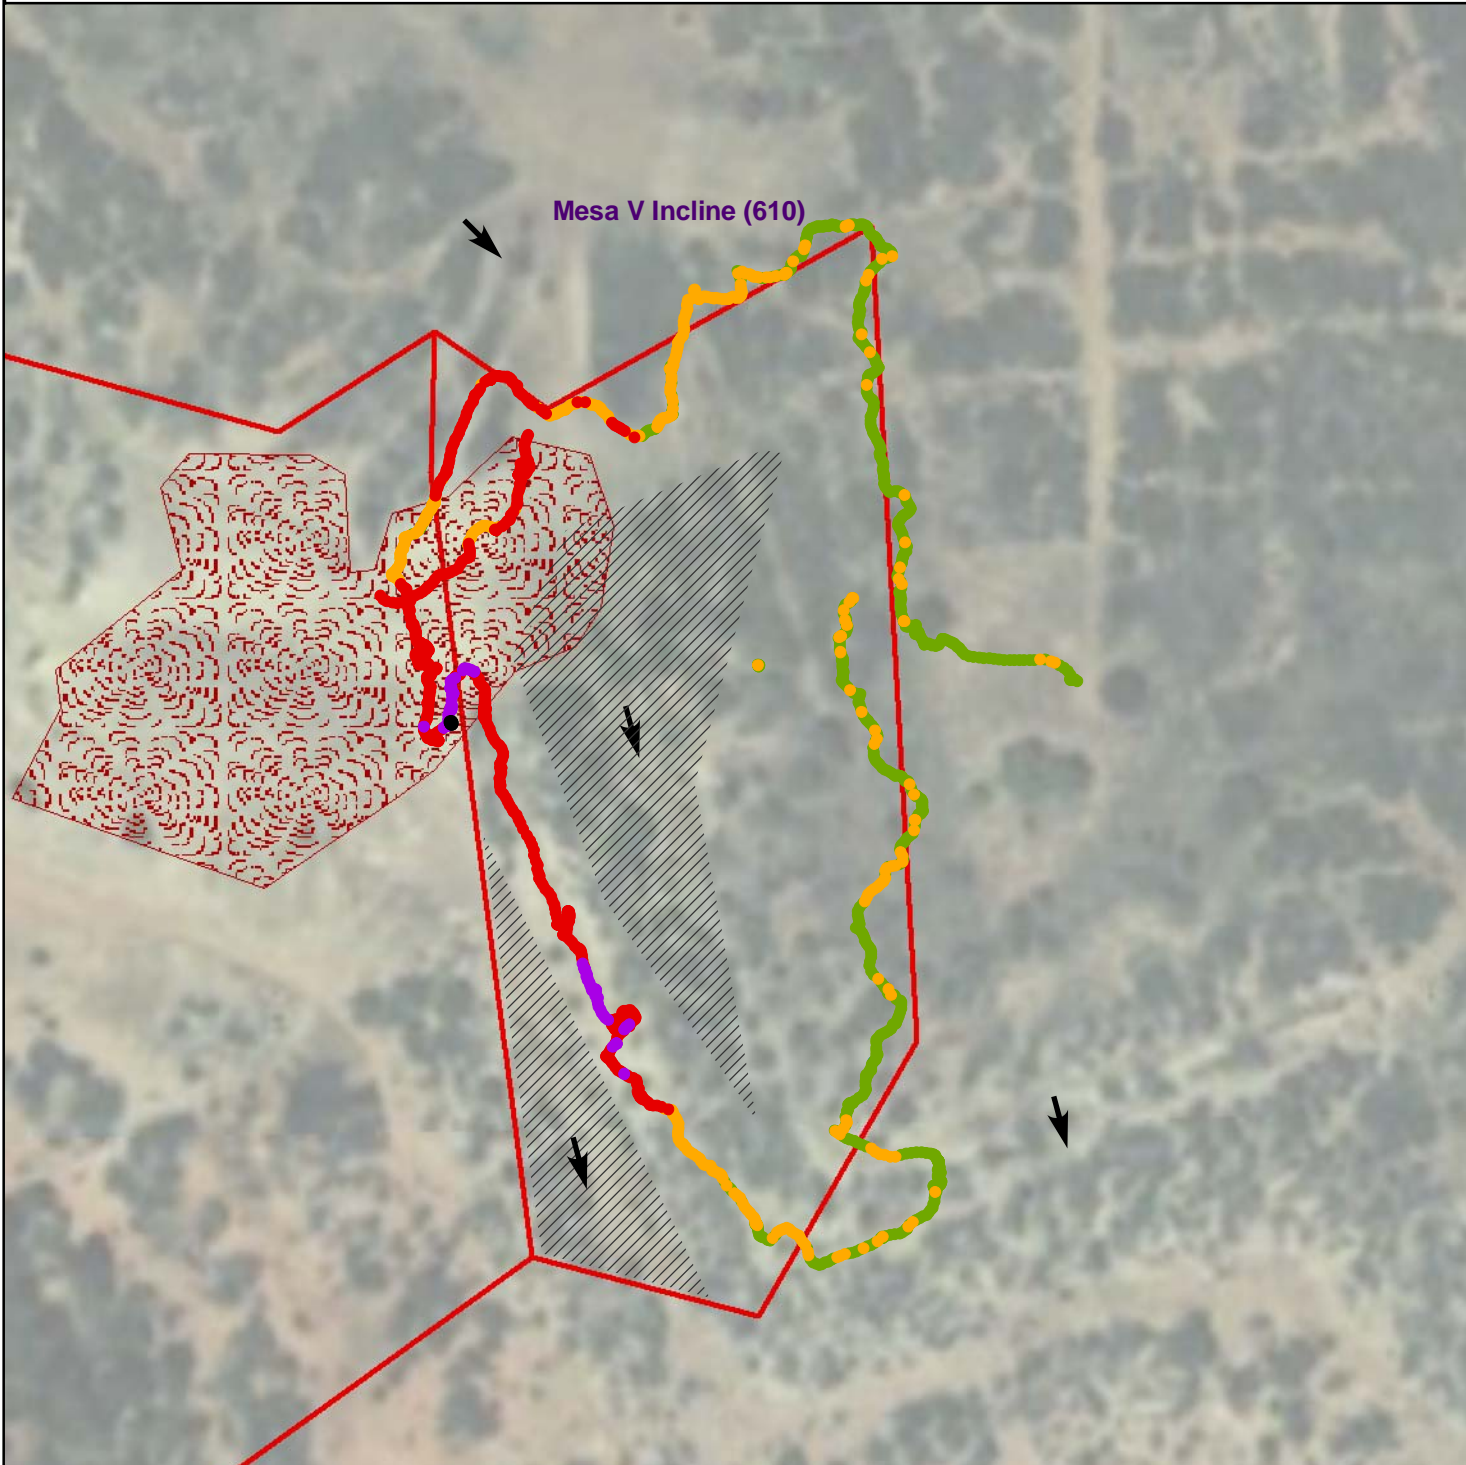
**Figure 2 - Gamma Radiation Measurements
Mesa V Incline (610)
Cove Chapter, Navajo Nation, Arizona**

**Gamma survey conducted 10/2009
Measured as counts per minute (cpm)**

Average background = 19,012 cpm
