Navajo Abandoned Uranium Mine

Site Screen Report

Joe Ben 1 AUM Site

Navajo AUM Northern Region

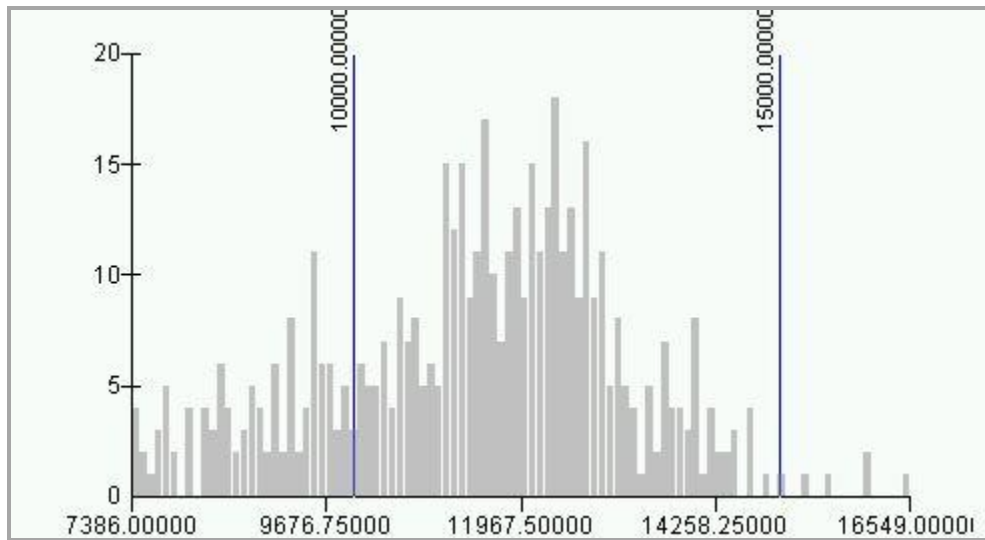
The following chart and statistics were generated by ESRI ArcGIS 9.3.1, and show the general distribution of the site gamma radiation measurements. The horizontal X axis represents the gamma radiation reading levels in cpm (lowest levels to the left). The vertical Y axis represents the frequency of each gamma radiation level.

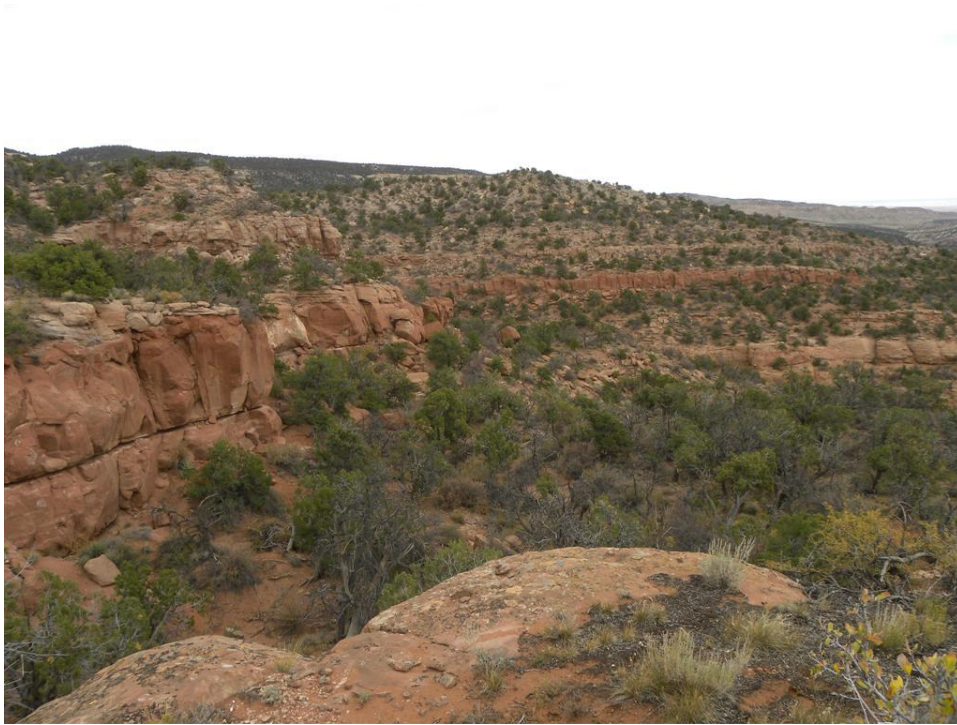
Photo 1. View of mine site in distance

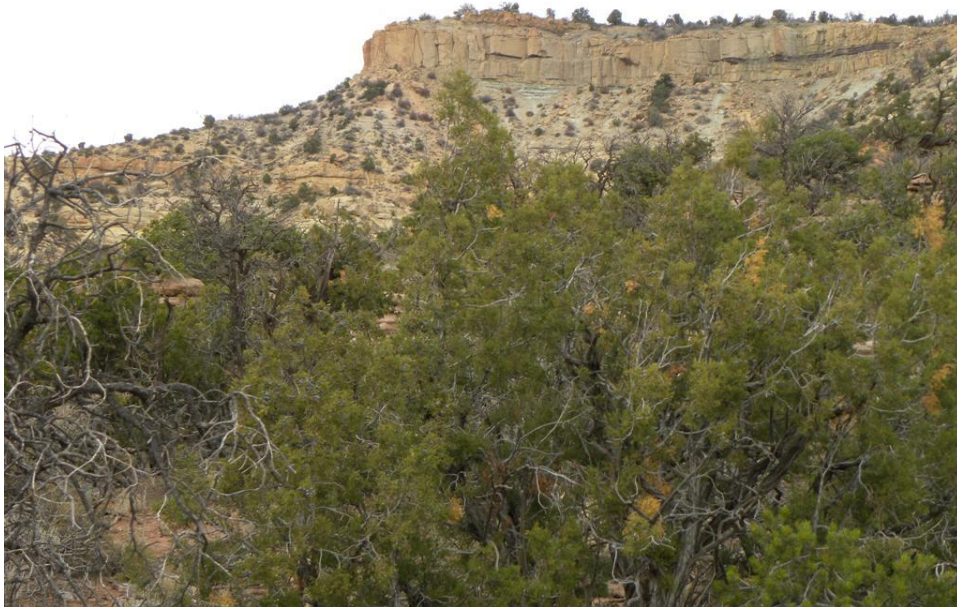
Photo 2. View of mine site in distance

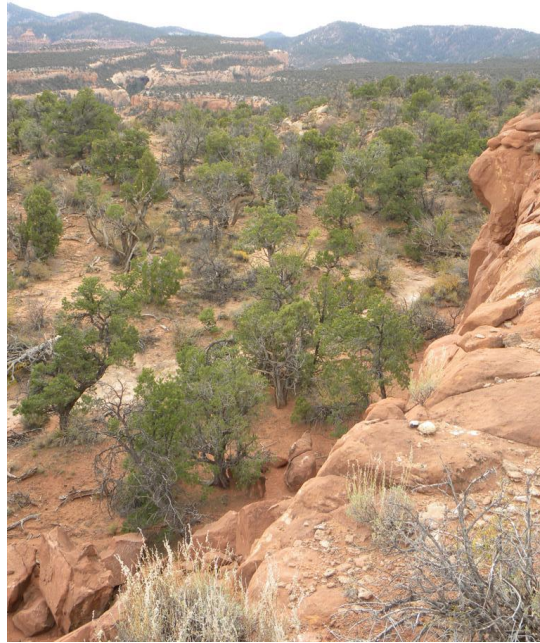
Photo 3. View down towards mine site

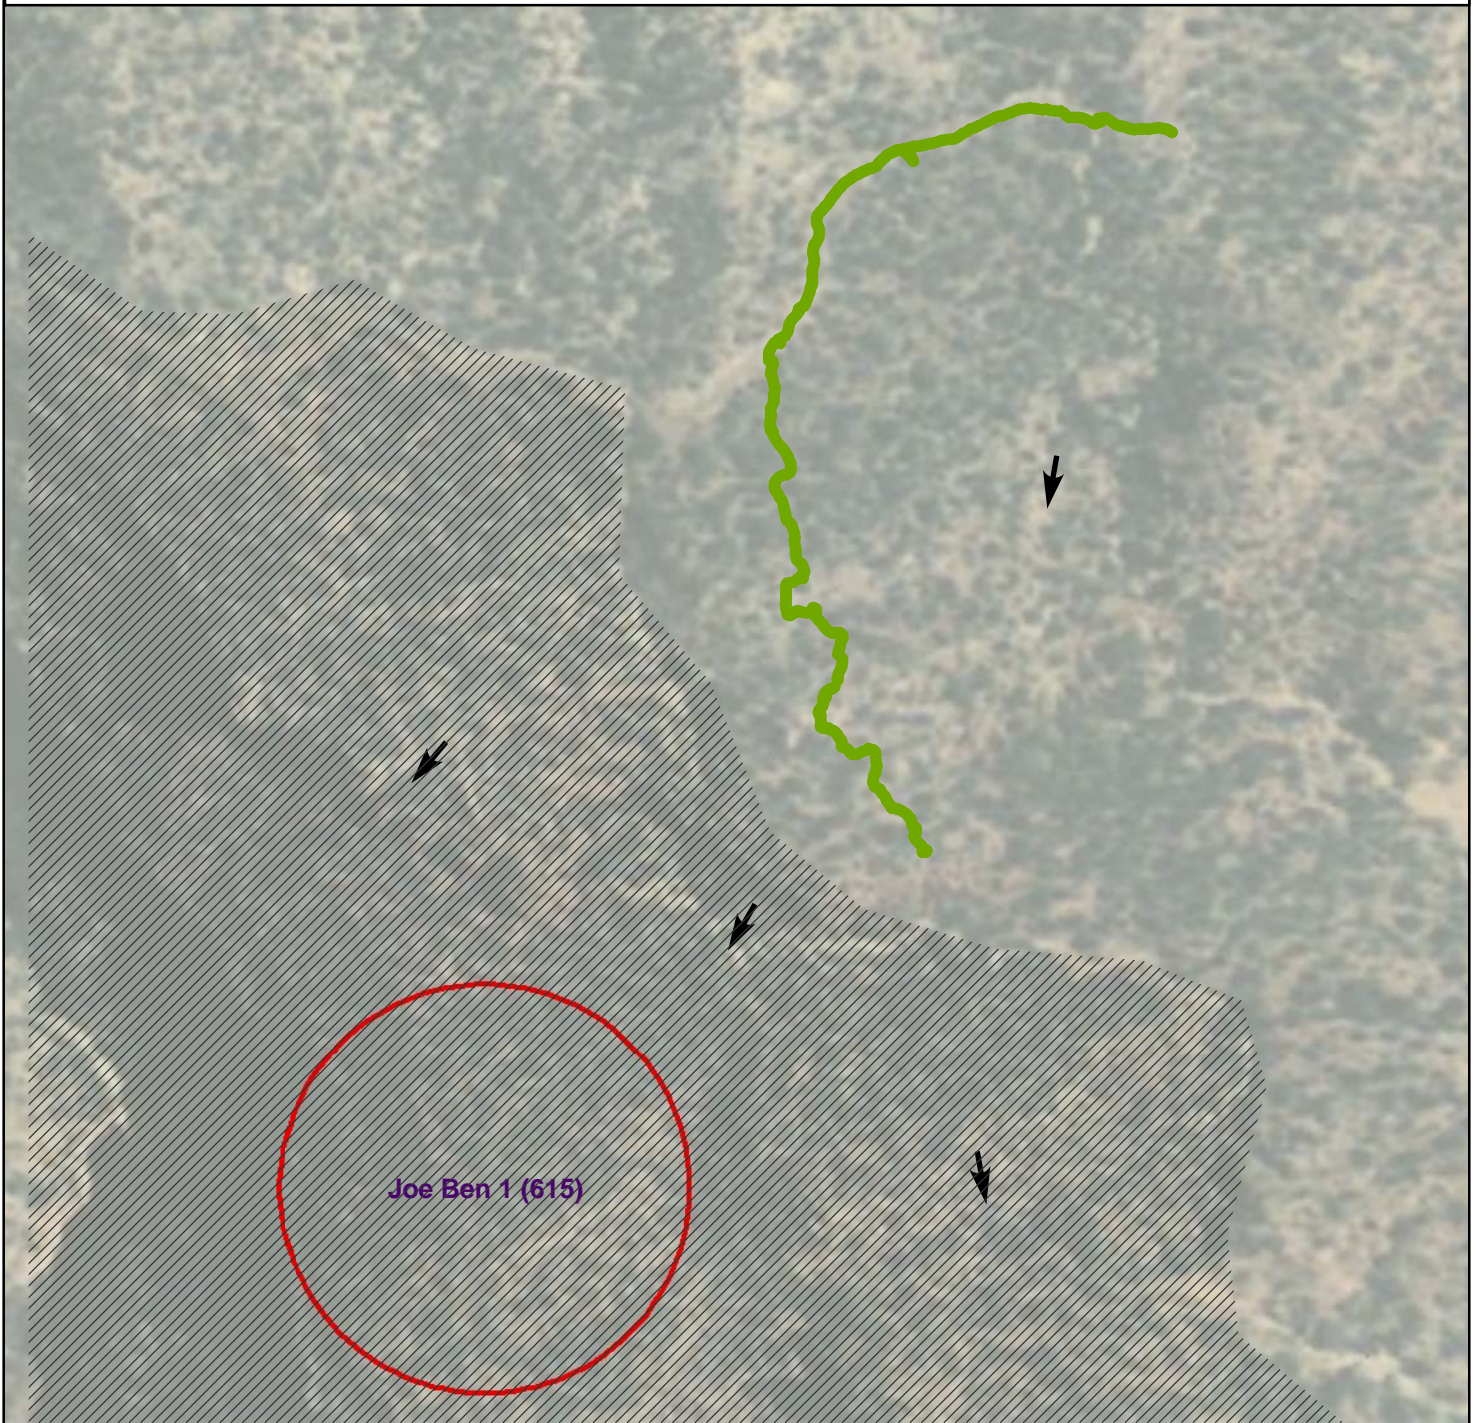
**Figure 1 - Gamma Radiation Measurements, Above Two Times Background
Joe Ben 1 (615)
Sanostee Chapter, Navajo Nation, Arizona**

Weston was unable to access the site during the October 2009 site screenings.
All known paths leading towards the site were impassable. See site screen report for documentation.

Gamma survey conducted 10/2009
Measured as counts per minute (cpm)

Average background = 8,965 cpm

Inaccessible due to steep grades

Weston was unable to access the site, all known paths leading to the site were impassible due to steep grades. Measurements were collected in the vicinity of the site, approximately 250' northeast of the site boundary. A total of 511 gamma radiation measurements were collected near the mine site, ranging from 7,386 cpm to 16,549 cpm. The measurements are represented in Figures 1 and 2.

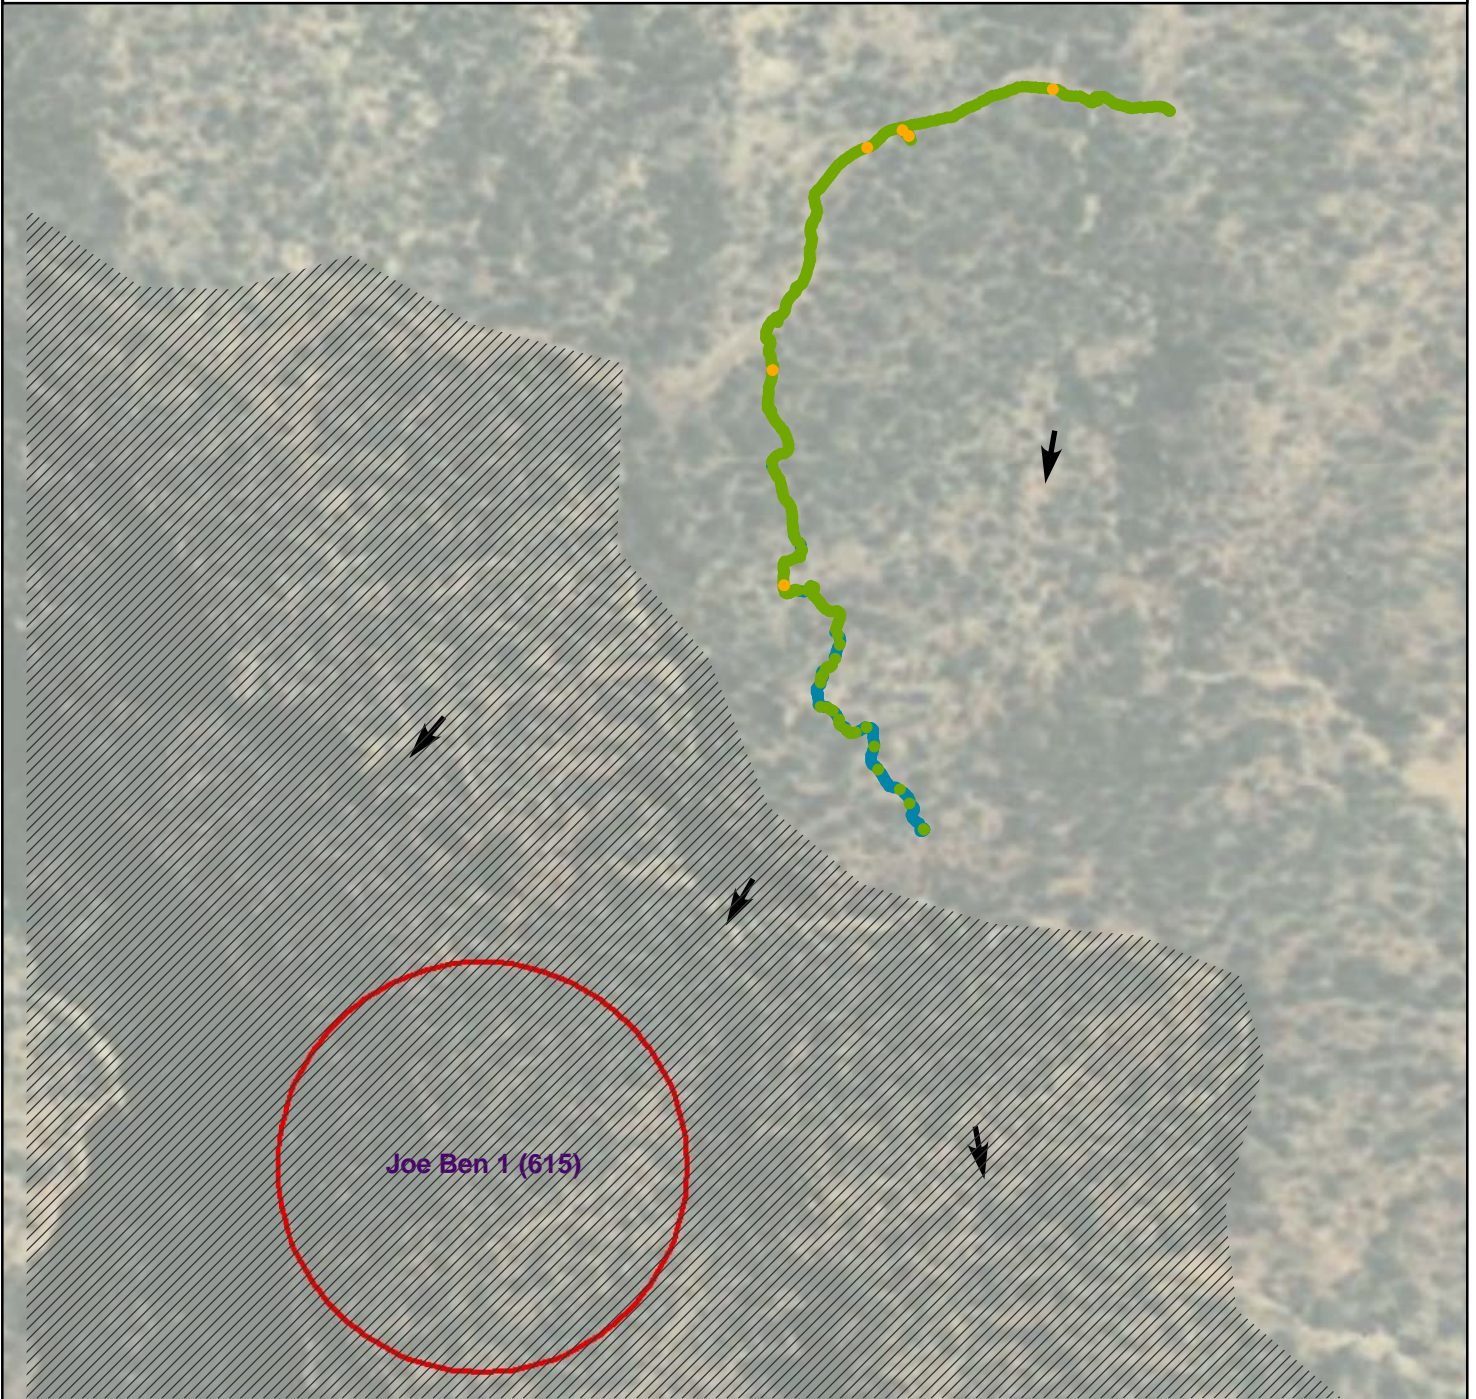
**Figure 2 - Gamma Radiation Measurements
Joe Ben 1 (615)
Sanostee Chapter, Navajo Nation, Arizona**

Weston was unable to access the site during the October 2009 site screenings.
All known paths leading towards the site were impassable. See site screen report for documentation.

Inaccessible due to steep grades

Gamma survey conducted 10/2009
Measured as counts per minute (cpm)

Average background = 8,965 cpm
